MINES BRANCH INVESTIGATION REPORT IR 66-105

**EXAMINATION OF FAILED COPPER
ALLOY FLEXIBLE METAL STEAM
HOSE ASSEMBLIES**

Two flexible metal joints, which had exploded at the new Union Station, Ottawa, were examined.

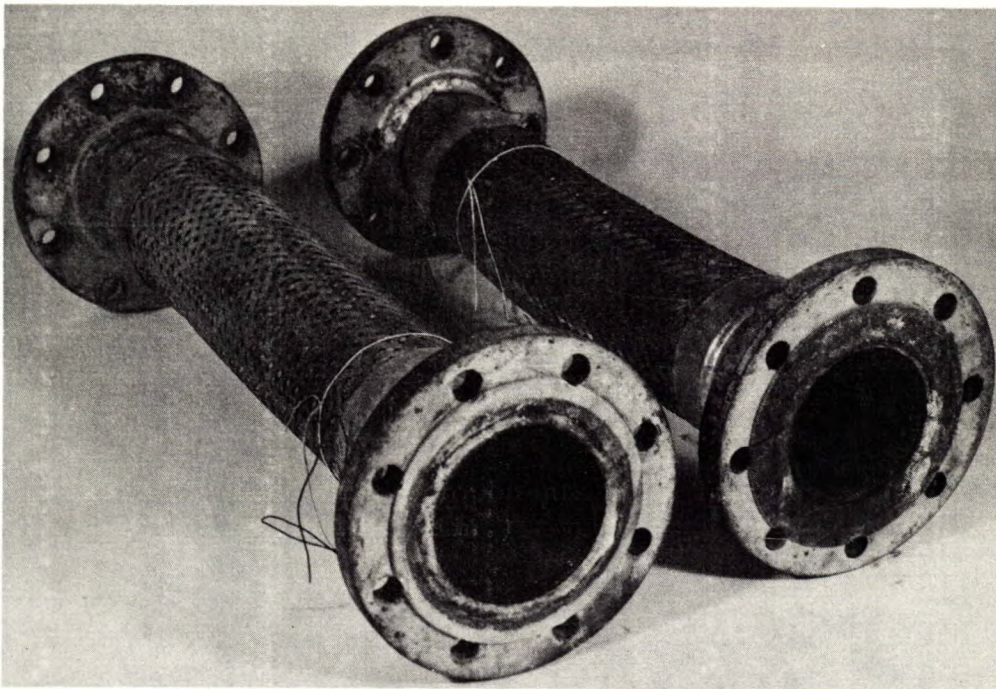
Two similar but longer joints which were received by National Research Council for comparative testing are shown in Figure 1. The recovered components of one of the other two failed joints are shown in Figure 2 to illustrate the extent of deformation and general mode of failure.

Figure 1. Flexible metal hose assemblies (live length 16-1/2 in.)

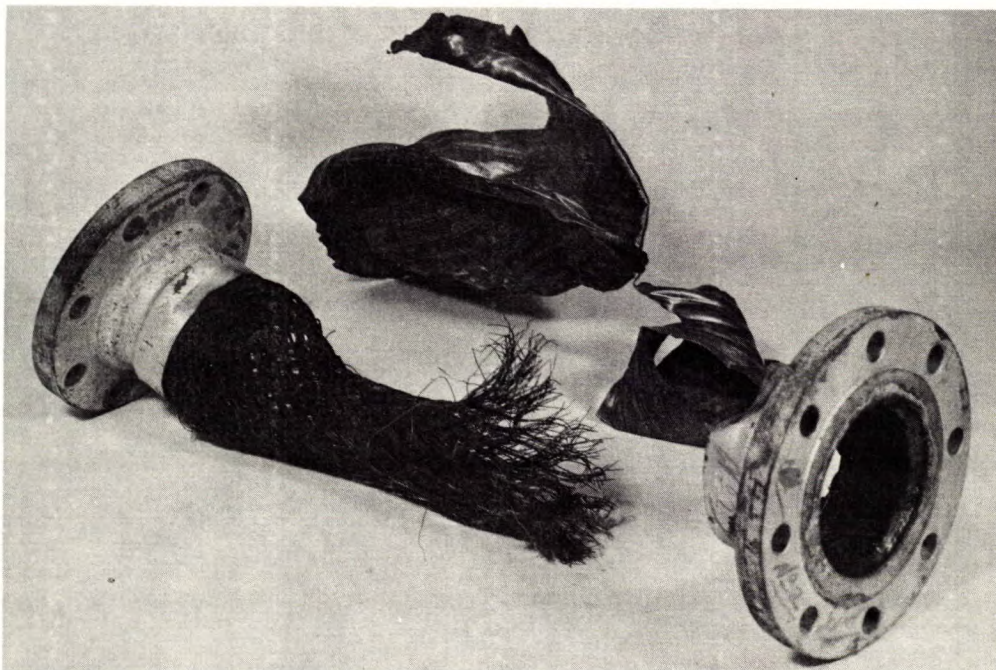
- (b) Joint No. 2. As shown in Figure 2, three components were recovered, although examination of the fractures indicate that smaller lens-shaped pieces (say 2" x 4") are missing from each end of the corrugated inner tube. The appearance suggests that initial failure occurred in the braid at the brazed joint on the right hand side of Figure 2, and that the inner corrugated tube had then extended under the steam pressure. It is proposed that failure of the inner tube then occurred at the left hand brazed joint of Figure 2, and, in pulling the corrugated tube through the braided sleeve, the necking down of this sleeve occurred. It would be expected that once the inner tube was separated from the sleeve, steam would escape, and no further fracture would occur. Hence it is proposed that the fracture of the inner tube at the right hand flange of Figure 2 was probably initiated by some bending or shear movement of the inner tube on the flange. Once this fracture was initiated, the inner tube, completely unsupported by the braid was torn and split upwards towards the already broken end, but the tear stopped before it reached this end. This can be seen in Figure 2 where the lens-shaped fractured end of the tube

can be seen just behind the right hand flange. In fact this fracture came from the left hand flange so that the whole corrugated tube should be displaced end to end.

Figure 2. Recovered components from Joint No. 2 (live length 10-3/4 in.)

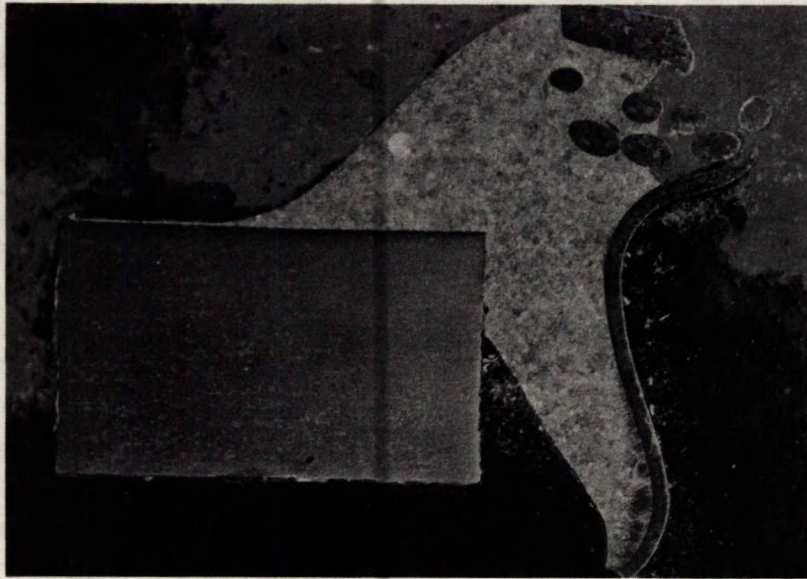
The joints consist essentially of an inner closely corrugated thin pipe of bronze (approximately 98.5% Cu, 1.5% Sn and 0.06% P) which is overlaid by a braided sleeve of brass wire (approximately 90% Cu and 9.5% Zn). These have been butted against the steel flanges, surrounded by a brass collar, and brazed to form a joint. A cross section of the joint, with the brass collar torn away to facilitate visual inspection, is shown in Figure 3.

Figure 3. Cross section of brazed joint showing steel flange, inner corrugated tube, wire braid, brazing metal and part of binding collar.

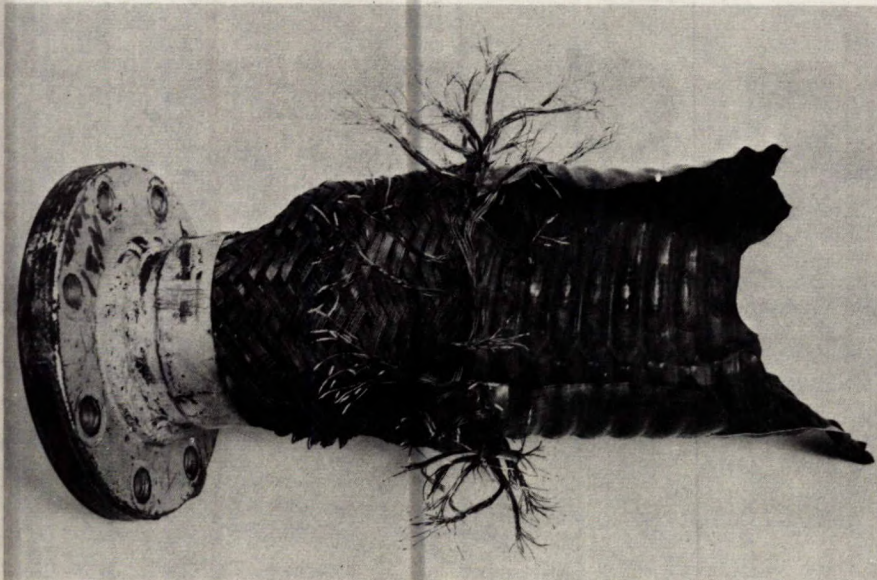
(a) Joint No. 1. The joint which is shown in Figure 4 is seen to be in two pieces, and the way in which the corrugated tube has split and forced the braided sleeve down towards one flange and other factors suggest that the progression of failure was as follows:

- (1) failure of the braid wires at or near the brazed joint,
- (2) extension of the inner corrugated tube,
- (3) failure of the inner tube near one end,
- (4) longitudinal splitting and opening of the inner tube from this end pushing the braided sleeve ahead of it towards the other end.

Figure 4. Joint No. 1 - photographed after preliminary examination of broken wire ends etc.

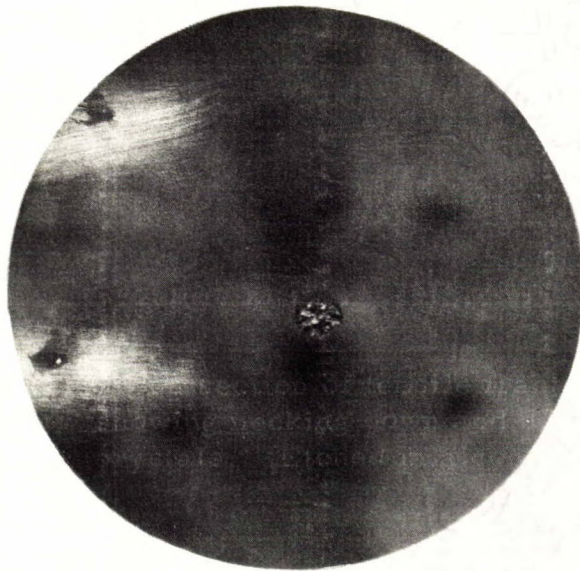
X10 approx.

Figure 5. Fractured end of braid wire broken in tension.

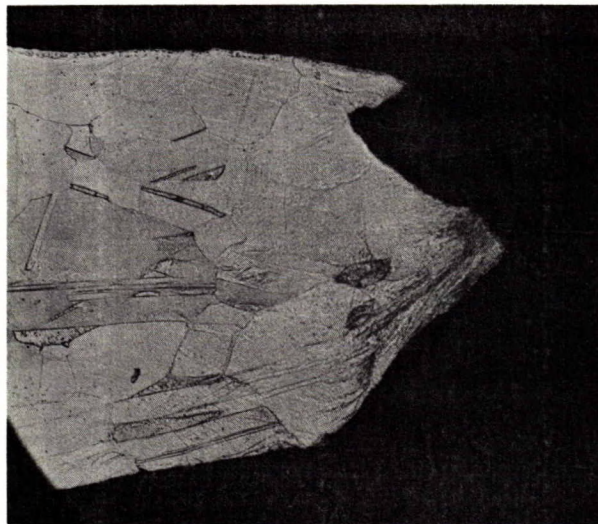
X100

Figure 6. Cross section of tensile fracture of braid wire showing necking down and deformation of crystals. (Etched in alcoholic FeCl_3).

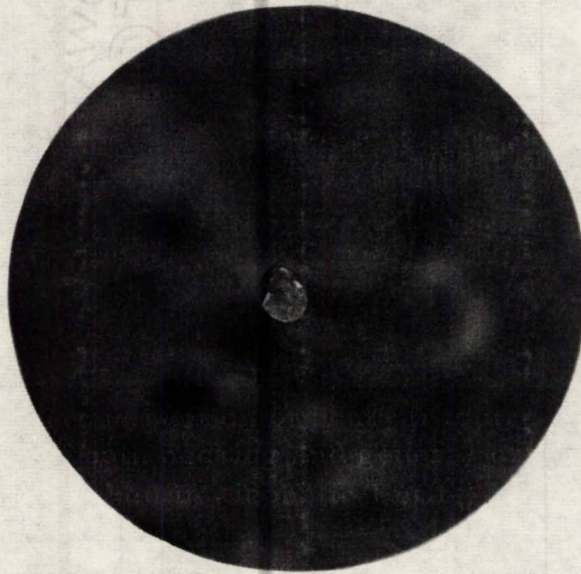
X10 approx.

in Figures 7 and 8. Of this total of 60 wires, 42 were in one area extending over about 2-1/4 in. of the circumference, and the others were close to this area.

Figure 7. End of braid wire from Joint No. 1 showing cut marks rather than tension failure.

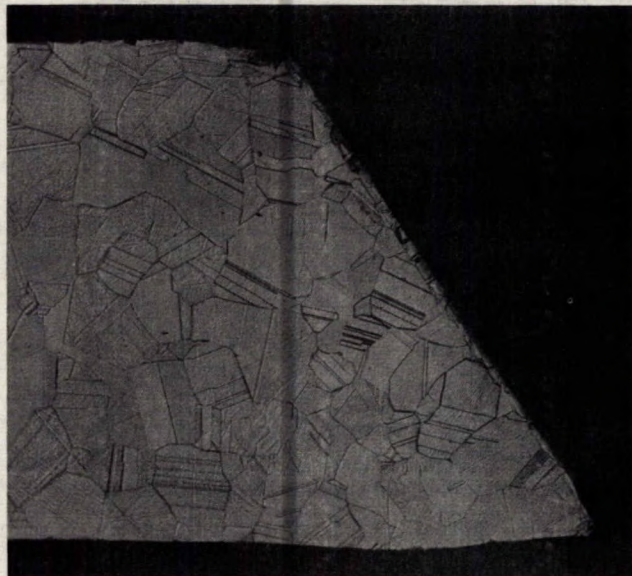
X100

Figure 8. Cross section of "cut" fracture showing absence of both necking and general crystals elongation. (Etched in alcoholic FeCl_3).

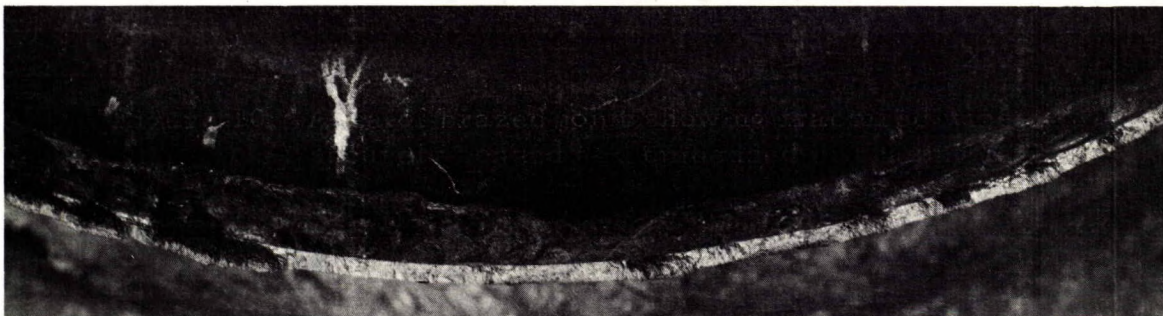
X2.5

By relating discoloured "water level" marks on the inner surface of the corrugated tube with those on part of the tube remaining on the flange, it was possible to orient the wires showing non-tensile fractures with the approximate section of the brazed joint approximately where they were located. Figure 9 shows a view of this area in the fracture after the outer brass collar had been removed, and for comparison, an area showing the full component of fractured wires bonded in the brazing metal is shown in Figure 10. It would appear therefore that over about 2-1/4 in. of the circumference of one end of Joint No. 1, 42 out of an expected total of 67 braid wires were not bonded to the brazing metal.

Figure 9. Top inside view of brazed joint from area showing "cut" wires after removal of outer brass collar. Note general absence of wires bonded into brazing metal.

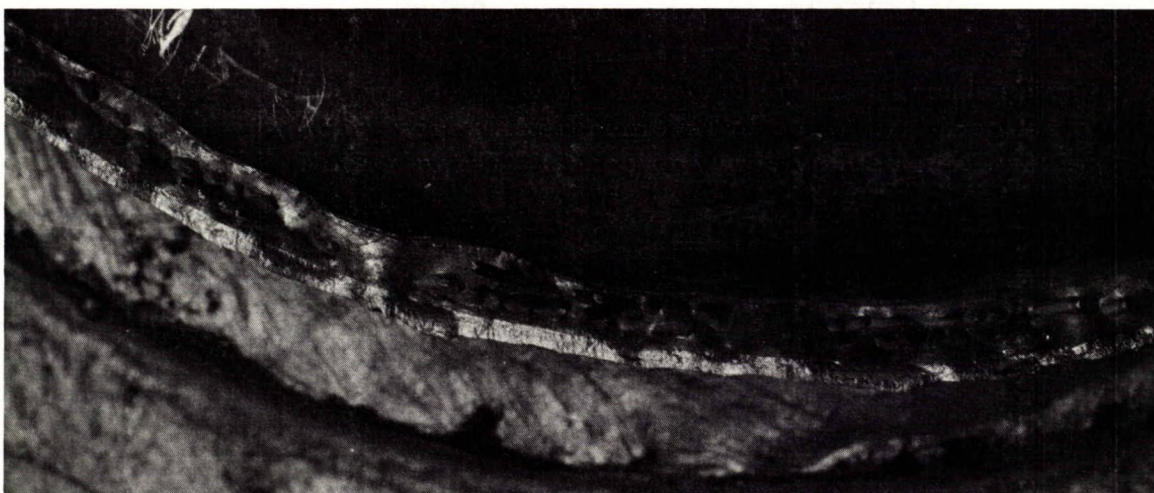
X2.5

It was noted that the fractures of the failed inner tube on the free flanges of both Joints 1 and 2 were very similar (Figure 11). Both contained what appeared to be an original tensile failure close to the braze, both ends of which tore upwards, and the extensive damage to the inner tube and collar at the opposite side of the fracture appears to have been caused largely by bending. Figure 10 shows the tensile portion of the fracture on the free flange of Joint 2.

Figure 10. Area of brazed joint showing fractured wires securely bonded and embedded in brazing metal.

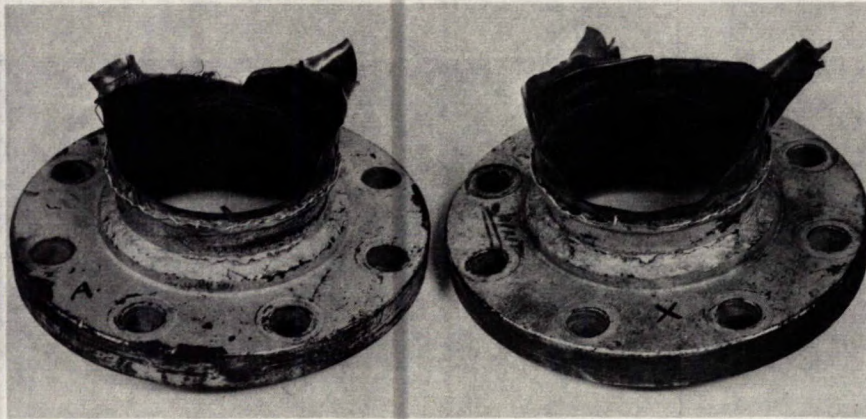
Figure 11. Two free flanges from No. 1 and No. 2 joints. Similarity of inner tube fractures suggests that fracture mechanisms were essentially similar. Outer brass collar has been peeled back to facilitate examination.

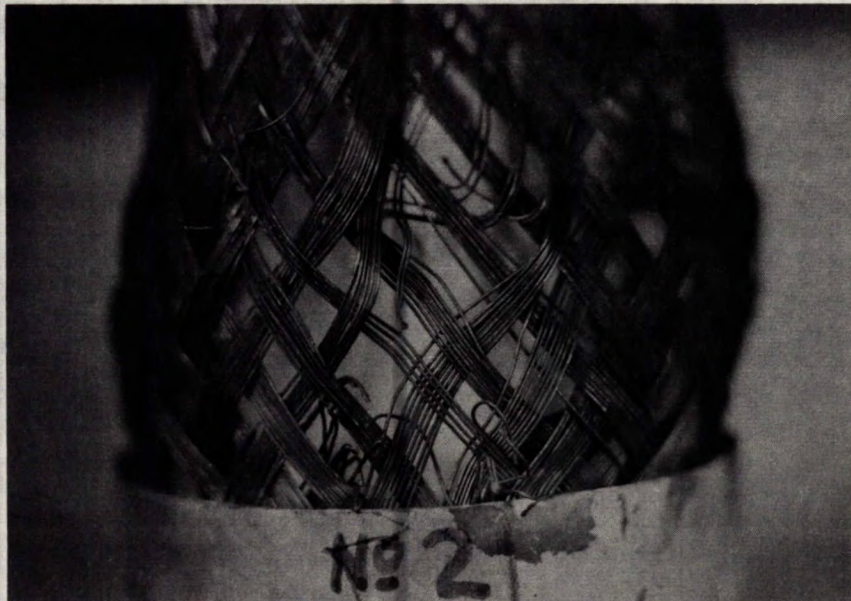
In one area of Joint 2, about 18 braid wires had been melted, presumably by the careless application of a brazing or welding torch, as can be seen in Figure 12. (It is not known whether these melted wires had been displaced before, during or after the explosion). Careful registration and examination of the corrugated inner tube in the area which would have been behind this heated zone suggested that the fracture passed a little away from this area, and that in any case, the fracture in this region was of secondary tearing origin, not that of primary failure.

Figure 12. Braid wires damaged by melting above the collar of Joint No. 2.

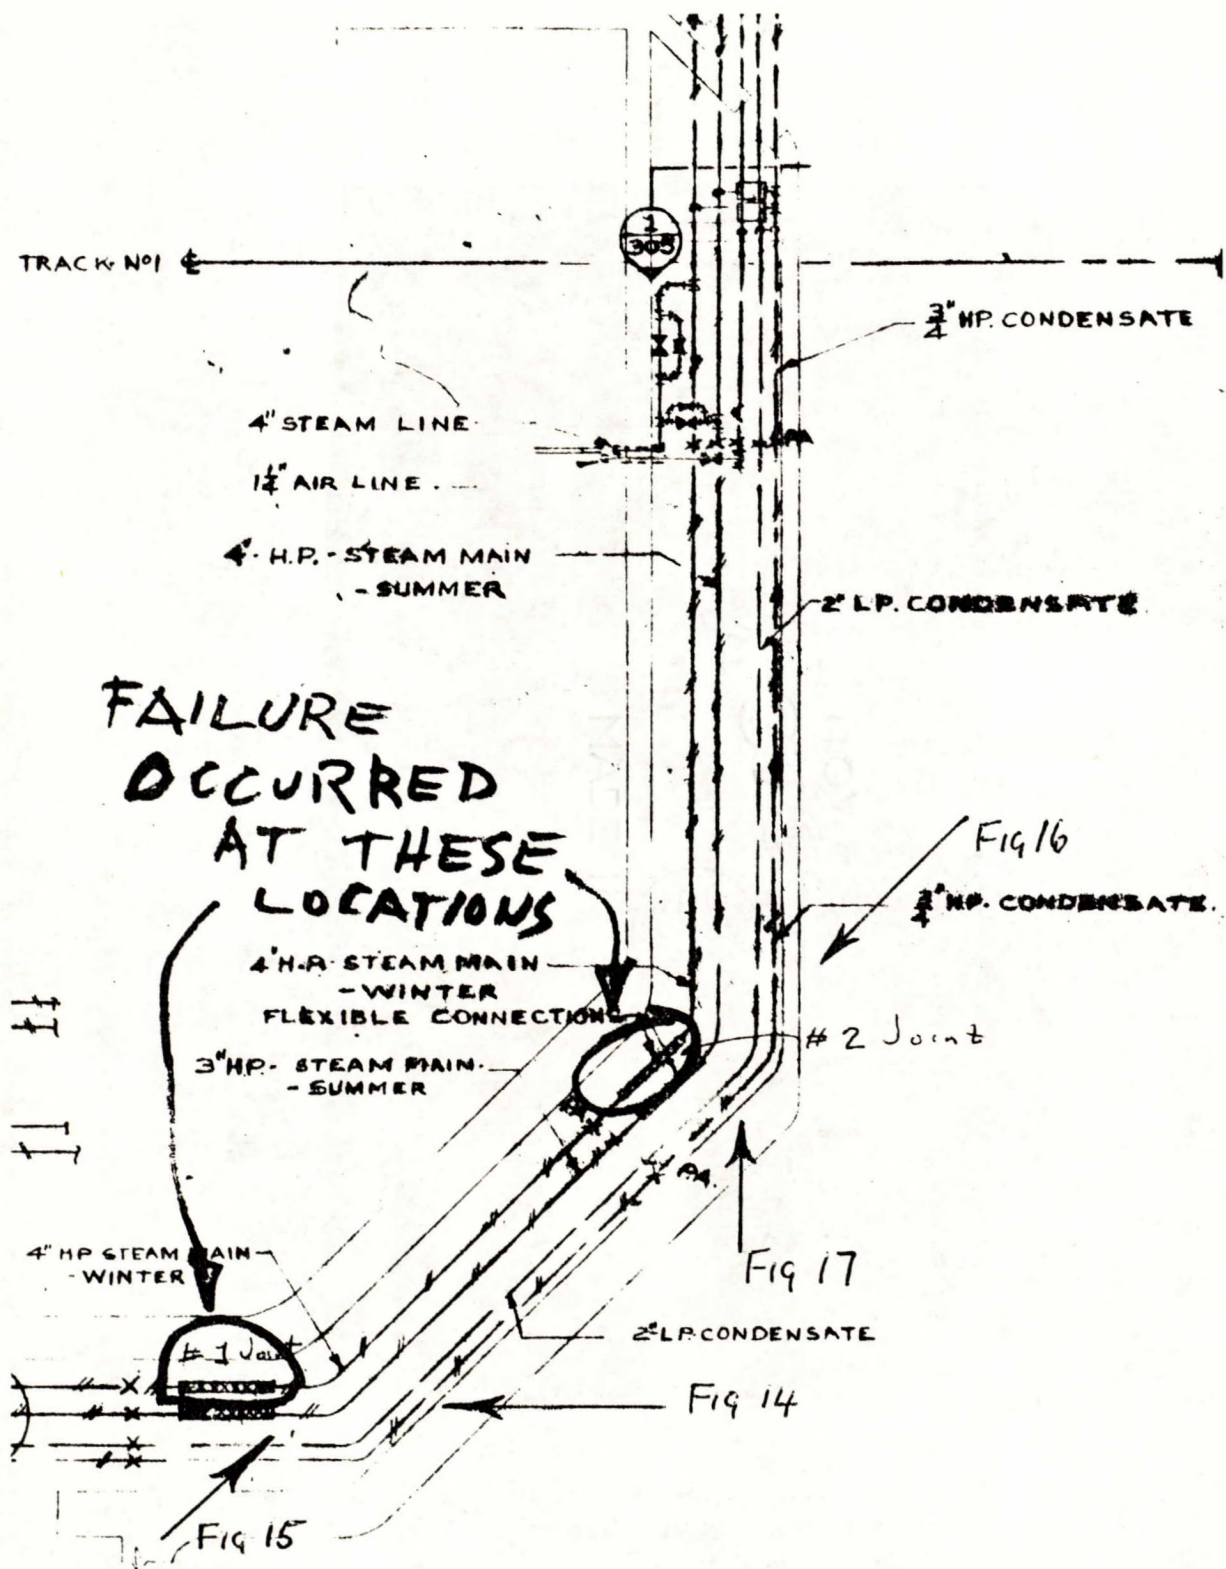
It was found that, in Joint No. 1 (Figure 13), 60 braid wires out of 432 were not bonded to the flange by the brazing operation. These unbonded wires were concentrated in one portion of the circumference so that in one 2-1/4-inch arc, only 35% of the wires were bonded. Although it is considered that this defect is significant, it is not known exactly what reduction in the bursting pressure of the joint it would cause.

A plan of the critical section of the piping system is given in Figure 13 which also shows the location and direction from which the following four photographs of the failure site were taken (Figures 14-17). It is most unfortunate that the failed expansion joints were stripped from the pipes before the photographs were taken. This makes it much more difficult to determine the mode of failure since the fractured surfaces can no longer be positively related to the movement of the steam pipe during the explosive failure.

Figure 13. Schematic of piping system in area of failure showing location and direction of Figures 14-17. Approx. scale 1/8 in. = 1 ft.

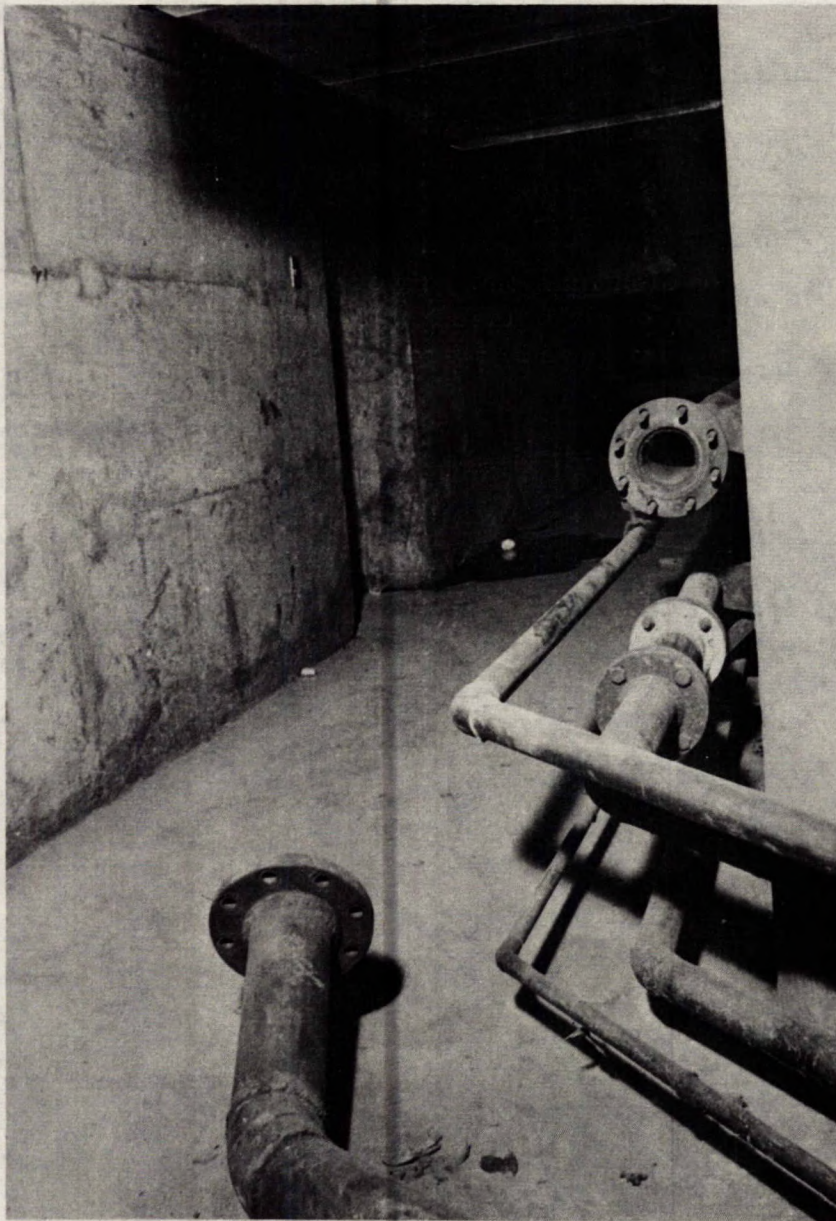
Considering the location of the pipes, and the damage to the piping system shown in Figures 14-17, this must now be explained in terms of a sequence of failure.

Figure 14. Joint No. 1 showing one arm held to the wall with a pipe bracket just behind the joint, the other arm being blown outward and away from the joint. (See Figure 13).

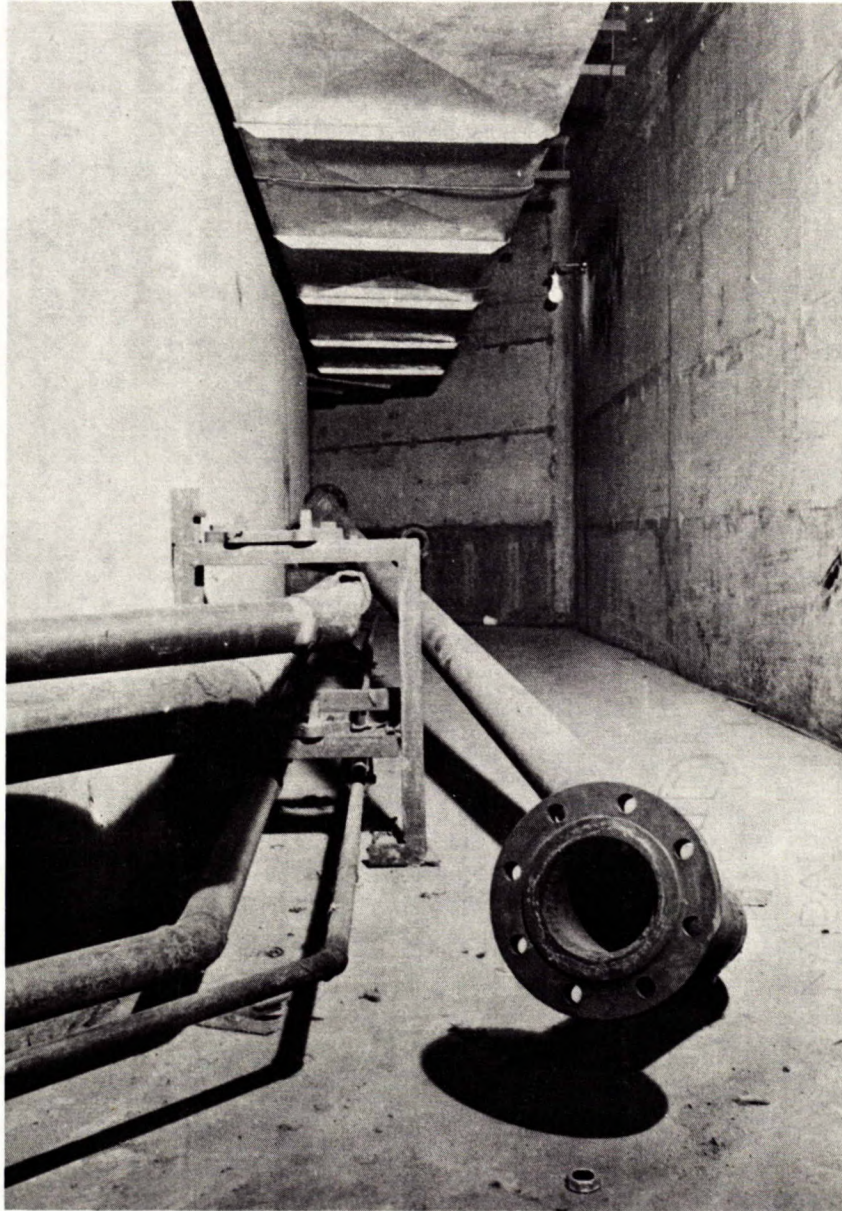
On the other hand, if Joint No. 1 failed first, this would blow the other unclamped arm off the pipe support bracket as shown in Figure 15, and this long unsupported arm of pipe would then exert a bending tearing movement on the pipe clamp and would cause the deformation to the pipe and to the clamp shown in Figure 16. This motion in turn would impart a severe side shear to Joint No. 2 which would probably be quite sufficient to initiate failure in this joint. It will be appreciated that although the boiler may only be connected to one end of the pipe, the system has enough capacity that in the event of failure there is a relatively large amount of stored energy on either side of the fracture. Thus there is probably enough stored energy in the system even on the side remote from the boiler to explosively propagate a second fracture.

Figure 15. Joint No. 1 showing longer arm blown off pipe support, and the displacement of the ends of Joint No. 2. (See Figure 13).

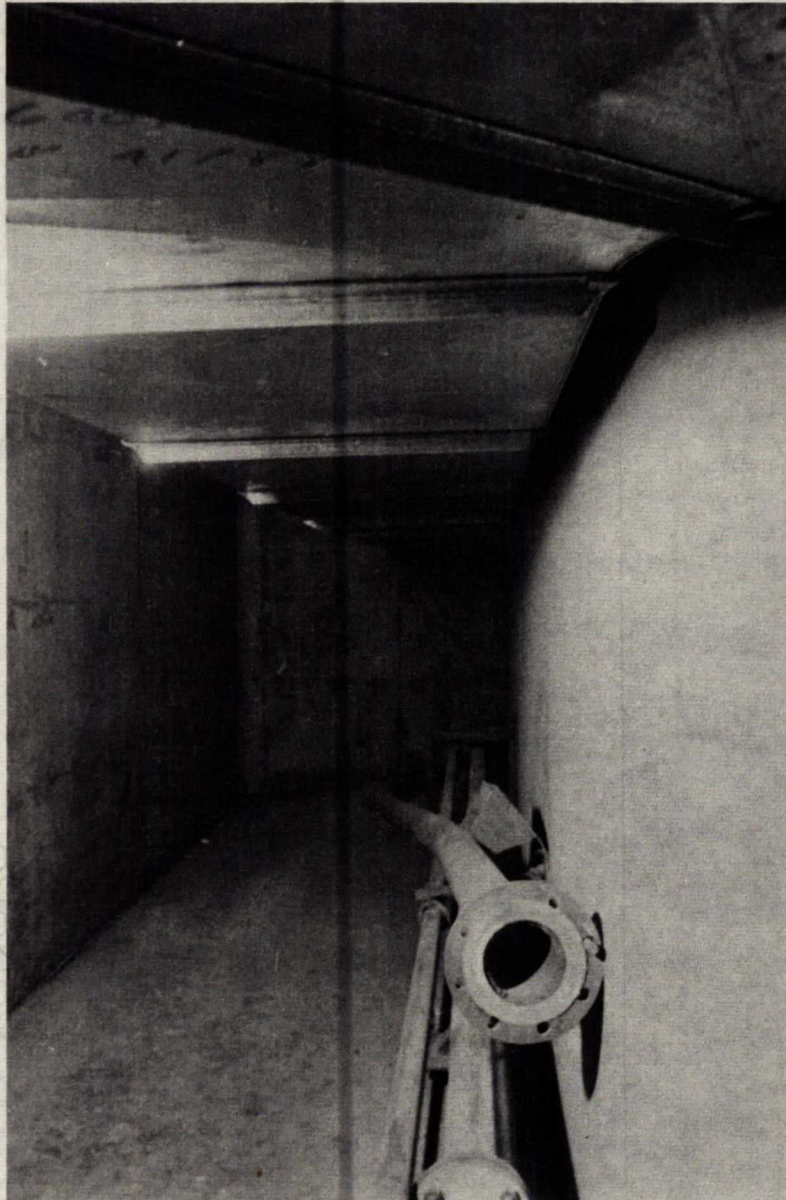
If it is assumed that Joint No. 2 failed first, then it would be expected as shown in Figure 17 that the arm of the pipe would be blown off the pipe supports. An axial load would be applied to the other side of the joint, but, as shown in Figure 16, this is fixed to the wall with a pipe clamp. Thus, unless this pipe clamp is sheared off the wall it would be expected that little load would be transmitted to Joint No. 1 by the failure of Joint No. 2. Since the pipe clamp although bent, still remains attached to the wall (Figure 16) the double failure cannot be readily explained on this basis. (See also Figure 18).

Figure 16. One end of Joint No. 2. Note particularly the deformation in the pipe in the region of the pipe bracket bolted to the wall, the deformation of the pipe bracket itself and the displacement of the end of the joint towards the wall. (See Figure 13).

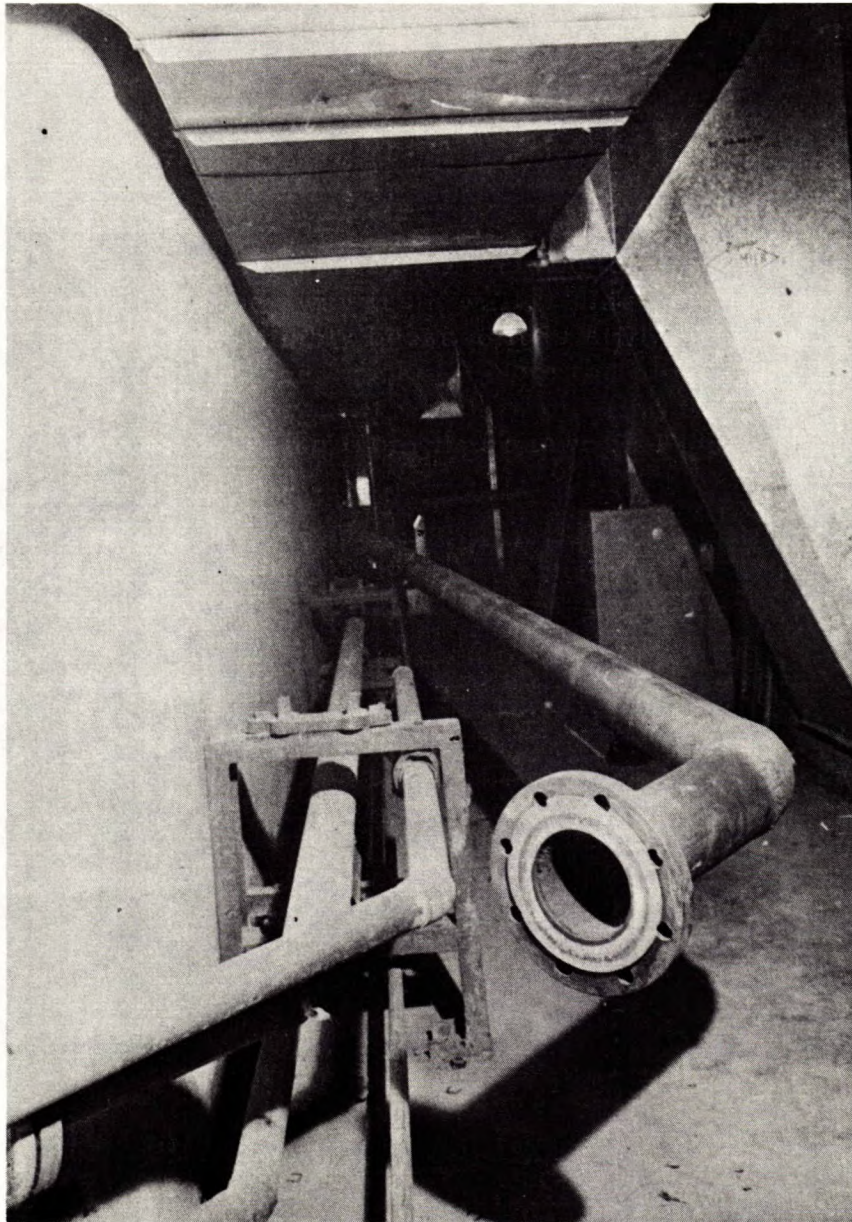
Figure 17. Other end of Joint No. 2 showing outward displacement of pipe away from wall. This pipe has not fallen presumably because it is still supported by the second pipe bracket. Note the pipe roller support on this bracket which is missing from the front bracket and also from that shown in Figure 15. (See Figure 13).

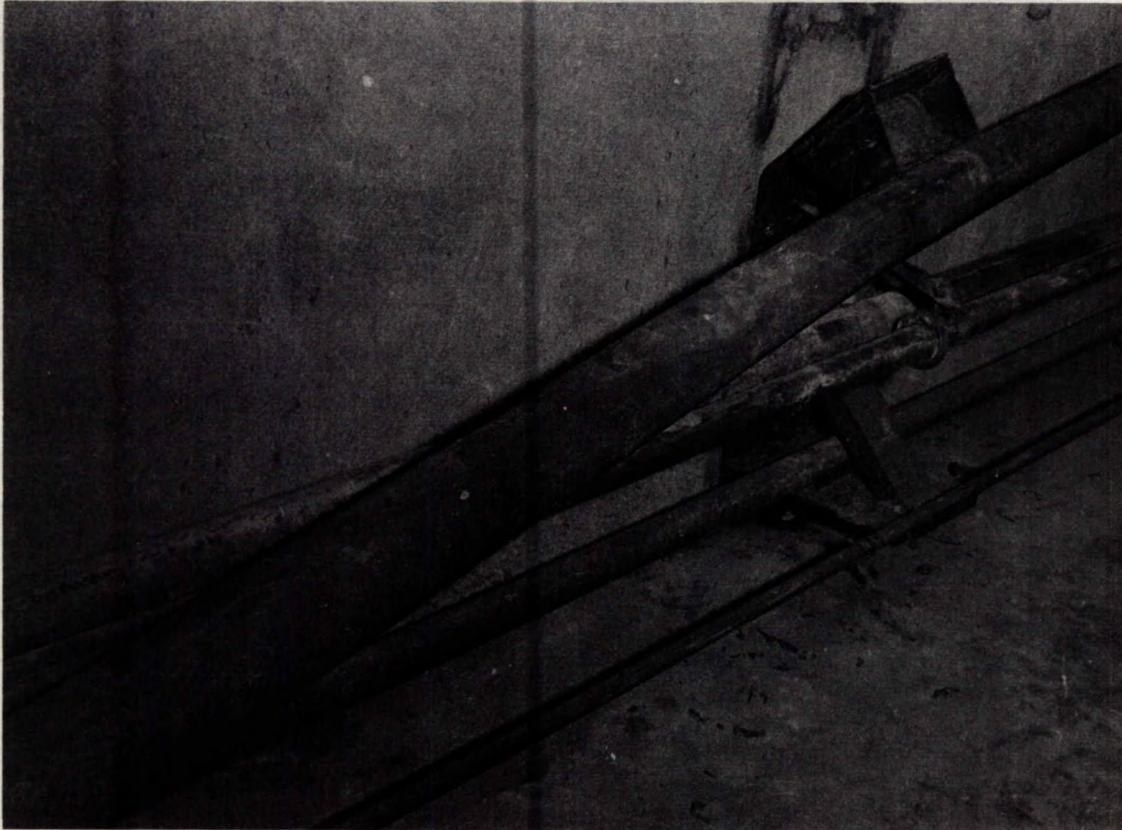
Figure 18. Detail of pipe wall clamp shown in Figure 16.
