**MINES BRANCH INVESTIGATION REPORT IR 67-10**

**EXAMINATION OF WELDED JOINTS IN  
SAMPLE FROM HULL OF  
C.C.G.S. 'SIR HUMPHREY GILBERT'**

**MARCH 6, 1967**

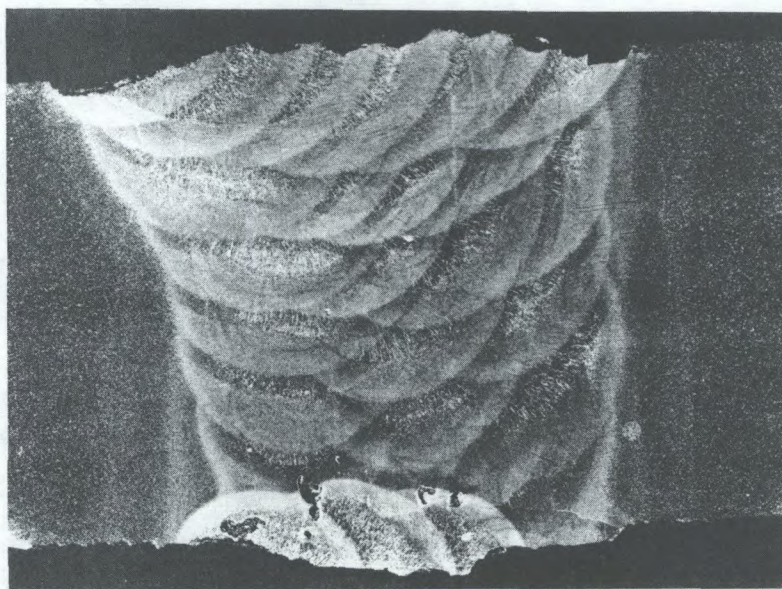
Figure 1. Section from longitudinal weld in the hull. The lower edge of the weld when located on the ship is at the right and the sea-water side is at the top. Mag. X2.

In Figures 1 and 4 it can be seen that the refined grain portions of the weld deposit corroded at a slightly slower rate than the coarser, columnar portions of the weld. This accounts for the appearance of the longitudinal crests on the welds.

Figures 1-3 inclusive show that there has been greater loss of metal at each edge of the longitudinal weld, with the greatest loss being on the upper edge (Figure 3). This is at least partly due to the fact that the last bead deposited was at the upper edge of the joint, thus leaving exposed a greater portion of coarse, columnar weld metal than would be present in any of the beads deposited earlier. Only the last bead would remain entirely in the as-deposited condition. All other beads would have portions of their areas refined by the heat of subsequent deposits. It is evident from Figure 3 that most of the columnar cast structure of the last bead has been lost by corrosion. The outer surface of the darker etching zone is only slightly below the original fusion line of the last bead.

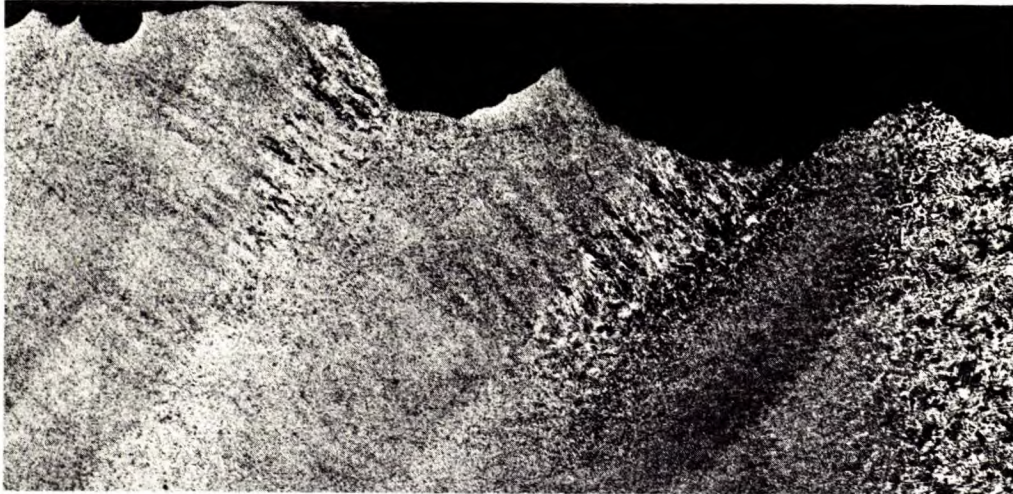
Figure 2. At lower edge of longitudinal weld, on seawater side. Mag. X11.

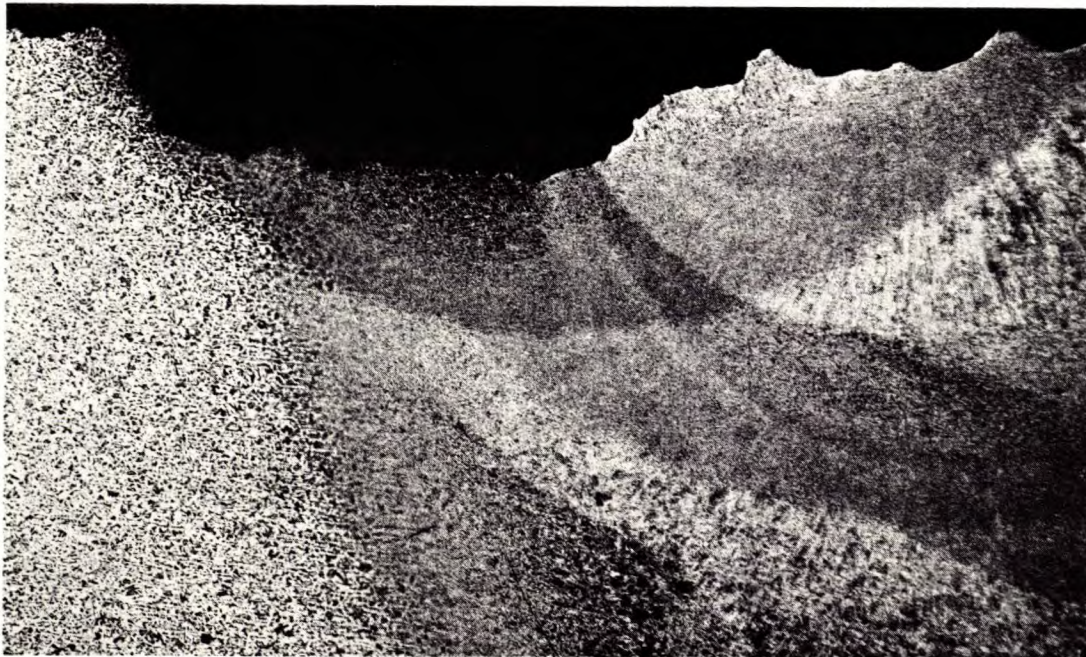
Figure 3. At upper edge of longitudinal weld, on seawater side. Mag. X11.

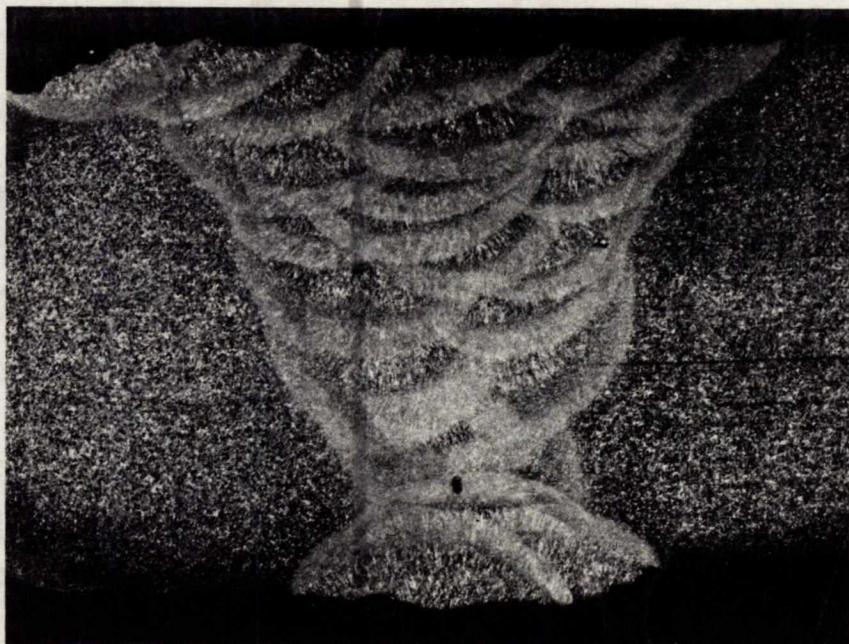
Figure 4. Section from transverse weld with forward edge of the weld when located on the ship at the left and the sea-water side at the top. Mag. X2.

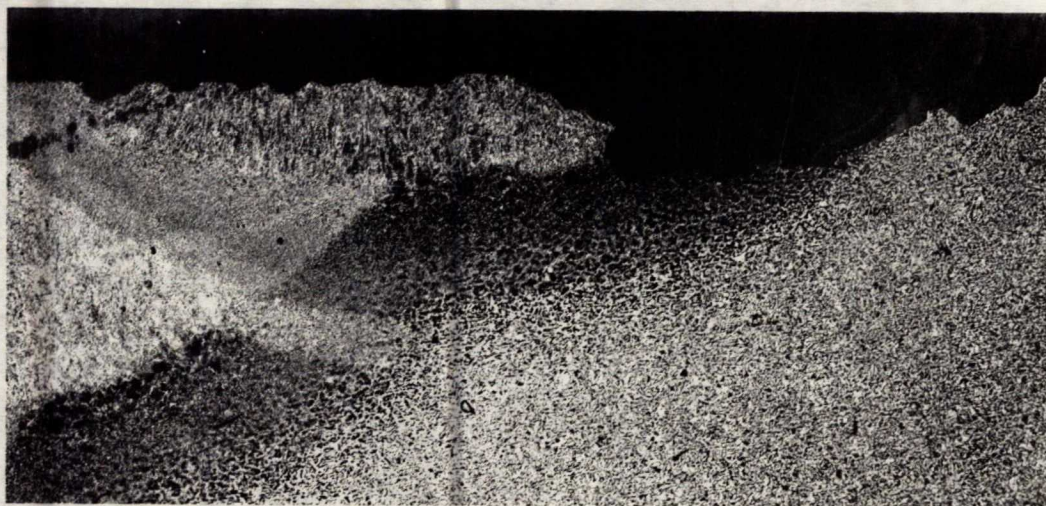
Figure 5. At forward edge of transverse weld, on sea-water side. Mag. X11.

On the transverse joint, a comparison of Figures 5 and 6 shows that there has been a greater attack on the forward edge. Again, the last bead was at the forward edge and much of this coarser columnar deposit had been corroded away.

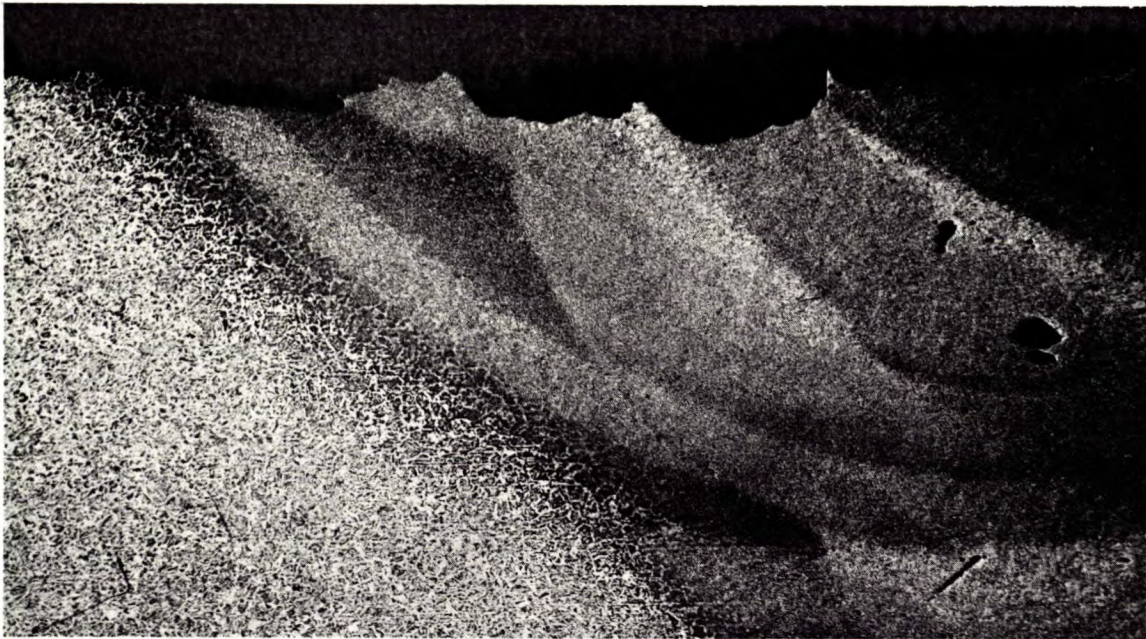
Figure 6. At rear edge of transverse weld, on seawater side. Mag. X11.

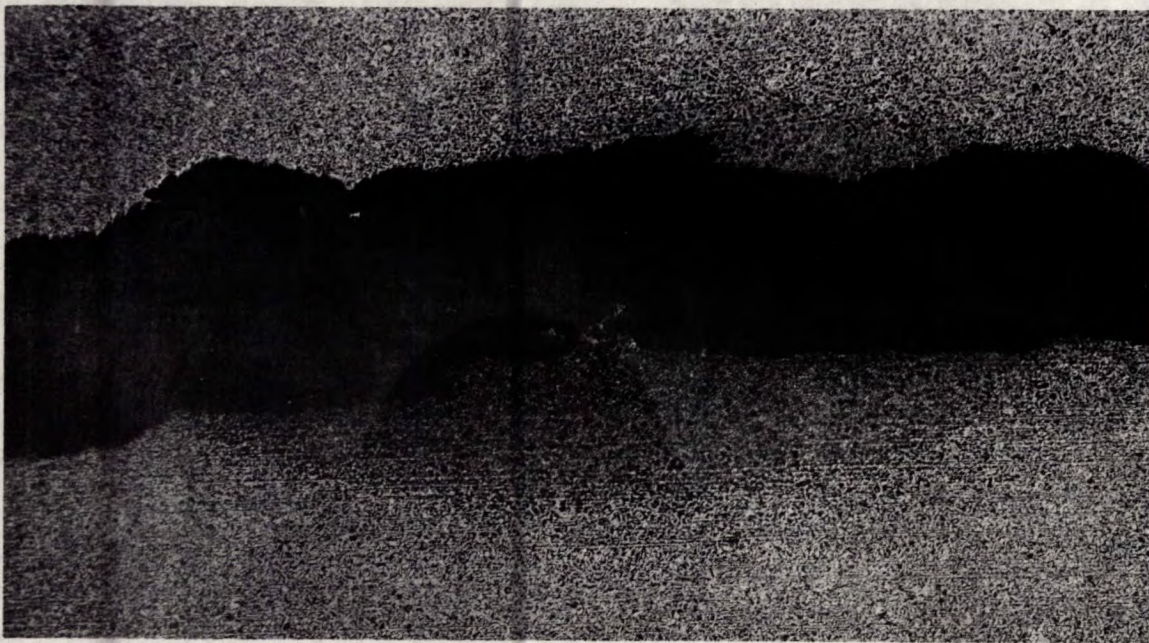
Figure 7 shows the structure at the base of the corroded grooves in the plate where alignment members had been welded onto the hull plating.

Figure 7. Showing the appearance at the bottom of each of the two grooves in the hull plate.  
Mag. X11.

In the lower specimen, only a small bit of weld metal remains and corrosion has extended into the heat-affected zone. In the upper specimen, corrosion has extended almost completely through the heat-affected zone.
