**MINES BRANCH INVESTIGATION REPORT IR 68-58**

# **EMBRITTLEMENT OF GALVANIZED FLUE PIPE**

**J.J. SEBISTY**

**SEPTEMBER 12, 1968**

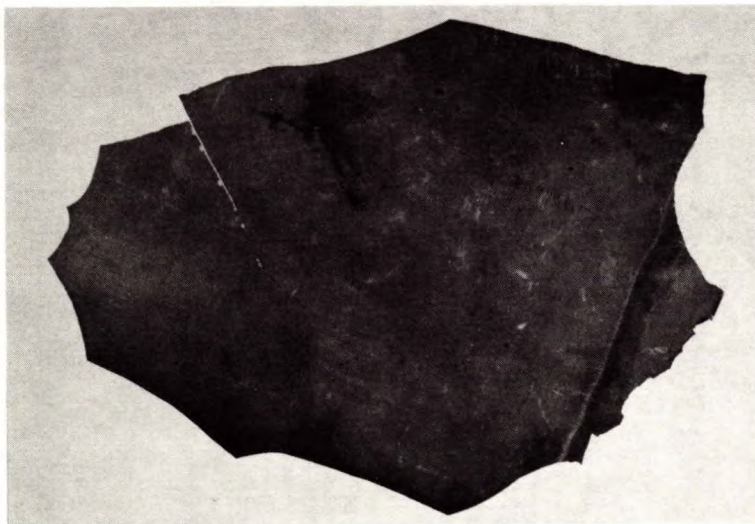
The general appearance of the sample suggested that the pipe had been made from galvanized sheet and this was confirmed by semi-quantitative electron-probe microanalysis. This being the case, there is no doubt that embrittlement was due to long-term exposure of the galvanized material in the high-temperature range quoted. As shown by the sharp edge-breaks in Figure 1, and the fact that pieces could be readily broken away with the fingers, the material possessed no ductility whatsoever.

Figure 1. Photograph of embrittled flue-pipe sample showing sharp edge-breaks, X1.

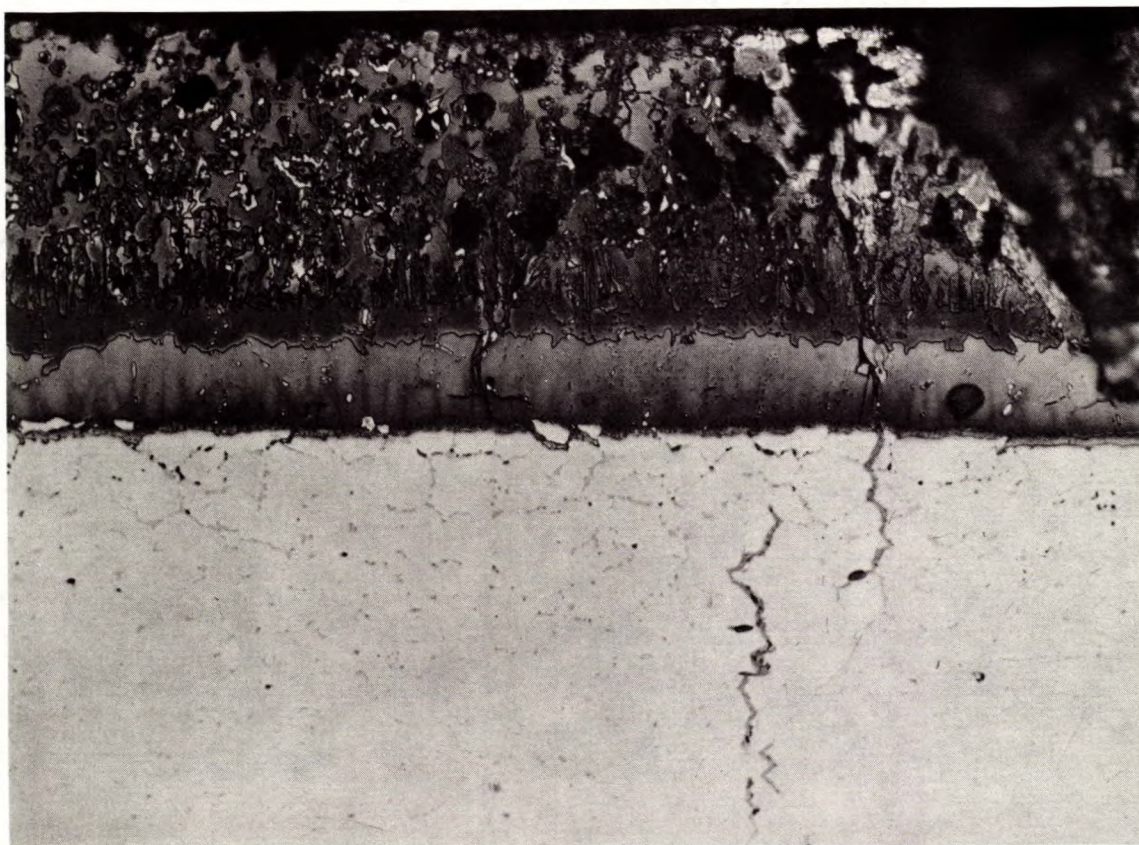
For record and reference purposes, metallographic examination of pieces from the sample was made, and Figures 2 and 3 illustrate typical cross-section microstructures. In Figure 2, the heat-affected coating is seen to consist of characteristic iron-zinc-alloy phase layers near the steel base and a thick, heavily oxidized and pitted outer layer. Intergranular penetration of the steel base by continuous chains of intermetallic compound particles was well defined near the steel surface. This tapered off in a characteristic manner farther down in the steel into a scattered distribution of individual particles. These were also located intergranularly as apparent on a heavily etched surface. The compound distribution in the steel base is somewhat better illustrated in Figure 3.

Deeply penetrating intergranular cracks were also found in the pieces examined. The relatively wide separations in Figure 2 appeared to be filled with oxidation products and, therefore, must have formed in service. The finer hair-line crack in Figure 3, on the other hand, was most probably formed when this particular piece was broken off for metallographic examination.

Figure 2. Typical cross-section microstructure illustrating coating features and intergranular penetration of steel substrate. Picral etch, X500.

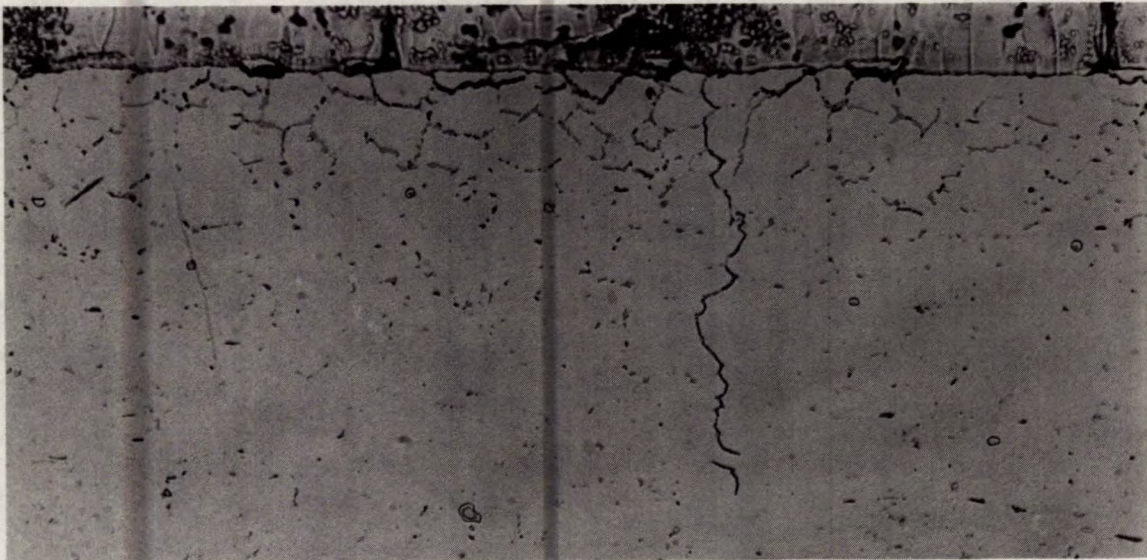
Figure 3. Intermetallic-compound penetration of steel substrate highlighted by different etching treatment. Nital etch, X500.

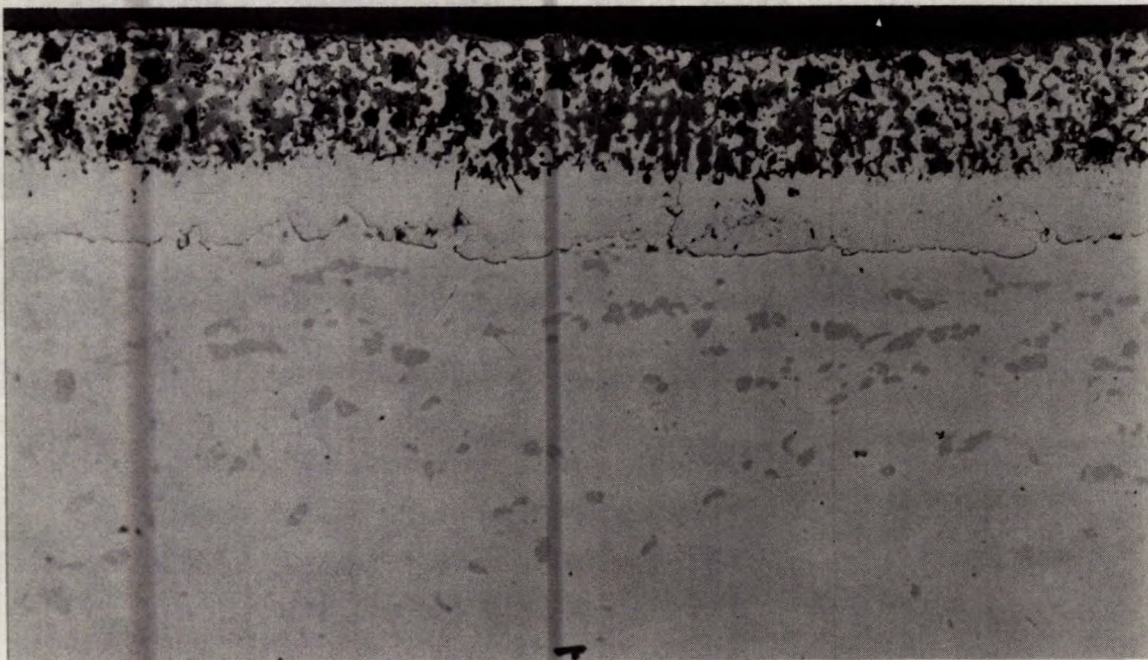
larger compound-particle size as in Figure 4. The particles were again nucleated intergranularly but there was no distinct link-up of the individual particles. As a matter of interest, the material still retained some ductility and required several bends back and forth through 180° in a vice before breaking. In the case of the test quoted previously, i.e., heating of galvanized strip for 84 days at 635°F (335°C), a typical microstructure is reproduced in Figure 5. Particular attention is drawn to the nature and extent of intergranular penetration of the steel, which was confined to a band a few grain-layers deep.

Figure 4. Microstructure of 24-gauge (0.025-in.) commercial galvanized strip heated in air for 10 days at 1000°F (540°C). Unetched, X500.

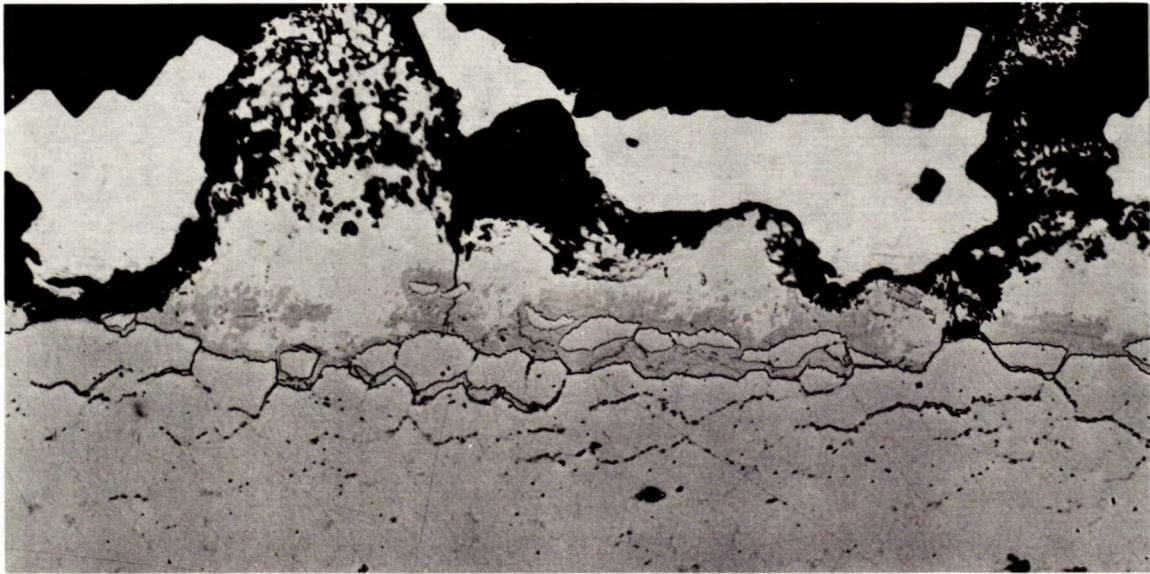
Figure 5. Microstructure of 24-gauge (0.025-in.) commercial galvanized strip heated in air for 84 days at 635°F (335°C). Nitramyl etch, X500.
