MINES BRANCH INVESTIGATION REPORT IR 70-30

**METALLURGICAL EXAMINATION OF
A "CHASE"-TYPE LITHOGRAPHIC FRAME
FROM THE CANADIAN GOVERNMENT
PRINTING BUREAU**

R. D. MCDONALD AND G. D. AYERS

PHYSICAL METALLURGY DIVISION

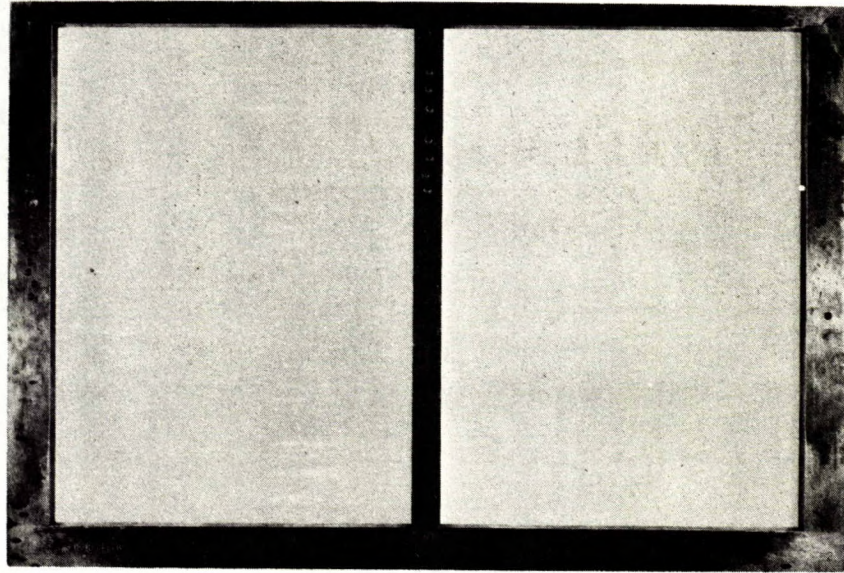
Figure 1. "Chase" as received

The "Chase" is shown in Figure 1. The holes had been drilled in the frame to obtain the material required for a chemical analysis.

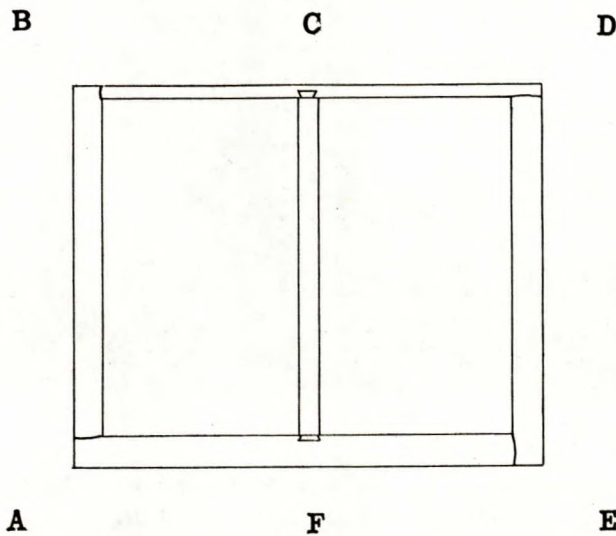
The "Chase" type frame was manufactured by butting and flash welding or upset resistance welding at each of the locations A, B, D and E shown in Figures 1 and 2.

Figure 2. Sketch of "Chase" illustrating the locations of flash welds at corners and fusion welds at dovetail joints on the cross member.

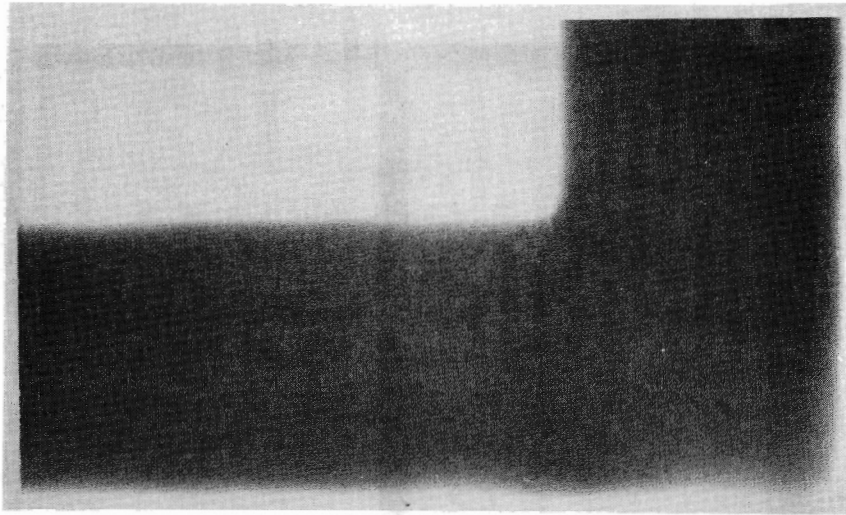
X-ray radiographs were taken at the six corner locations A to F inclusive, indicated on the sketch in Figure 2. No evidence of porosity or slag inclusions was found at corner locations A, B, D or E. A small crack indication, as shown in Figure 3, was found at the inside corner of each of these locations.

Magnetic-particle inspection confirmed the presence of the discontinuities or cracks that were located by the radiographic examination.

Figure 3. Radiograph of area around location A, showing evidence of crack.

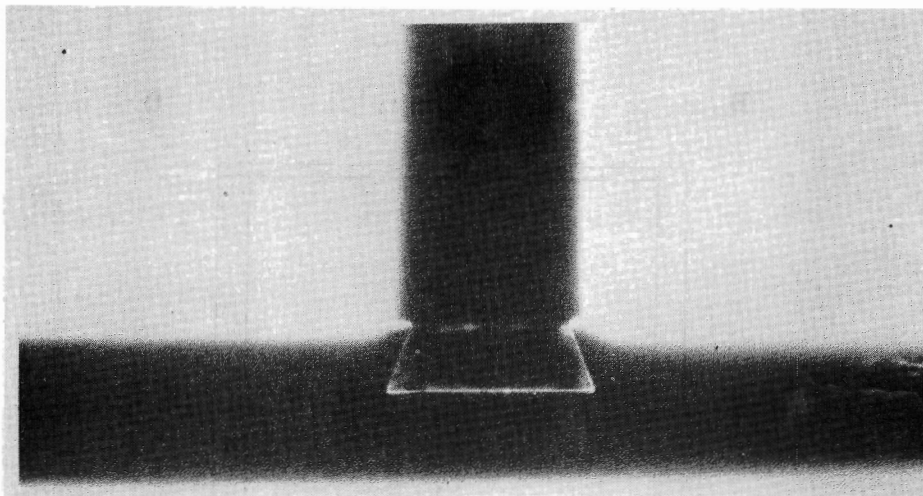
The radiographs taken at C and F show that the middle member of the frame had been dovetailed to fit into members AE and BD. The radiograph at C, shown in Figure 4, is similar to that at F.

The presence of the light outline around the dovetail indicated lower-density regions. This observation, as well as the presence of porosity at the dovetail, indicated that the middle members were thinner at the dovetail ends, and that metal-arc welding had been used to fuse the members together, and to permit obtaining flush surfaces after grinding.

The cross piece at the middle of the frame was joined by means of a dovetail joint at each end and fusion welding, as shown in Figures 4 and 8. The fusion was made at the joints in the planes of the plate.

Figure 4. Radiograph of area around location C, showing dovetail construction.

The dovetail joint, although evidently satisfactory, could be strengthened somewhat by having a greater depth of weld deposit at the line of interface of the dovetail.

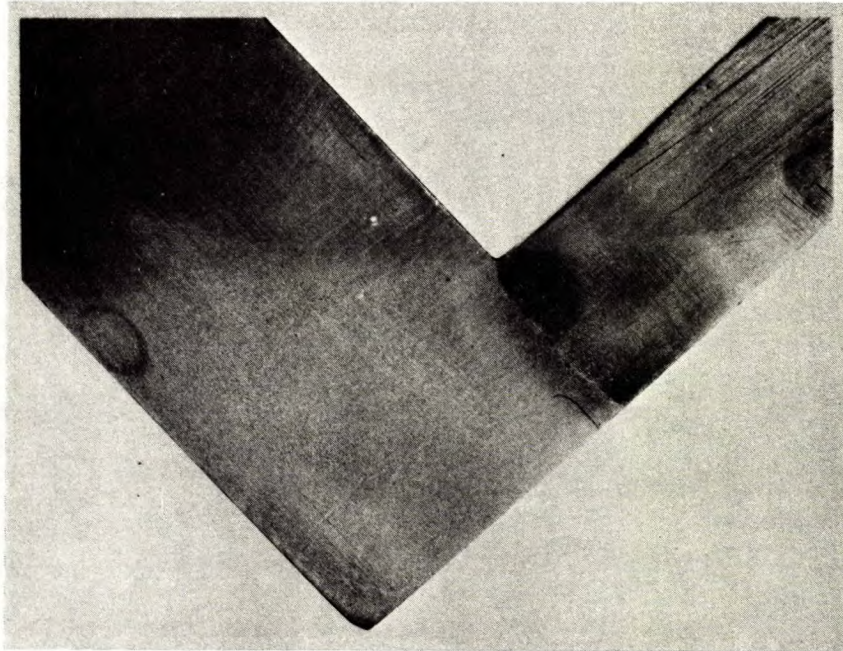
Each of the corners A, B, D and E was polished with grit #2 emery paper and etched with a 2% nital solution. The appearance of the etched surface revealed the orientation of the different members of the frame as well as supplying further evidence that they had been flash or upset resistance welded. A photograph of location B is shown in Figure 5. To explore this evidence further, a micro-specimen was cut at corner A, Figure 2, and polished. This is shown in Figures 6(a) and 6(b). The appearances and the dimensions of the inclusions show that they are longitudinal in part of the specimen and transverse in the other. This indicates that two pieces of material were joined at right angles to one another.

Figure 5. Area around location B showing where the two pieces were butted and flash welded. The surface was ground and etched 15 sec in 2% nital.

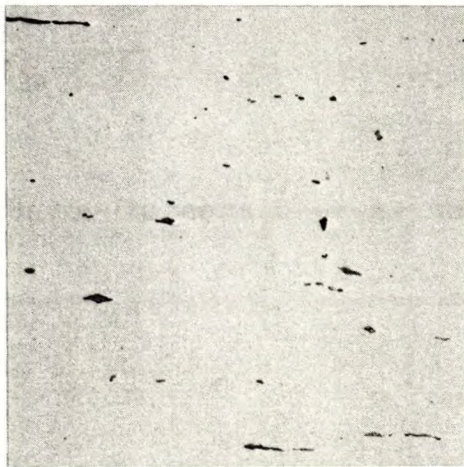
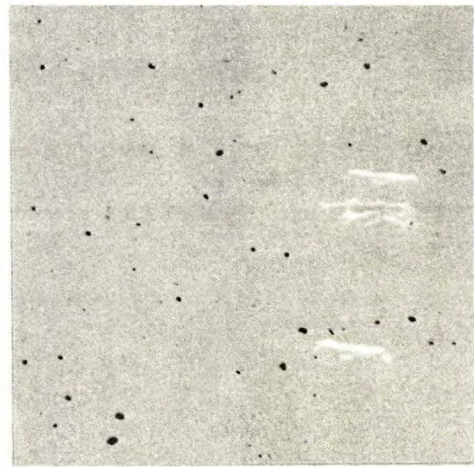
Photomicrographs taken on the same surface of a specimen from the area around location A. The orientation of the inclusions shows that there were two pieces of material welded together at right angles.

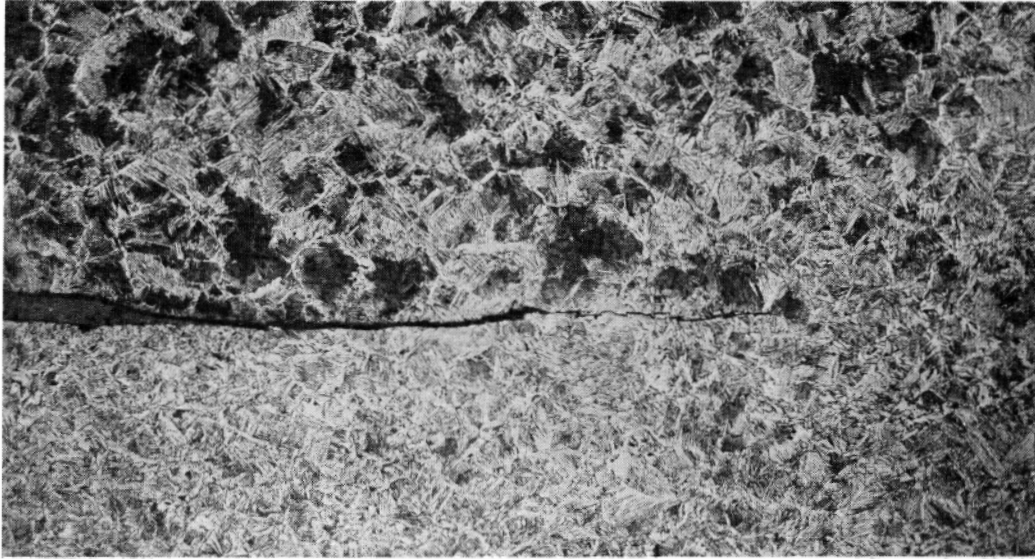
A micro-specimen from corner B was polished and etched to permit viewing the apparent crack as oriented in Figure 3. This revealed that the crack actually resulted from a lack of fusion of the plates at the inner corner for a distance of 0.25 in.

Beyond that point the metal had fused properly. This is illustrated in Figure 7.

Figure 7. Partial lack of fusion in weld area of corner B.

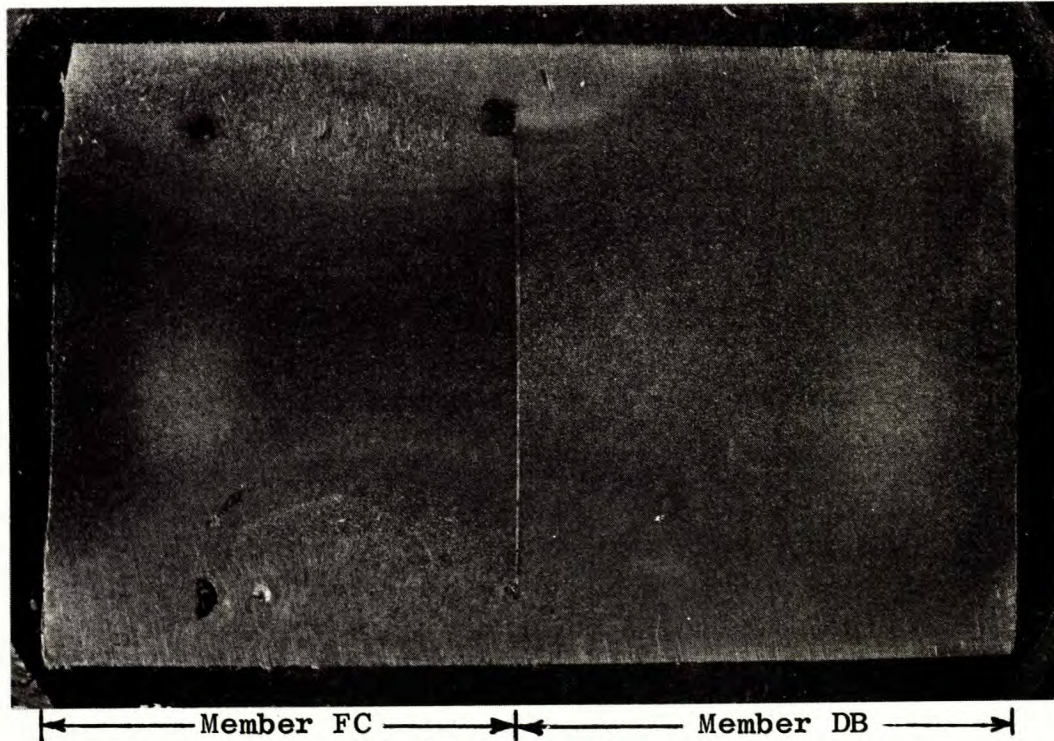
A hardness survey of the fusion weld at the dovetail joint in member FC, shown in Figure 8, gave the following Rockwell B hardness values.

Weld Metal	94
Fusion Line	96
Heat-Affected Zone	85-92
Base Metal	92

These hardness values showed that the weld metal could have approximately the same hardness as the cold-worked base metal and that there had been a slight softening in the heat-affected zone due to annealing of the cold-worked material.

A micro-specimen, from location C, Figure 2, was prepared and etched in nital to show the fusion weld joining members DB and FC at the dovetail joint. This section of the joint is illustrated in Figure 8.

Etched 20 sec in 2% nital.
Figure 8. Section through plate thickness cut in the FC direction, showing the fusion weld at the dovetail joint of members FC and DB.

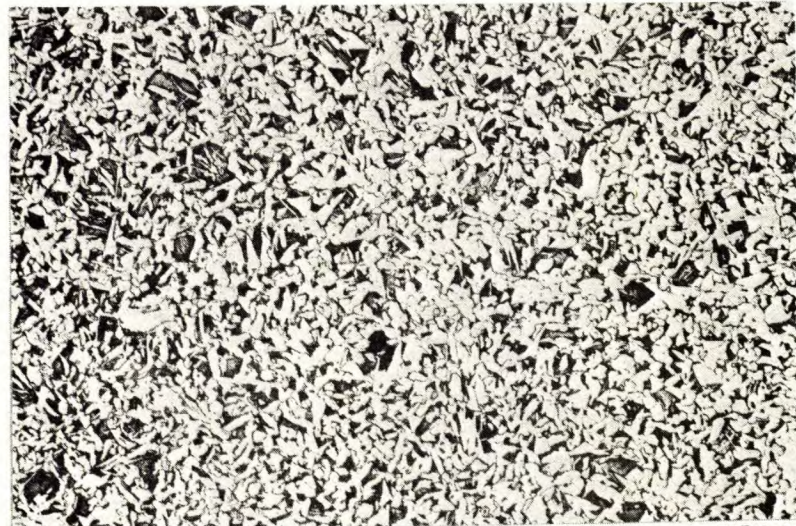
A transverse specimen from member BC was polished and etched in 2% nital. This procedure showed that the micro-structure Figure 9, was composed of ferrite and pearlite, and was consistent with an SAE 1018 grade of steel. Although cold work was not evident in the micro-structure, the degree of cold work required to provide those tensile properties obtained might not be visually detectable.

Etched 15 sec in 2% nital. X100
Figure 9. Microstructure of base metal consisting of dark pearlite and light ferrite grains.
