MINES BRANCH INVESTIGATION REPORT IR 71-58

**INVESTIGATION OF REFRACTORY FAILURE  
IN A BOILER COMBUSTION CHAMBER**

**MINERAL PROCESSING DIVISION**

AUGUST, 1971

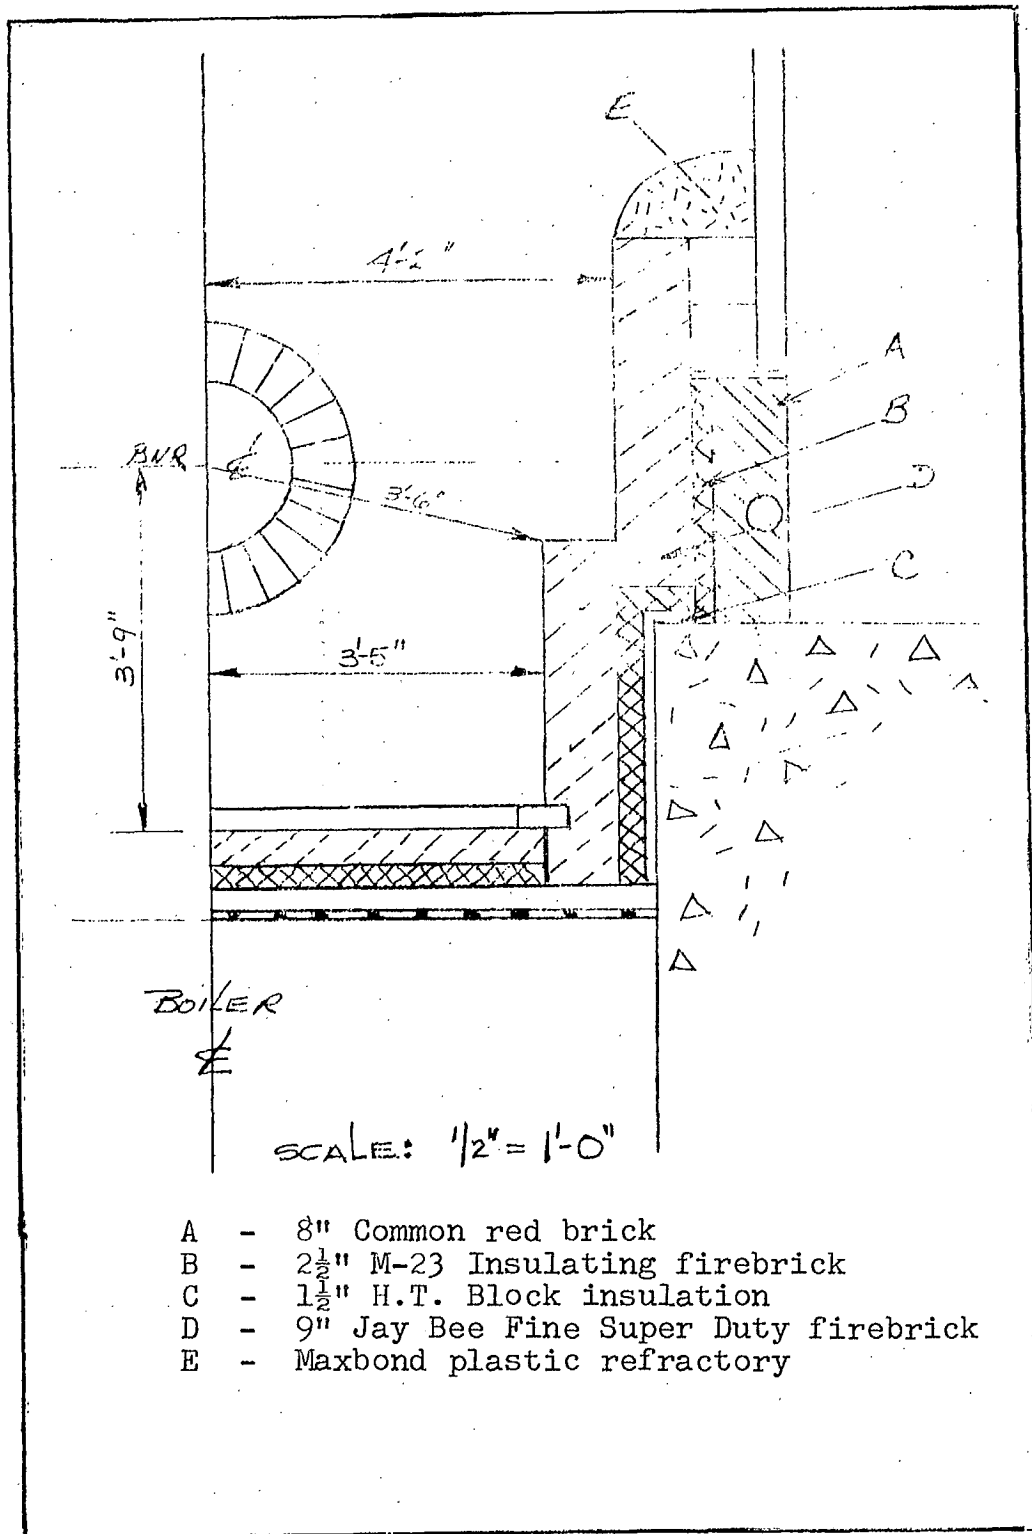
Figure 1. Cross Section of Boiler Combustion Chamber.

chamber as viewed from the target wall is shown in Figure 1. Only the right side is shown, the left side being a mirror image. The stepped region of the side wall, referred to above, can be clearly seen.

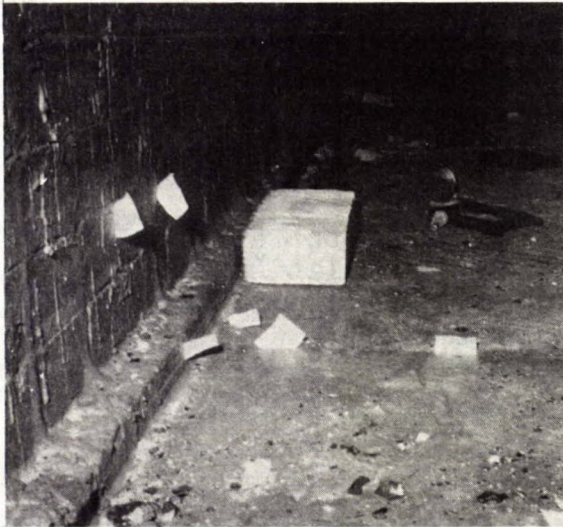
- a) West wall and floor. The white objects are pieces of paper which were inserted into a crack running along the floor and up the wall. Front view is shown in (c).

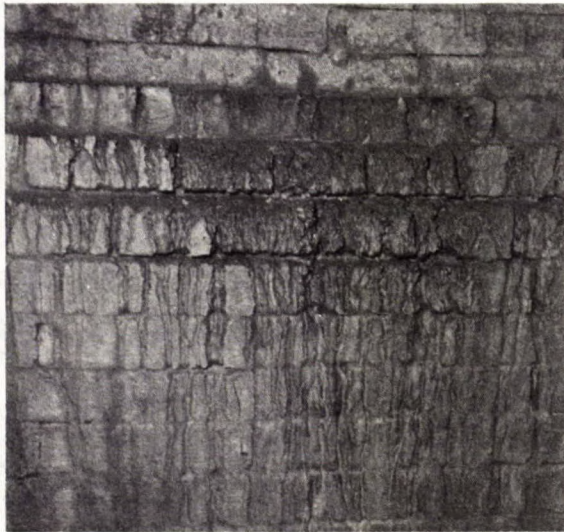
- b) West wall, showing erosion of brickwork and mortar. Note gauging caused by rivulets of molten material running down the wall. Erosion is particularly severe in the stepped region.

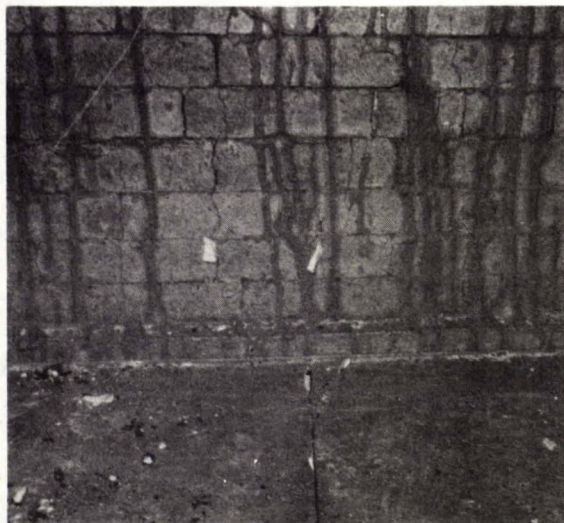
- c) West wall, bottom section, showing cracking of wall and floor.

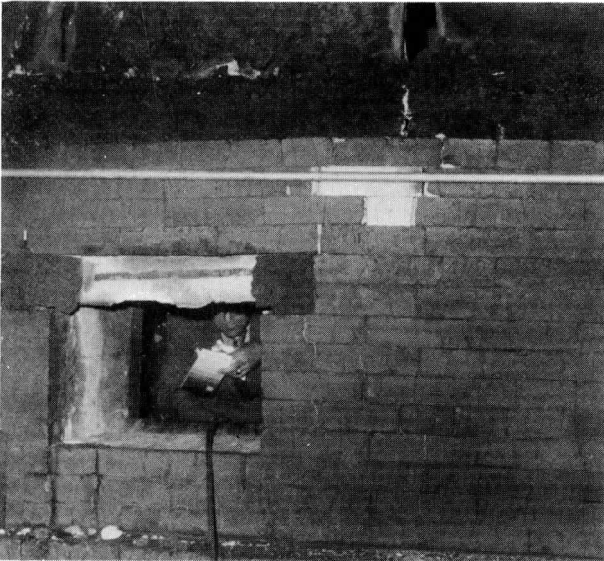
The conditions of the walls and floor, after the shut down on May 10, 1971, are shown in Figure 2. Particular attention should be paid to Figure 2(d) which shows an accumulation of a slag-like material above the refractory brickwork. This material appears to be resting on the plastic refractory used to cap the brickwork.

d) East wall, top section.  
Note accumulation of slag  
above wall at left of  
picture.

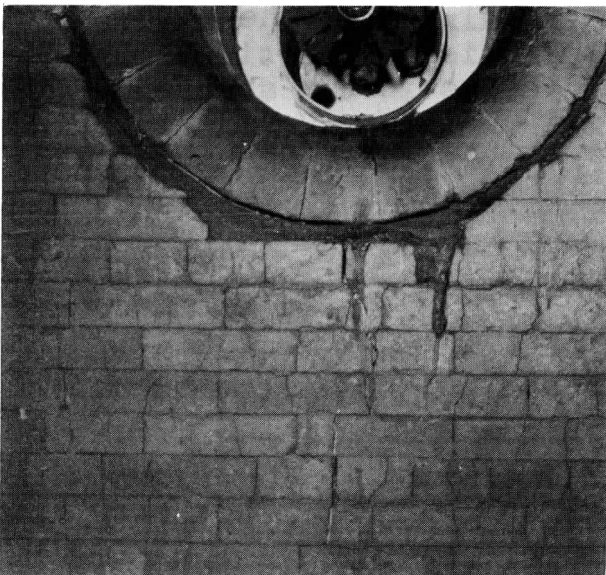
e) Front wall, bottom section.

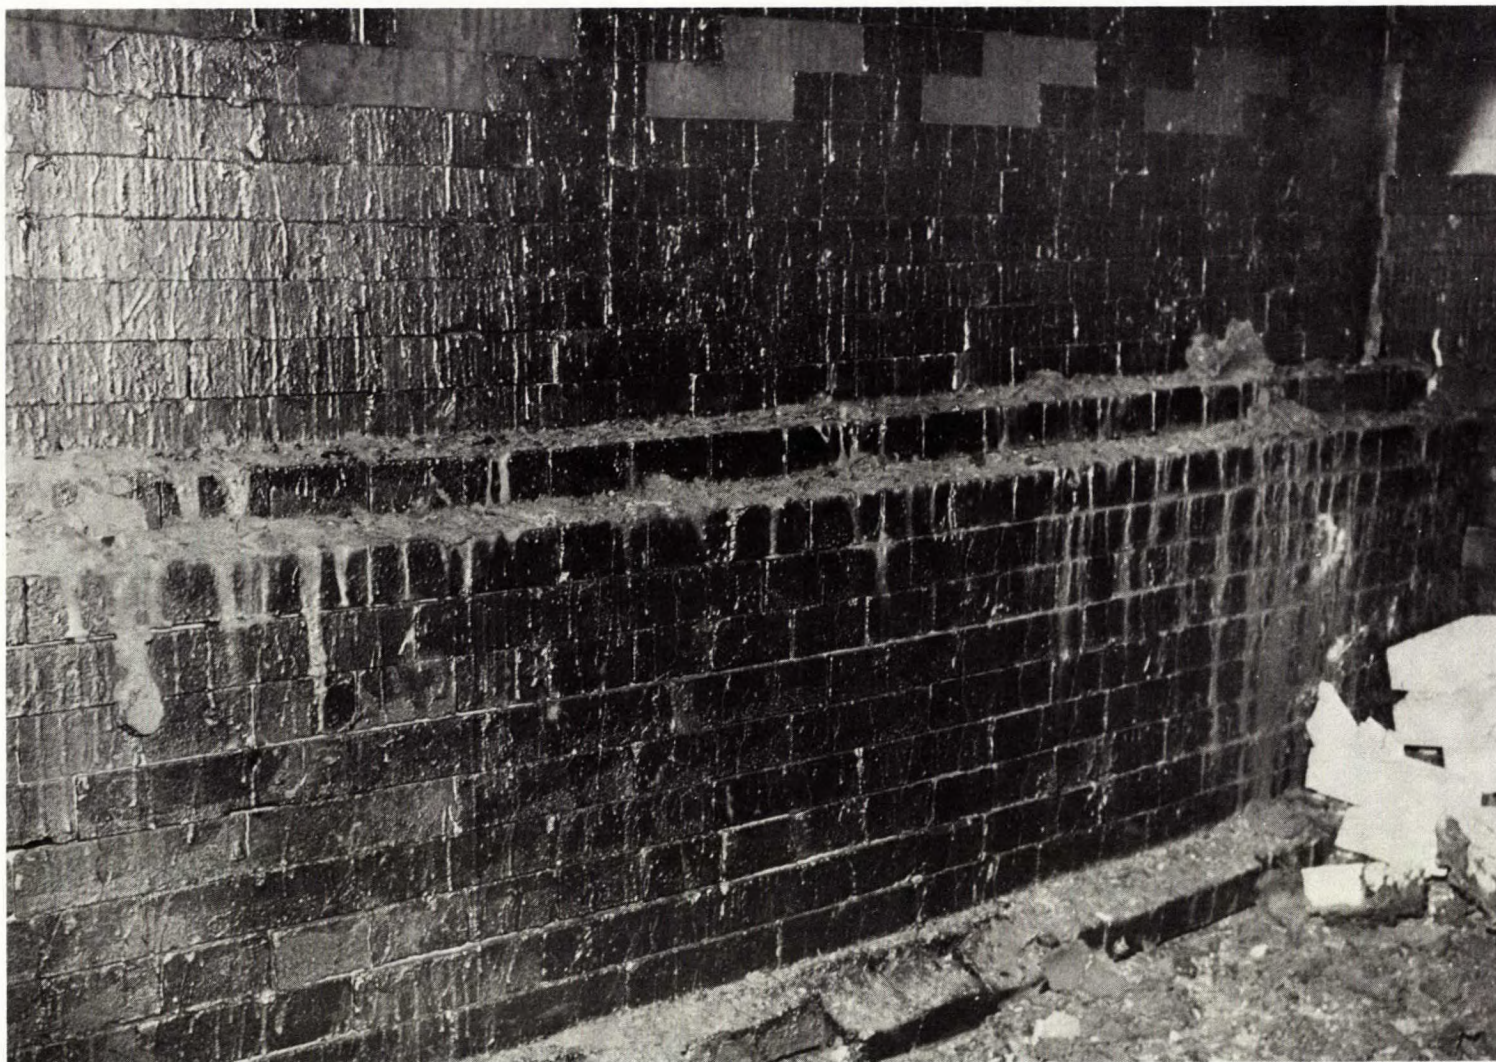
Figure 3. Damage to west wall in combustion chamber of Boiler #1.  
Note Glazing of brickwork and accumulation of molten material on steps.

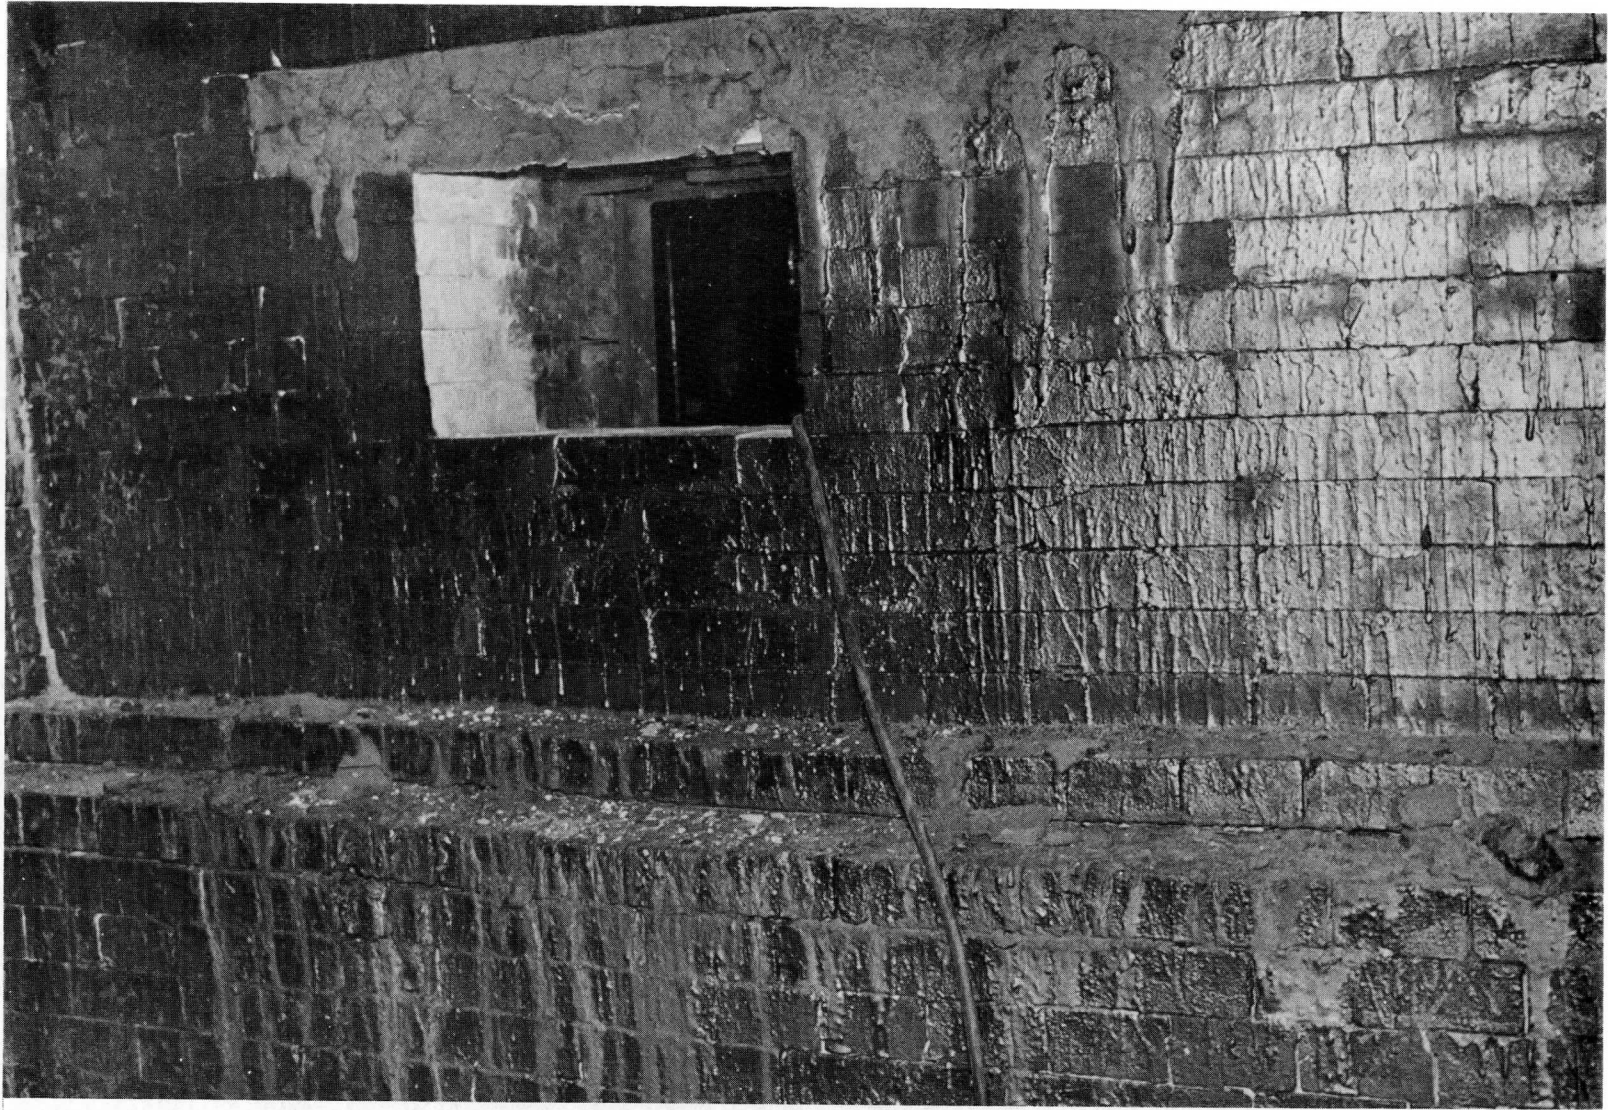
Figure 4. Damage to east wall in combustion chamber of  
Boiler #1

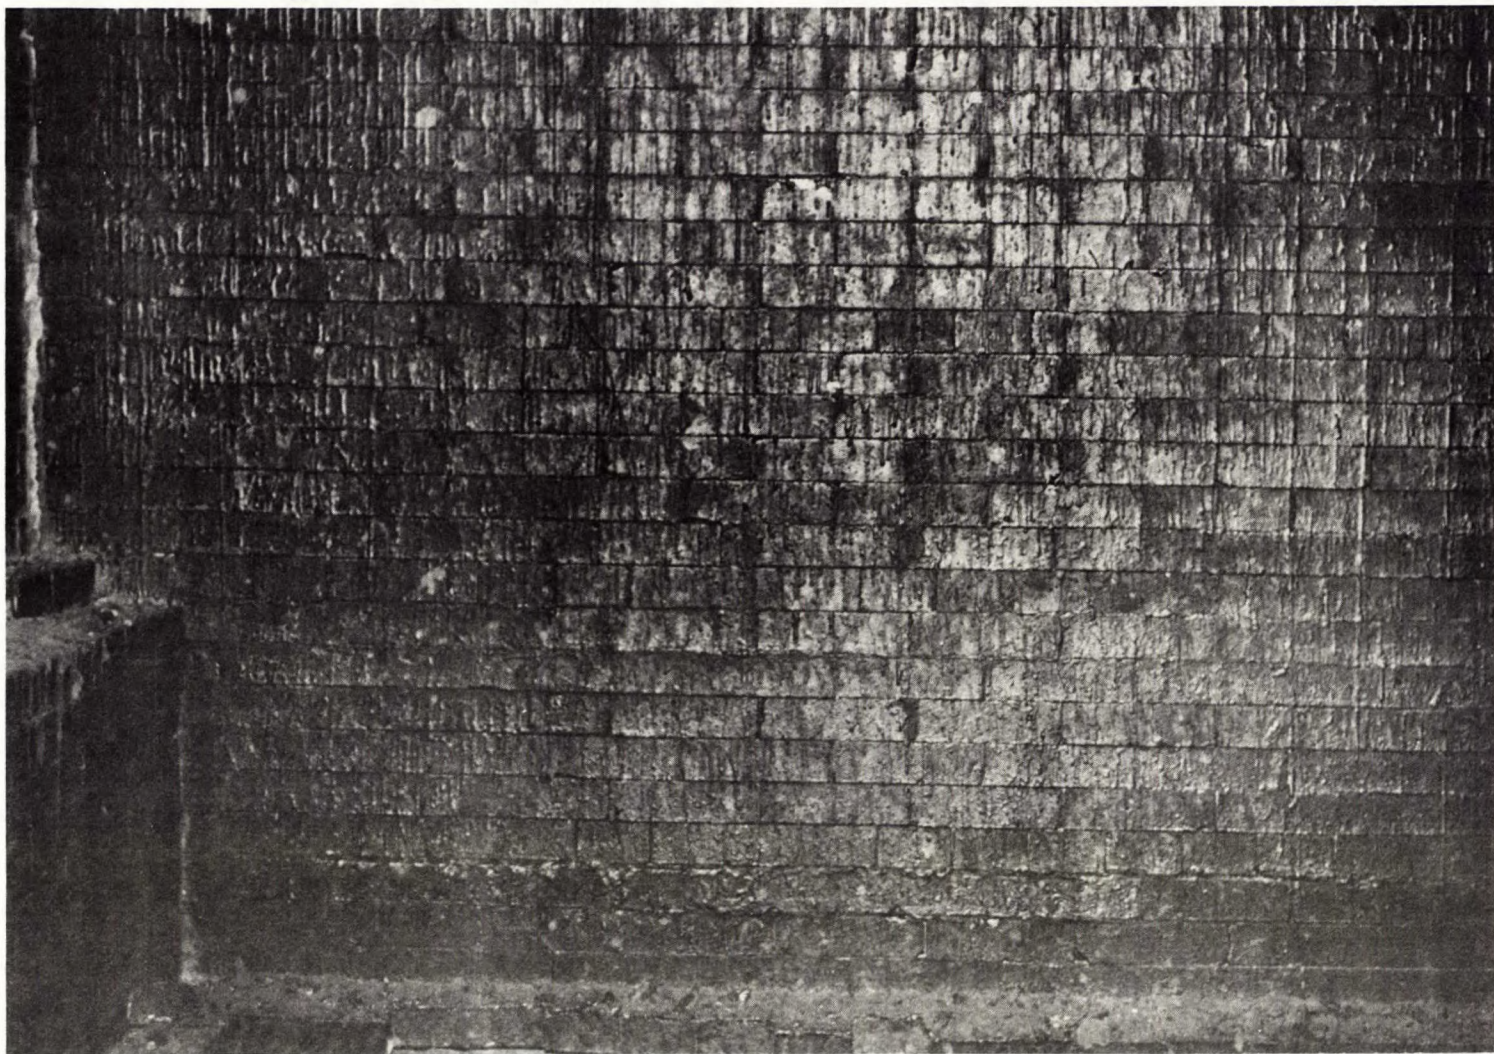
Figure 5. Target wall of Boiler #1.  
Note that brickwork is glazed but not  
severely damaged.

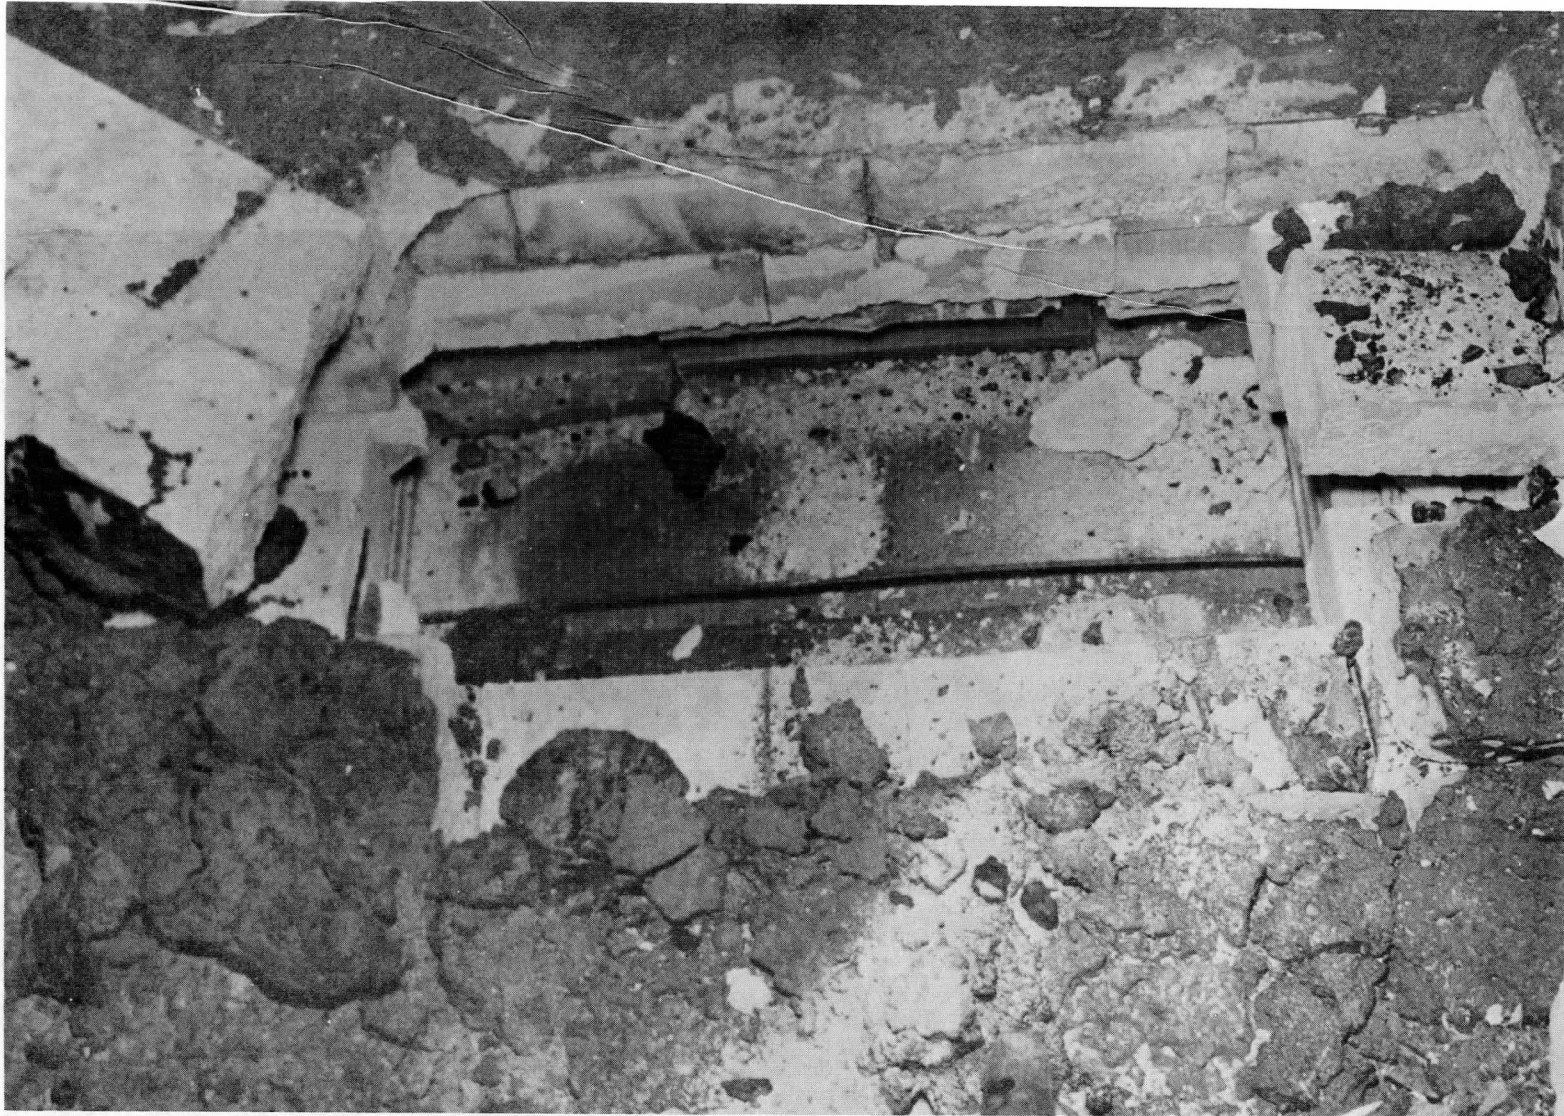
Figure 6. Floor of combustion chamber in Boiler #1.  
Note heavy accumulation of slag-like  
material.

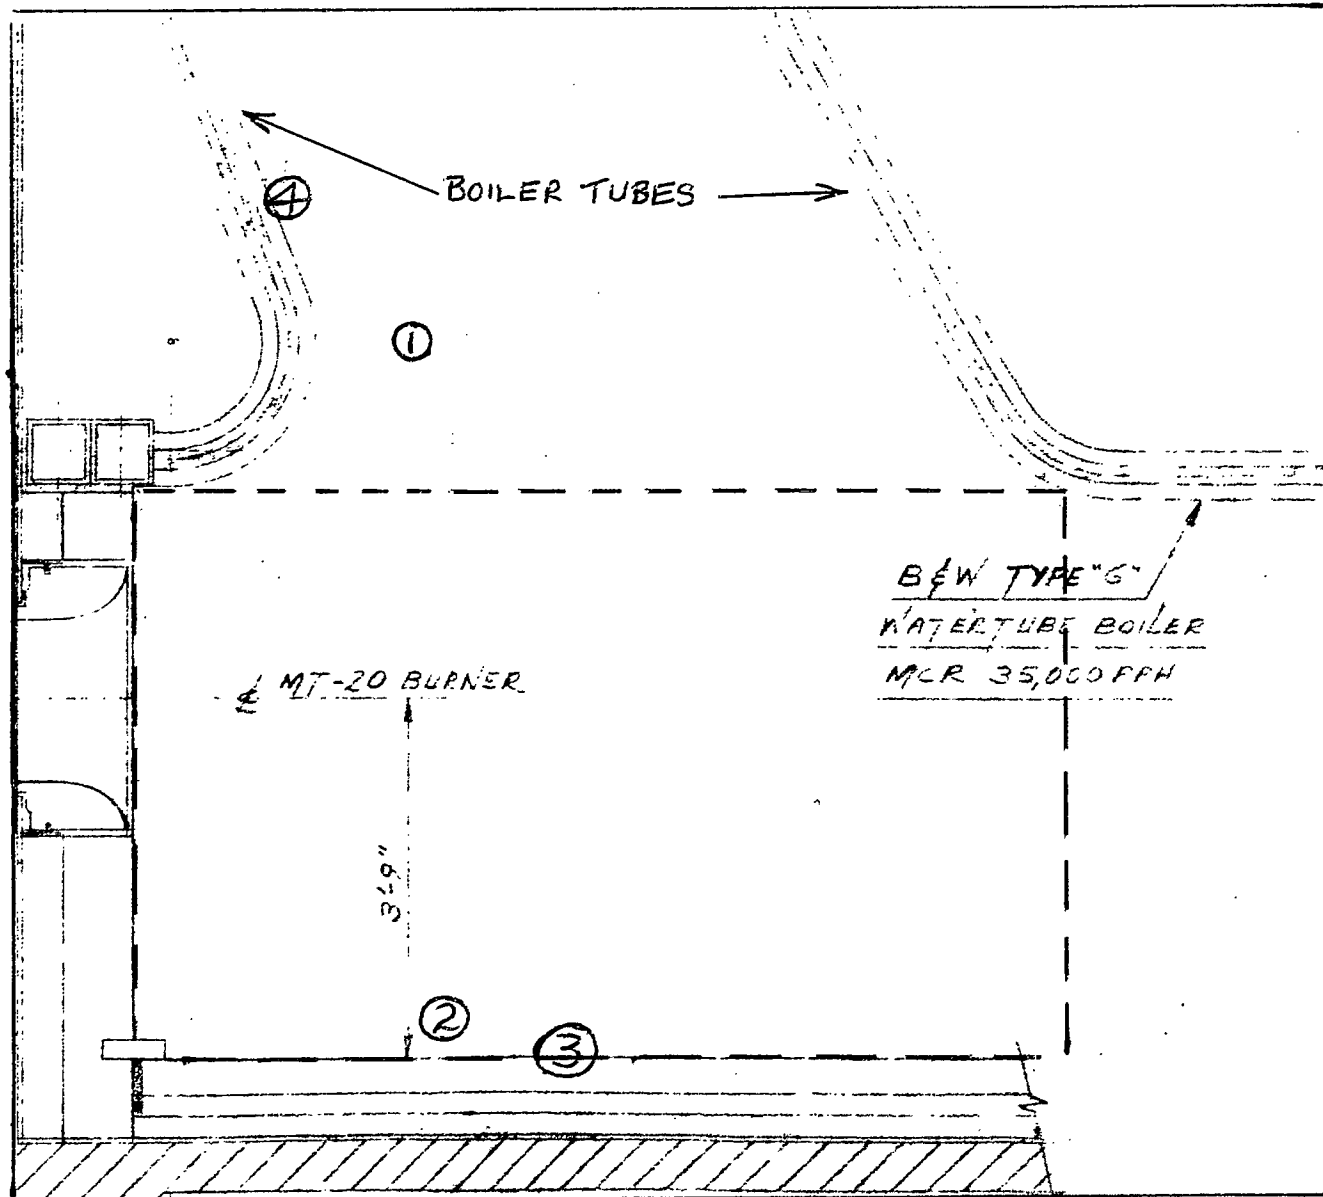
Both the front and target walls showed the least damage. This is probably due to the fact that both are vertical walls with no stepped regions which would allow the accumulation of falling material to take place. Furthermore, they are protected by overhangs formed by the boiler tubework as shown in Figure 7. The dotted rectangle in Figure 7 depicts the approximate position of the firebrick lining.

Figure 7. Showing position of boiler tubes and approximate position of refractory lining (Dotted Rectangle)  
 Note: Numbers refer to the areas from which samples were taken for examination.

ash from the boiler east wall close to the front wall (Area #1 in Figure 7);

slag from the top layer of material on the floor (Area #2 in Figure 7);

dense glassy material from the floor (Area #3 in Figure 7);

slag from the front and rear of the west wall (Area #4 in Figure 7);

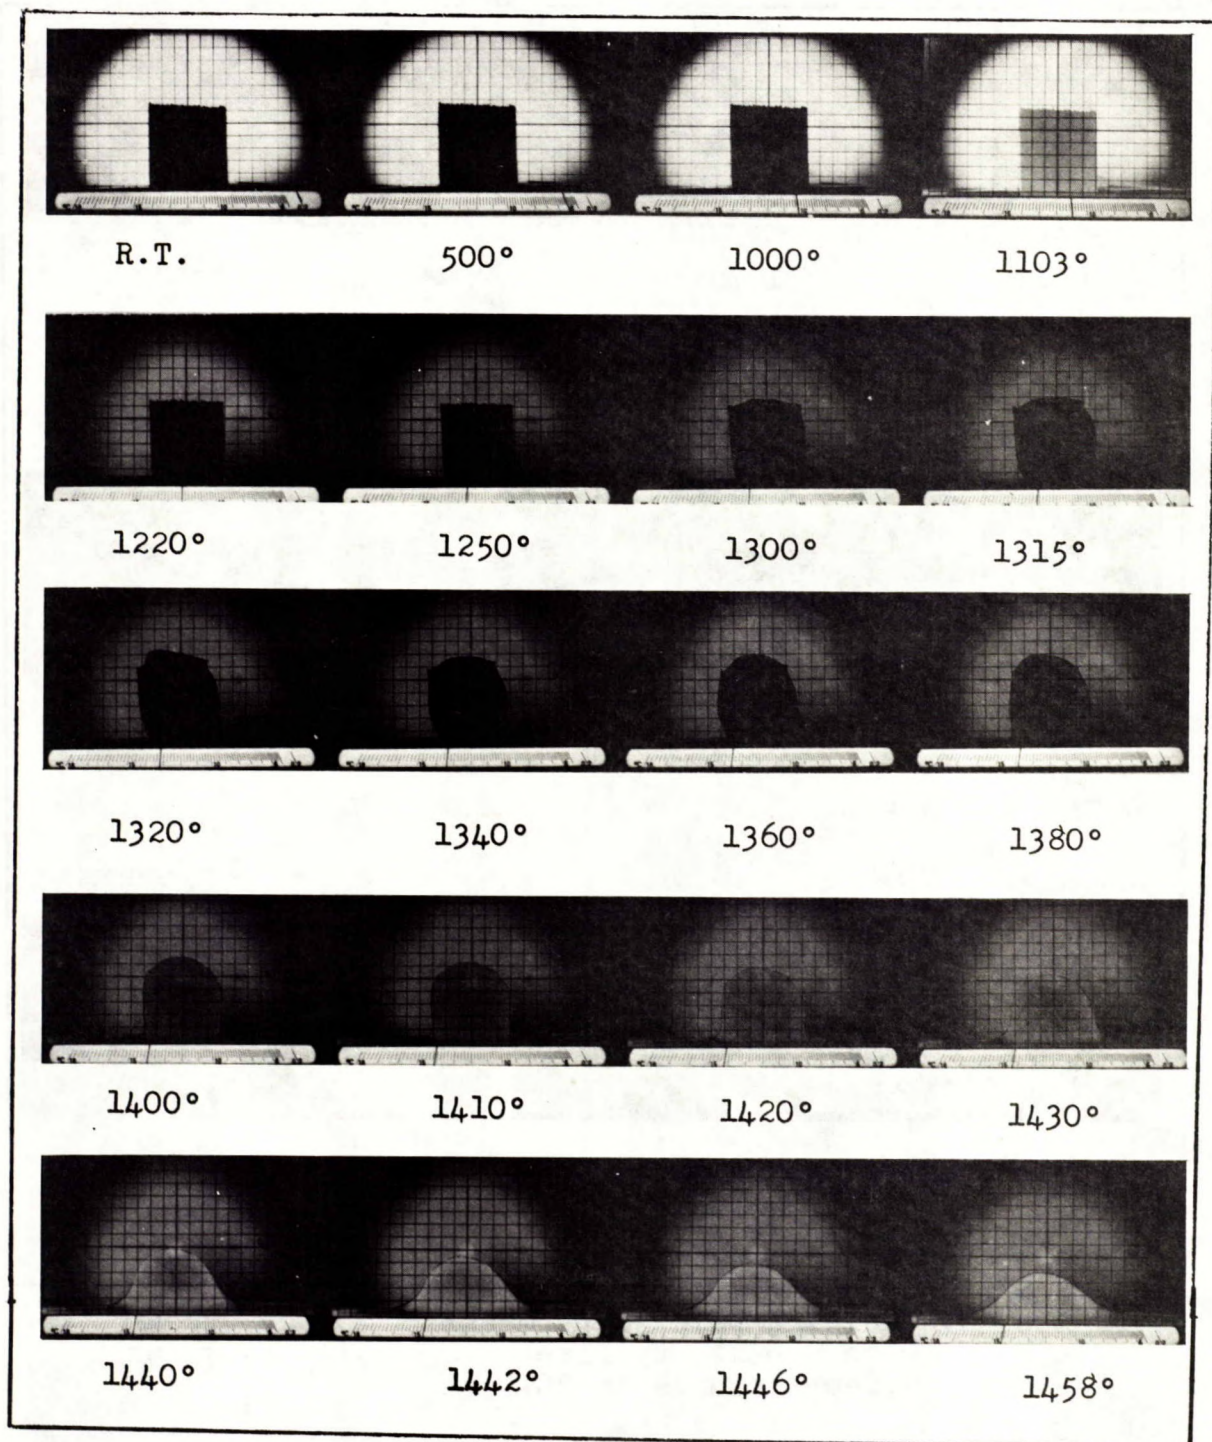
Heating was carried out at a rate of 18°F (10°C)/min. until the specimen melted. The changes which occur on heating the fly ash (Sample 1) in air are shown in Figure 9. The specimen shrinks up to 2282°F (1250°C), bloats from 2372°F (1300°C) to 2516°F (1380°C), and finally melts. The melting point is taken to be the hemispherical point(2) which in this case was 2624°F (1440°C). The changes in brightness of the specimen are due to differences in surface radiation and to the fact that a blue filter was inserted between the specimen and the ocular at 2192°F (1200°C).

Figure 9. Melting point determination of fly ash (Sample 1) in air (Temperatures in °C).

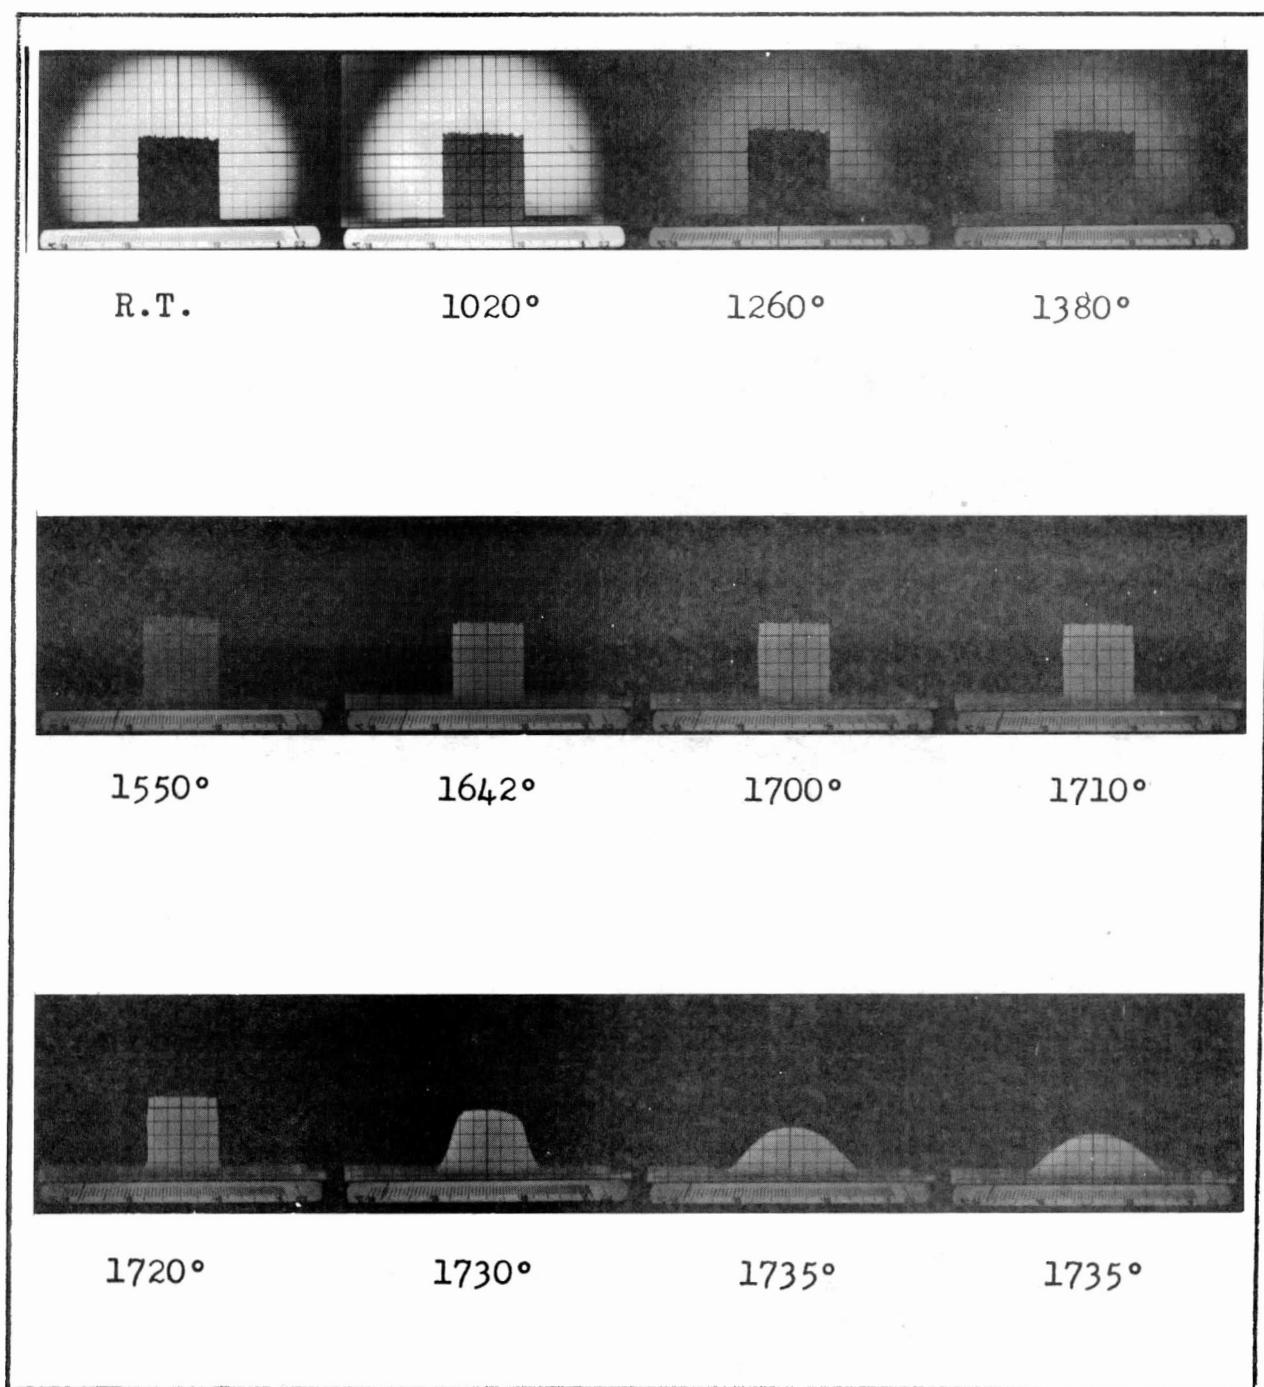
Figure 10 shows the changes in the unused Jay Bee firebrick (Sample 5) on heating in air. The melting point lies between 3146° and 3155°F (1730° and 1735°C) indicating a P.C.E. of Cone 33.

Figure 10. Melting point determination on unused Jay Bee Super Duty firebrick (Sample 5) in air (Temperatures in °C).

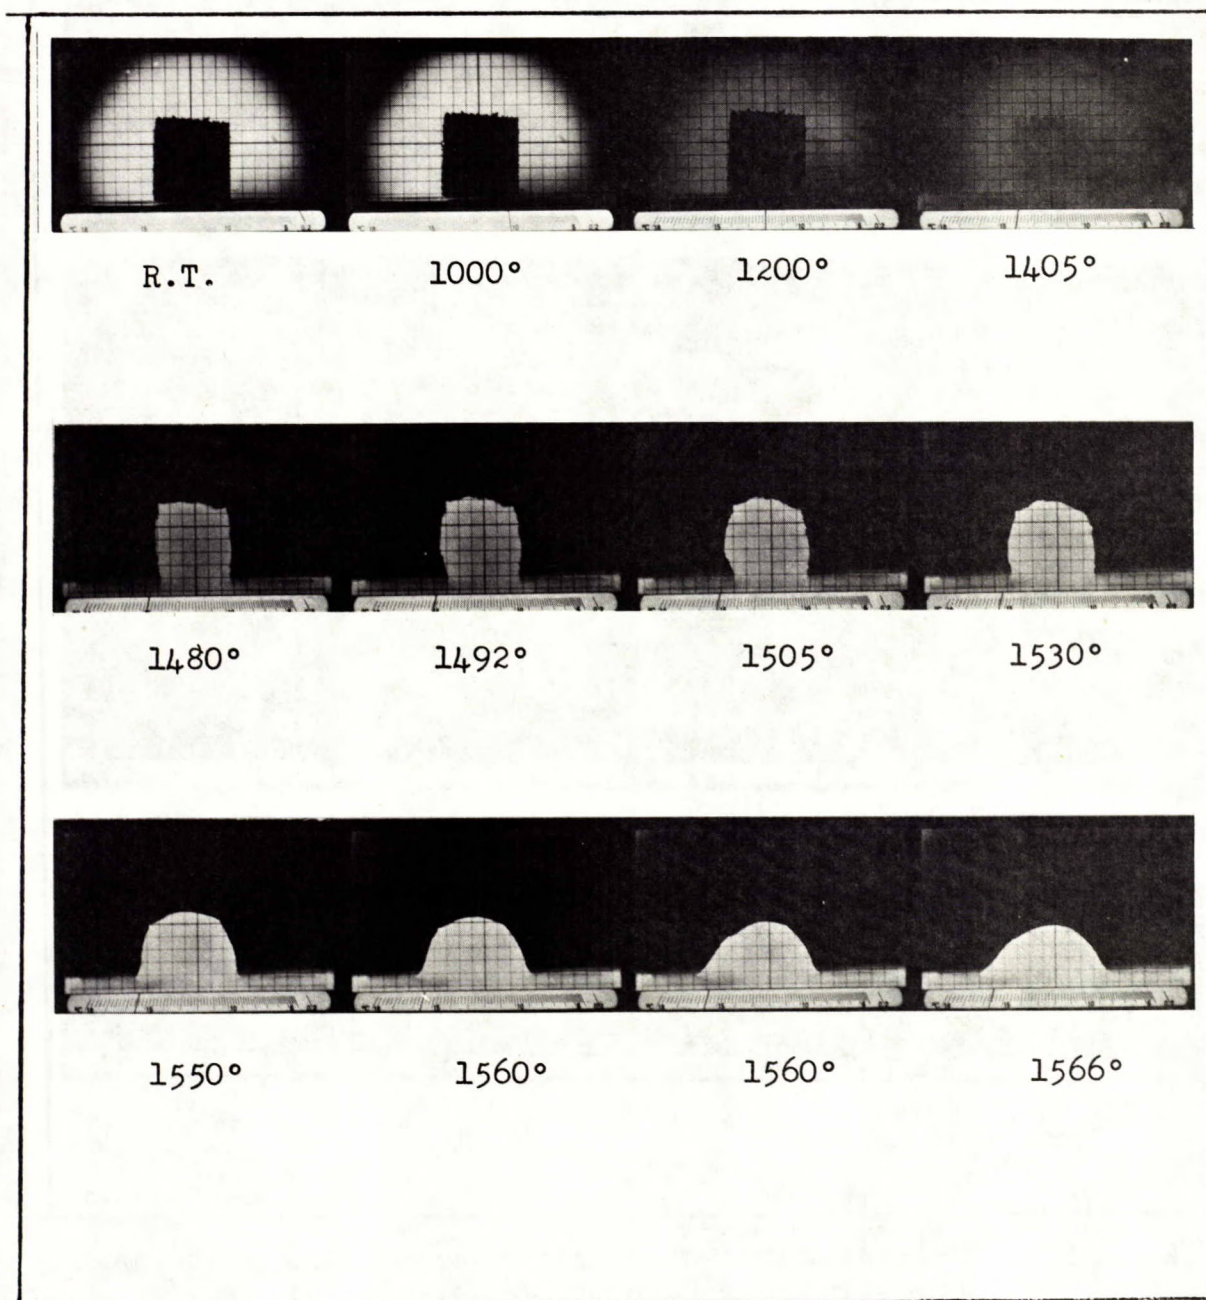
The changes which occur in the Maxbond Plastic refractory (Sample 7) on heating in air are shown in Figure 11. The melting point is approximately 2850°F (1566°C) indicating a P.C.E. of Cone 20. This material softens and distorts under its own weight at about 2696°F (1480°C).

Figure 11. Melting point determination on plastic refractory (Maxbond) (Sample 7) in air (Temperatures in °C).

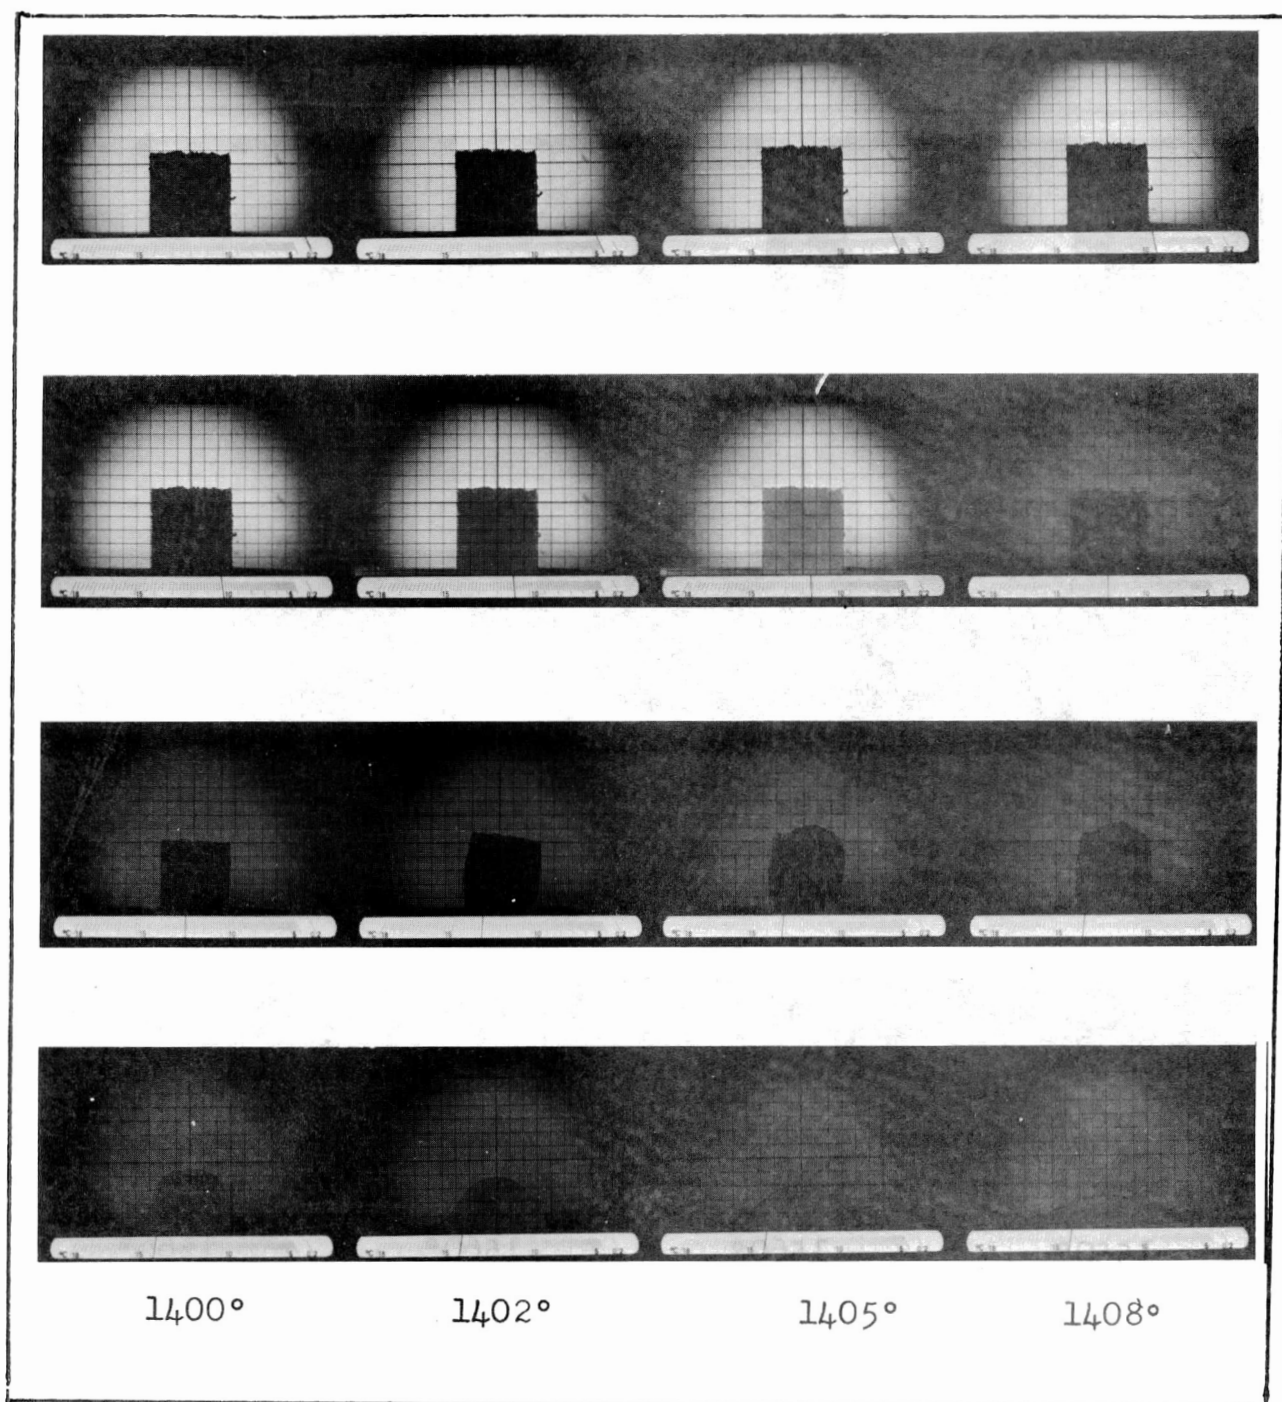
Figure 12 shows the changes which occur in the glassy material from the floor of the combustion chamber (Sample 3) on heating in air. Shrinkage commences between 2190° and 2280°F (1200° and 1250°C) after which bloating takes place from 2370° to 2550°F (1300° to 1400°C). The melting point is approximately 2550°F (1482°C).

Figure 12. **Melting** point determination on glassy material from floor of furnace (Sample 3), in air. (Temperatures in °C)

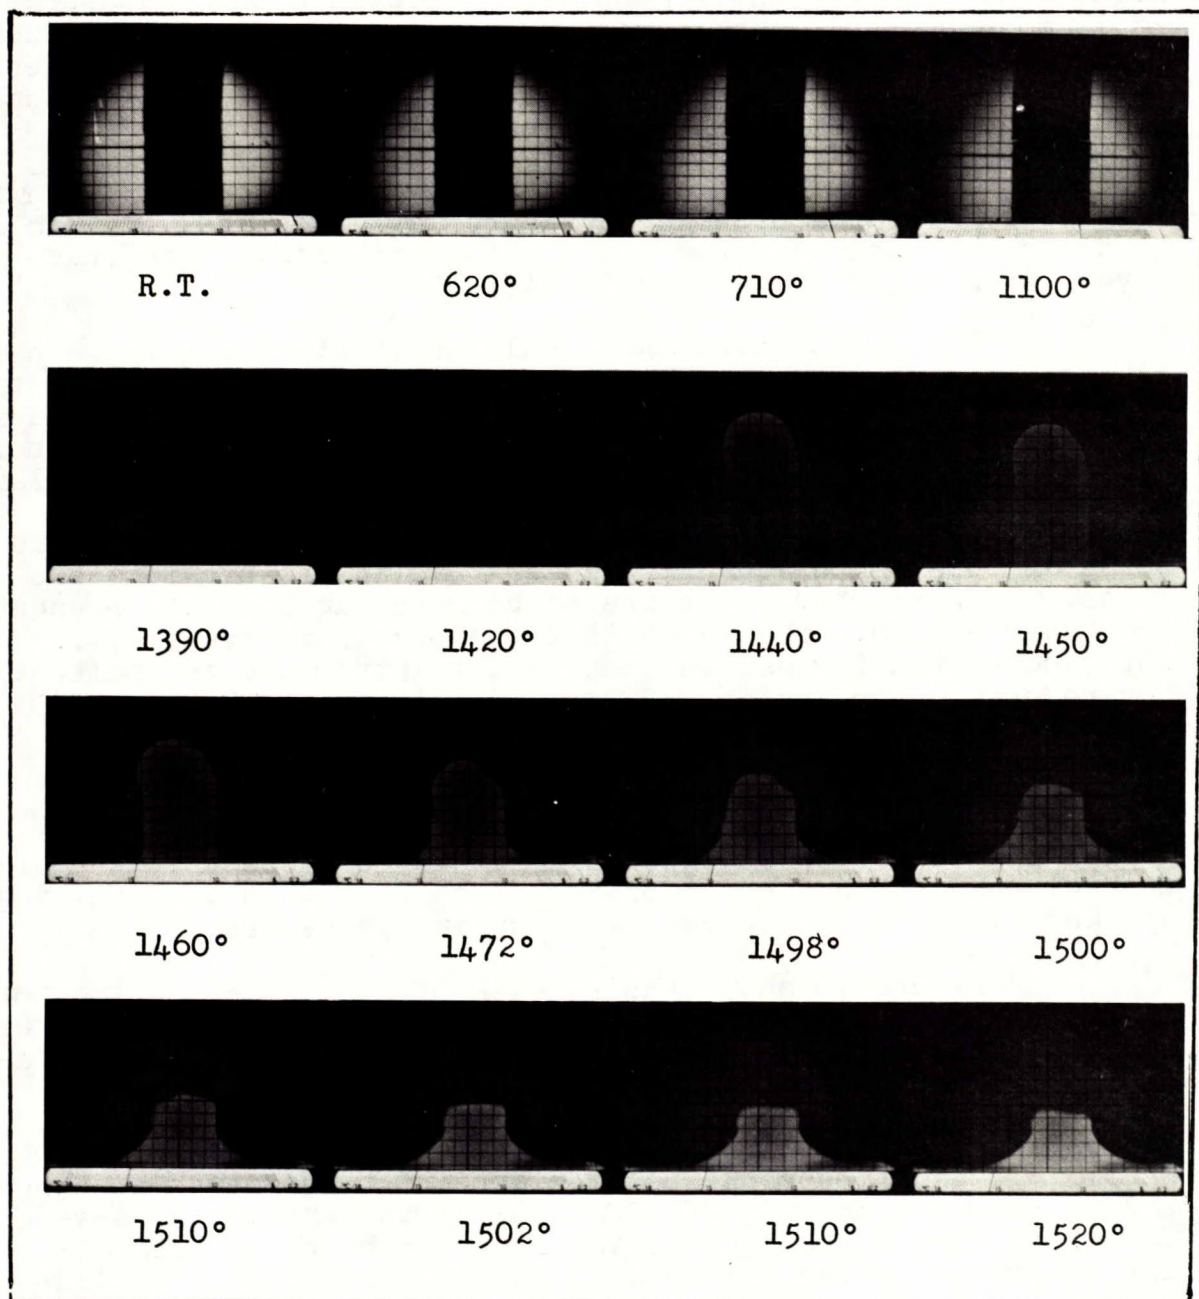
The results of heating the fly ash in contact with the Jay Bee Super Duty firebrick can be seen in Figure 13. Fusion of the ash takes place as observed in Figure 9 though the firebrick specimen appears unchanged up to 2642°F (1450°C). At 2660°F (1460°C) the molten ash begins to run off the firebrick specimen as indicated by the formation of a meniscus at the bottom of the setting. This process continues until at 2735°F (1502°C) the flat top of the firebrick specimen shows above the

Figure 13. Melting of fly ash (Sample 1) on unused Jay Bee Super Duty firebrick (Sample 5) in air. (Temperatures in °C) (ash specimen in top).

meniscus. Some erosion has occurred as indicated by the rounding off of the corners. Shrinkage of the firebrick specimen alone would occur at this temperature due to sintering of the minus 200 mesh material (Figure 10). Severe erosion appears to commence at 2768°F (1520°C). The heating rate employed here was high, such that the experiment was completed within 2½ hours. It is most probably that severe erosion of the firebrick would occur at temperatures lower than 2758°F (1520°C) if sufficient time were allowed. However, it seems clear that for erosion to occur, the ash must be in the fused state.

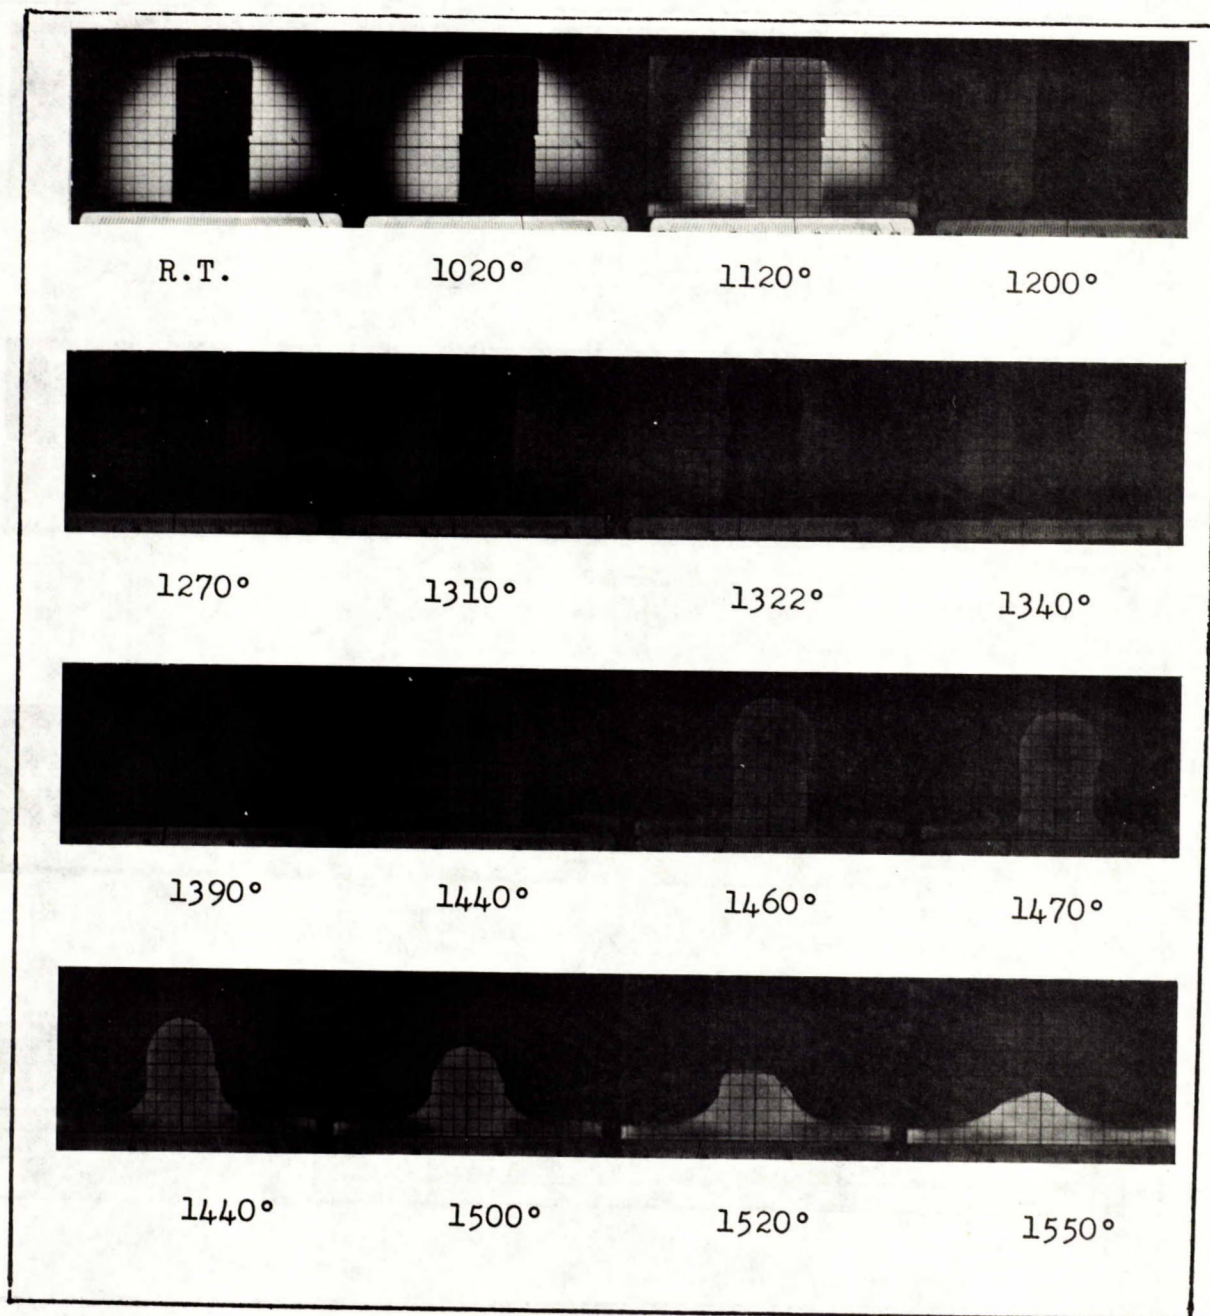
The results of heating the fly ash in contact with the refractory mortar are shown in Figure 14. They are very similar to those obtained with the super duty firebrick. Note that severe erosion occurs at 2822°F (1550°C).

Figure 14. Melting of fly ash (Sample 1) on refractory mortar (Sample 6) in air (Temperatures in °C).
