MINES BRANCH INVESTIGATION REPORT IR 71-58

**INVESTIGATION OF REFRACTORY FAILURE  
IN A BOILER COMBUSTION CHAMBER**

**MINERAL PROCESSING DIVISION**

AUGUST, 1971

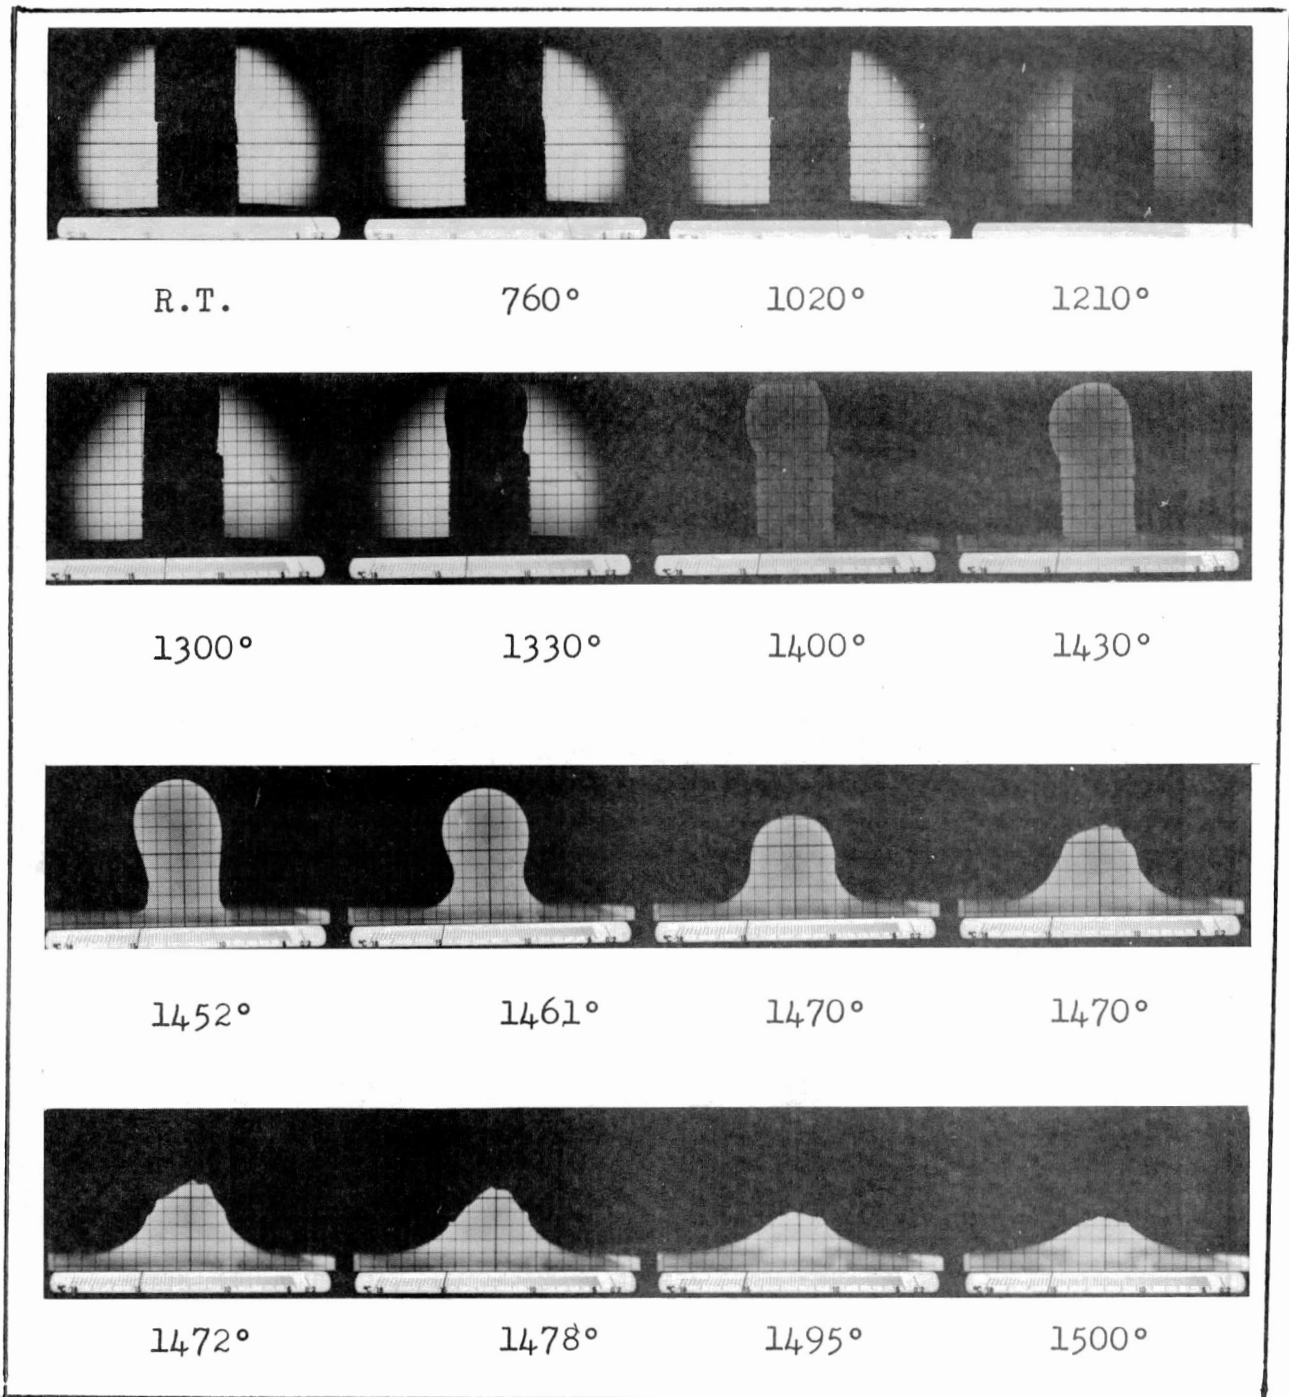
Figure 15 shows the results of heating the fly ash in contact with the Maxbond Plastic refractory. It is evident that this material is much less resistant to attack by the molten ash than either the Jay Bee Super Duty firebrick or the refractory mortar. Note the configuration of the specimen at 2660°F (1461°C). This was not observed in Figure 13 or Figure 14 at the same temperature, and it suggests that the viscosity of the liquid phase at this temperature is higher than in the previous two cases. However, there appears to be more liquid phase present. The above evidence indicates that the plastic refractory is attacked by the fly ash as soon as the latter becomes molten. Severe erosion begins at 2678°F (1470°C) and at 2732°F (1500°C) the refractory specimen has practically disappeared.

Figure 15. Melting of fly ash (Sample 1) on Maxbond Plastic refractory (Sample 7) in air (Temperatures in °C).

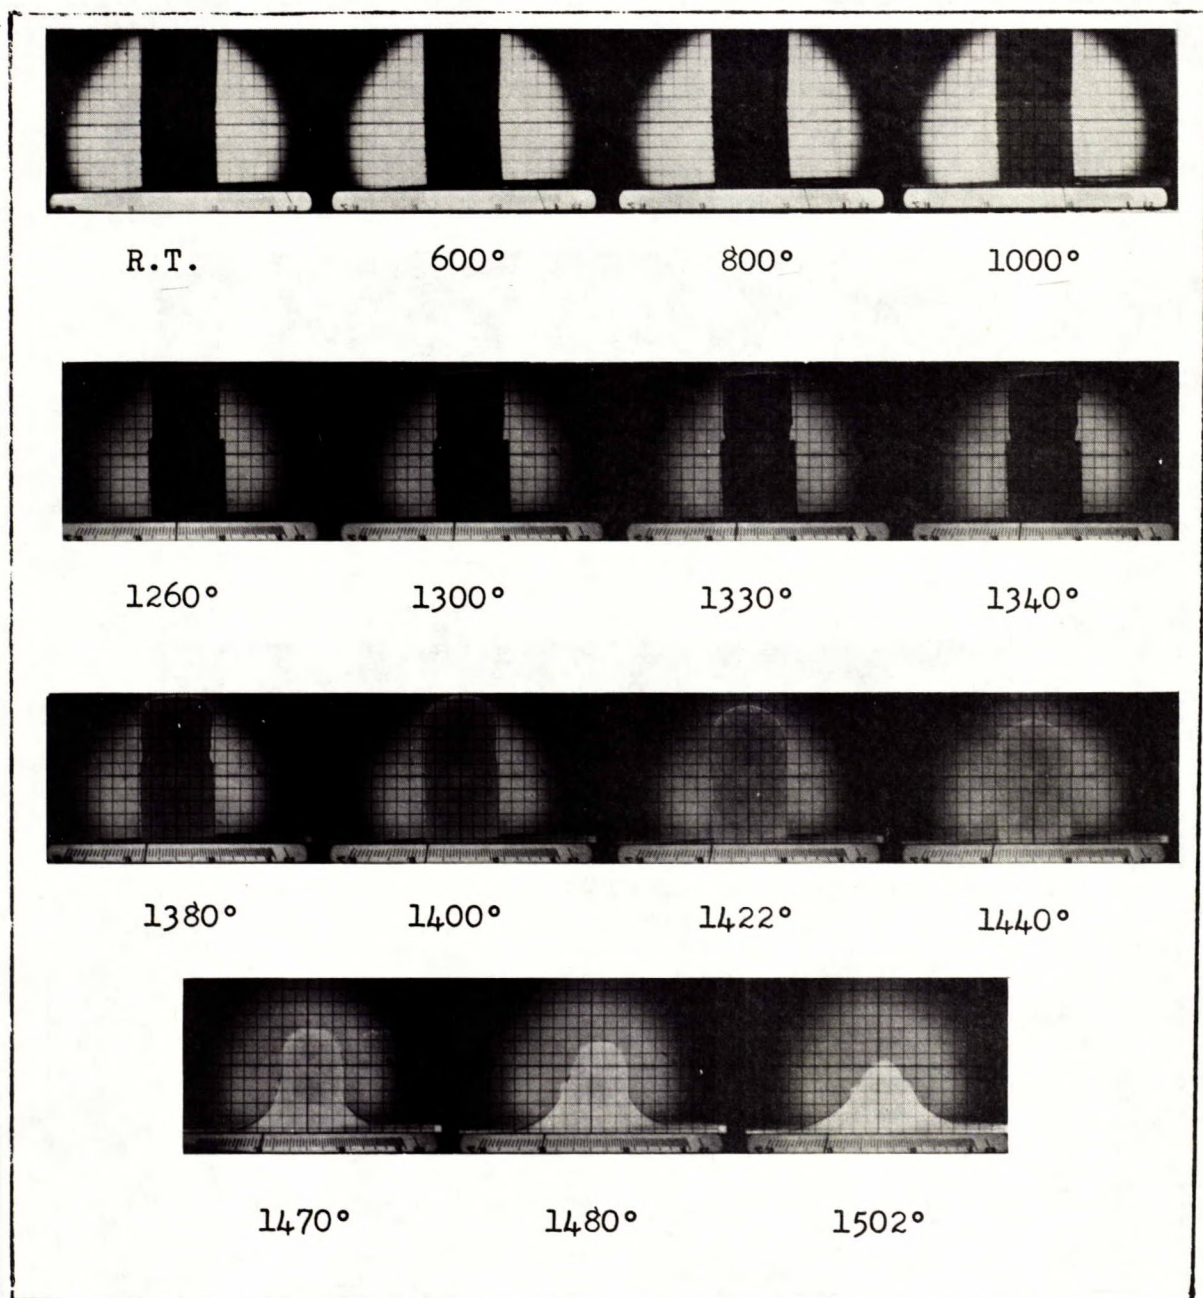
Figure 16 shows the results of heating a specimen of fly ash in contact with a specimen of the unused Jay Bee super duty firebrick in an atmosphere of nitrogen. Under these conditions the fly ash shows practically no bloating tendency though some liquid phase is present at 2444°F (1340°C) as indicated by the bubble on the right hand side of the specimen. Erosion of the firebrick specimen appears to commence at about 2678°F (1470°C) and, at 2735°F (1502°C), the erosion is severe. Therefore, under these conditions the firebrick is less resistant to attack by the molten ash than if heated in air (Figure 13).

Figure 16. Melting of fly ash (Sample 1) on unused Jay Bee Super Duty firebrick (Sample 5) in nitrogen. (Temperatures in °C).

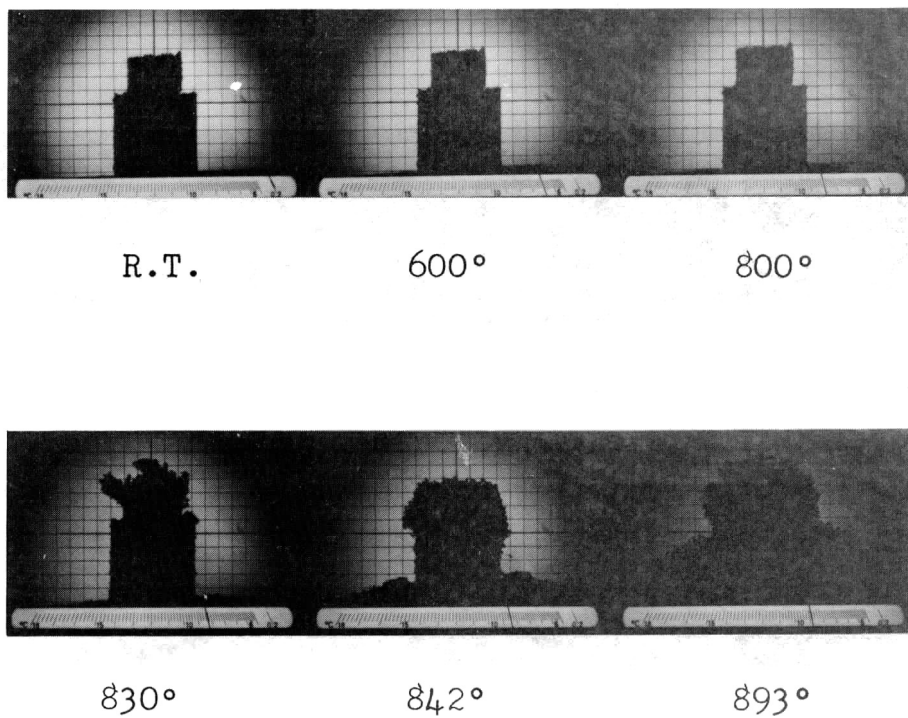
The results of heating fly ash in contact with the firebrick in a natural gas atmosphere are shown in Figure 17. Between 1472° and 1526°F (800° and 830°C) the ash specimen began to disintegrate into a loose powdery mass and, at 1640°F (893°C), the firebrick specimen was almost completely enveloped. Heating was discontinued at this point to avoid damaging the furnace tube.

Figure 17. Heating of fly ash (Sample 1) on unused Jay Bee Super Duty firebrick (Sample 5) in natural gas. (Temperatures in °C).

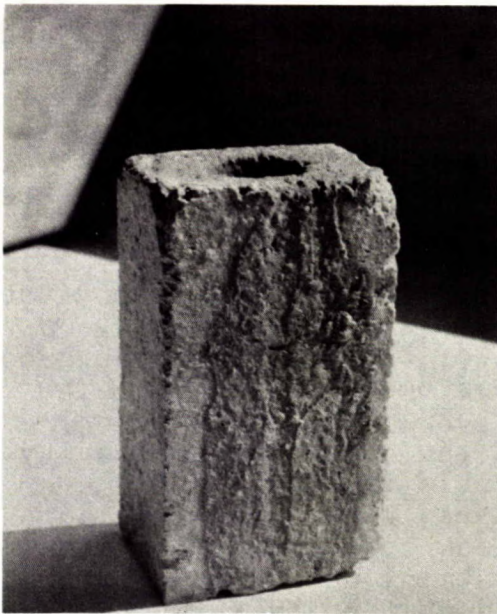
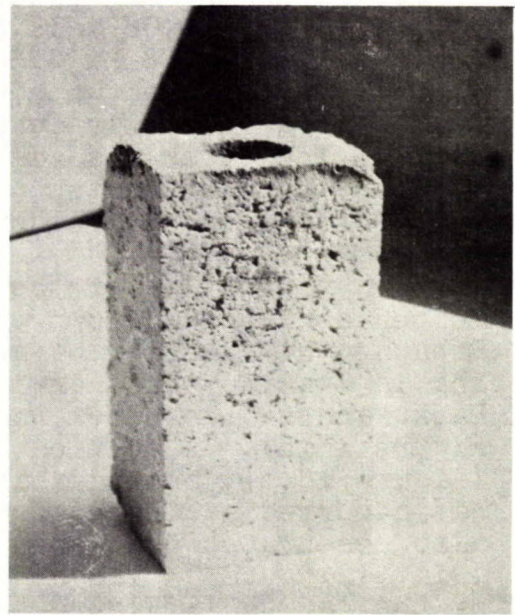
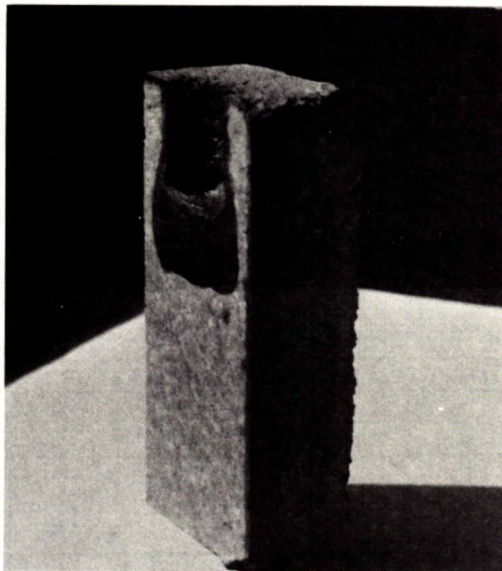
Figure 18. Results of heating fly ash in air to  $2894^{\circ}\text{F}$  ( $1590^{\circ}\text{C}$ ) in a cylindrical cavity cut in unused Jay Bee Super Duty firebrick. a) Showing grooving of brick caused by flow of molten ash. b) Showing reverse face to be undamaged. c) Section through cavity showing increase in diameter at bottom of cavity due to fluxing, and deep penetration into brick.

Grooving of the front face of the block caused by the molten ash running downwards can be seen in Figure 18(a). Because the quantity of ash was limited, the extent of the grooving is less severe than if the flow had been continuous. The back face of the block was completely undamaged as seen in Figure 18(b). A section, cut through the centre of the cavity (Figure 18(c)), showed that a considerable increase in diameter had occurred at the bottom. Furthermore, the molten ash had also penetrated downwards into the block to a depth of about 1 in. (2.54 cm). The needle-like crystals, seen at the bottom of the cavity in Figure 18(c), were identified by X-ray Diffraction Analysis as mullite, (3Al<sub>2</sub>O<sub>3</sub>·2SiO<sub>2</sub>).
