MINES BRANCH INVESTIGATION REPORT IR 72-8

EXAMINATION OF WAVERIDER MOORING FROM COME-BY-CHANCE, NEWFOUNDLAND

G. J. BIEFER AND R. D. MCDONALD

FEBRUARY 16, 1972

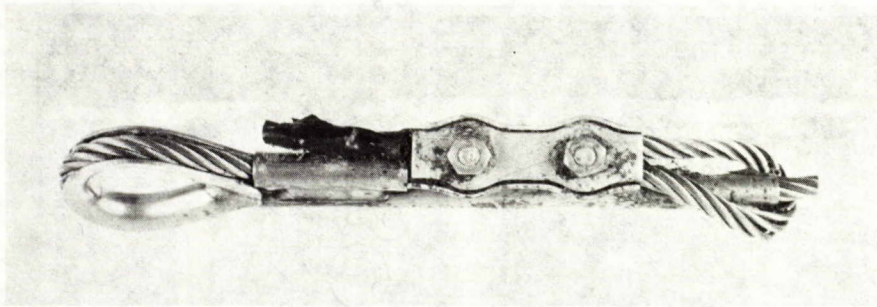
Each of the rope ends was fitted with terminals of the type shown in Figure 1. The rope was stated to be Type 302* stainless steel and the metal fittings Type 316 stainless steel. The Type 316 steel showed no significant corrosion attack. One of the terminals was made up in a non-standard way in that the loop over the shaft (at right in Figure 1) was omitted, but, rather a tight bend was made over the right-hand bolt under the screwed-on lid. Rust was observed to be bleeding from under the lid and was found to originate at the region of sharpest bend around the bolt. Here, several wires had broken through and others were thinned by corrosion, some to the point of breaking. Typical corrosion damage is shown in Figures 2 and 3.

Figure 1. Standard rope terminal from upper strop.

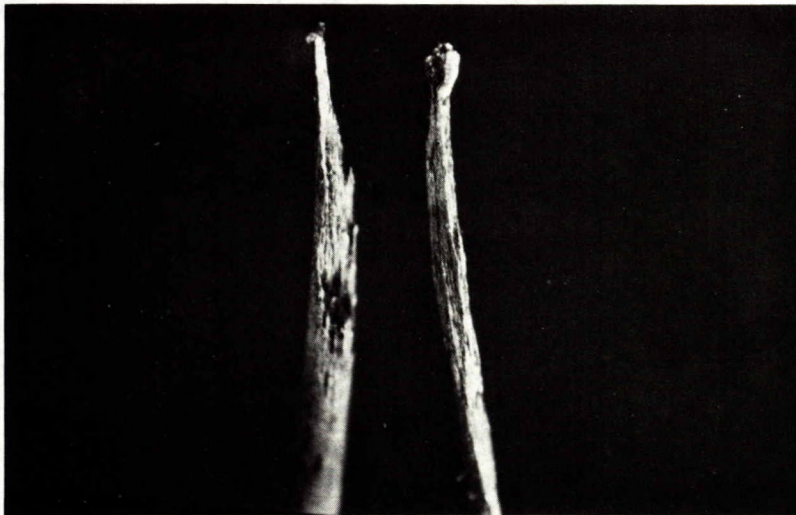
Figure 2. View of broken wires taken from the end fitting of the upper strop showing evidence of corrosion.

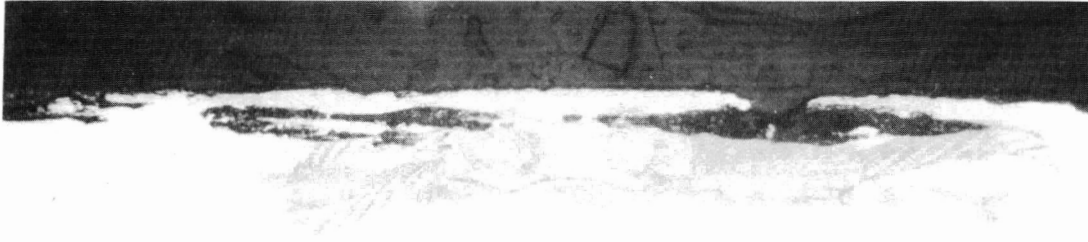
Figure 3. A metallographic section of one of the wires shown in Figure 2 illustrating the appearance of corrosion pits at an early stage of the attack.

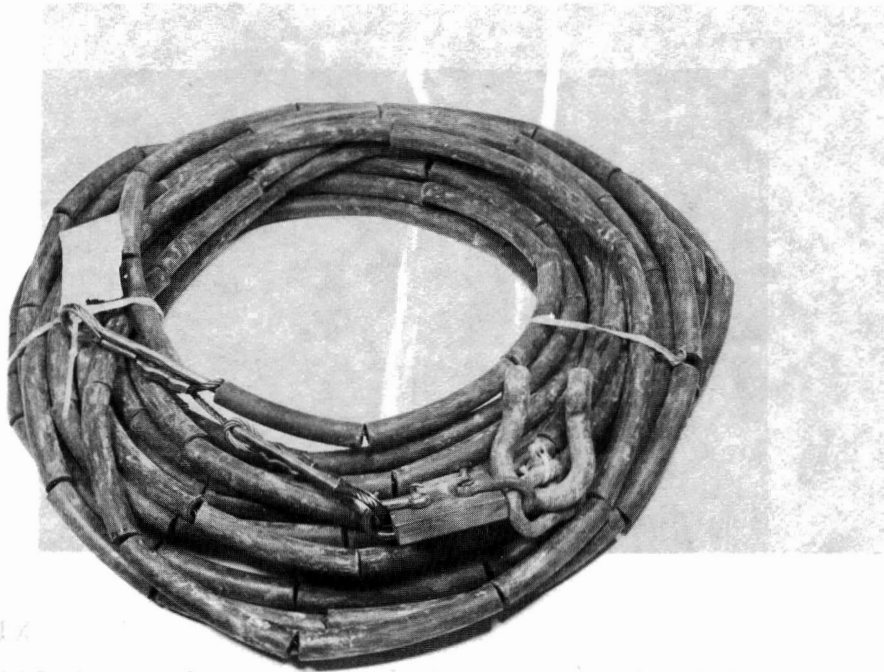
Figure 4 shows the lower strop, including terminals and beading of rubber hose. The latter was designed to protect the rope against possible abrasion damage caused by intermittent contact with the ocean bottom.

Figure 4. Lower strop, showing rubber beading and rope terminals.

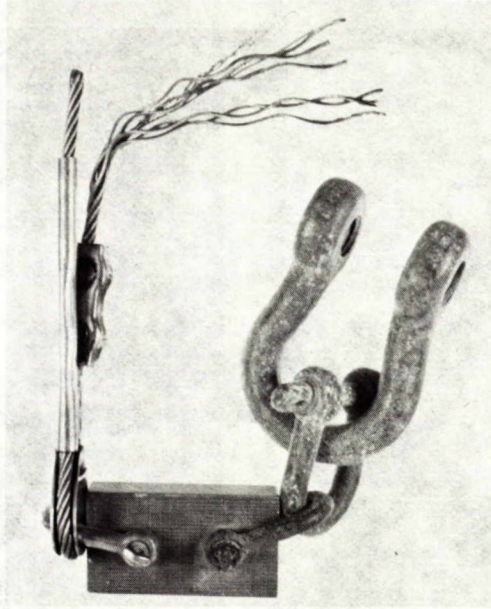
The lower end of the strop was connected to a chain anchor which was electrically separated from the rest of the system by a "Celeron" insulator. This is shown in Figure 5. At the right are seen two galvanized shackles and a third ordinary steel one, the latter being fastened directly to the insulator. Visual observation indicated little or no corrosion damage to the galvanized shackles, though they seemed to have lost most of their zinc. The ordinary steel showed many large shallow pits and loosely adherent corrosion product.

Figure 5. Lower terminal of lower strop.

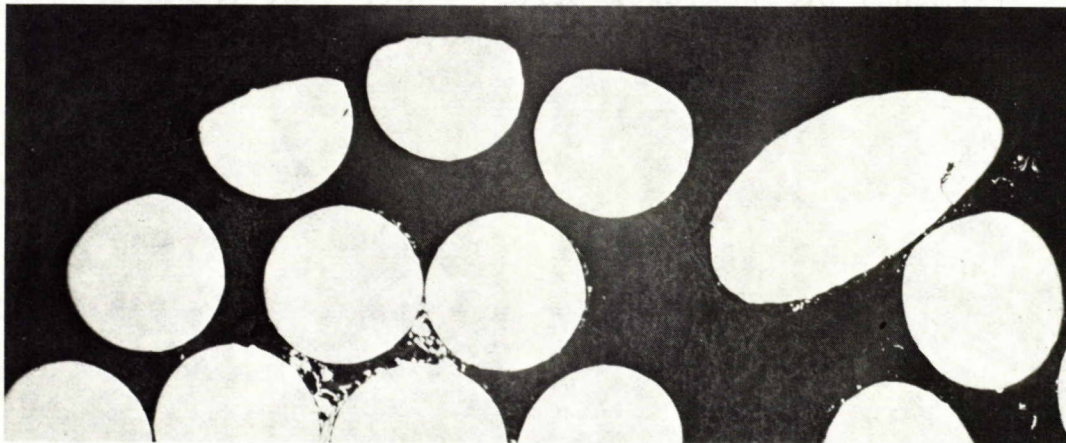
Under examination by low-power stereomicroscope, the outermost parts of the rope at the thimble of the upper terminal seemed flattened, and the six broken ends were flattened. Metallographic sections were made in the vicinity of the main concentration of broken ends (Figure 6). It is seen that there are flattened wires at the surface of the rope but no evidence of corrosion attack. Apparently, abrasion was the principal cause of stranding in this case.

Figure 6. Wires flattened by abrasion on the upper terminal of the lower strop.

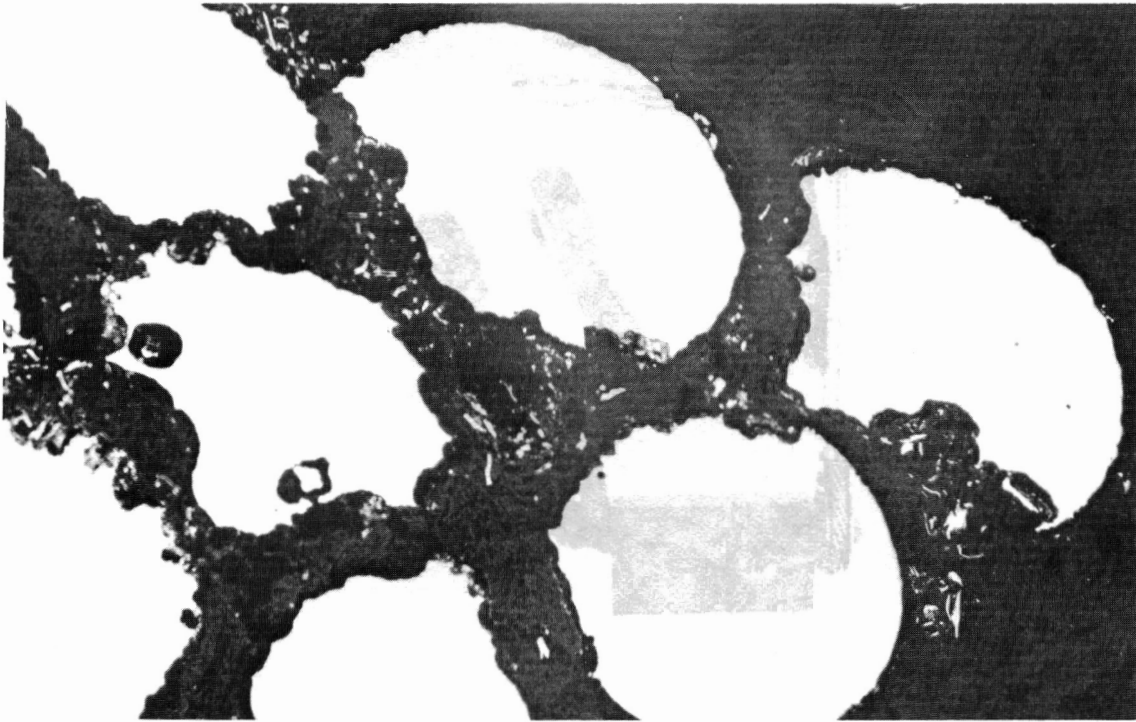
Under examination by low-power stereomicroscope, the stranding seen at the thimble of the lower terminal appeared to result from crevice corrosion which was proceeding within a strand. Some individual wires were seen to be so thinned by corrosion that they were on the point of breaking. Whereas attack was quite severe at the area where the stranding had occurred, it was not as severe at adjacent areas, nominally subject to similar conditions. Metallographic sections were made in the vicinity of the stranding and an illustrative photomicrograph is shown in Figure 7. This shows individual wires to be severely corroded.

Figure 7. Wires showing severe corrosion attack on the lower terminal of the lower strop. Note that the severest attack is on the inner surfaces of the wires in the strand.

1. After 3 months in a mooring at Come-by-Chance, Type 302 stranded rope has lost approximately 10% of its strength because of crevice corrosion.
2. Rope in the end fittings, especially at the thimbles and in other regions of severe bending, has shown more intense crevice corrosion than at other parts of the strops, leading to breakage of some wires.
3. The outermost wires of the rope on the upper thimble of the lower strop showed definite abrasion damage, leading to broken wires.
4. If practicable, the replacement of Type 302 by Type 316 stranded cable should give improved service in that crevice corrosion should be minimized.
