MINES BRANCH INVESTIGATION REPORT IR 74-9

**EXAMINATION OF A WHEEL AND AXLE ASSEMBLY
REMOVED FROM TANK CAR UTLX 13695**

R. D. MCDONALD AND D. M. NORMAN

PHYSICAL METALLURGY DIVISION

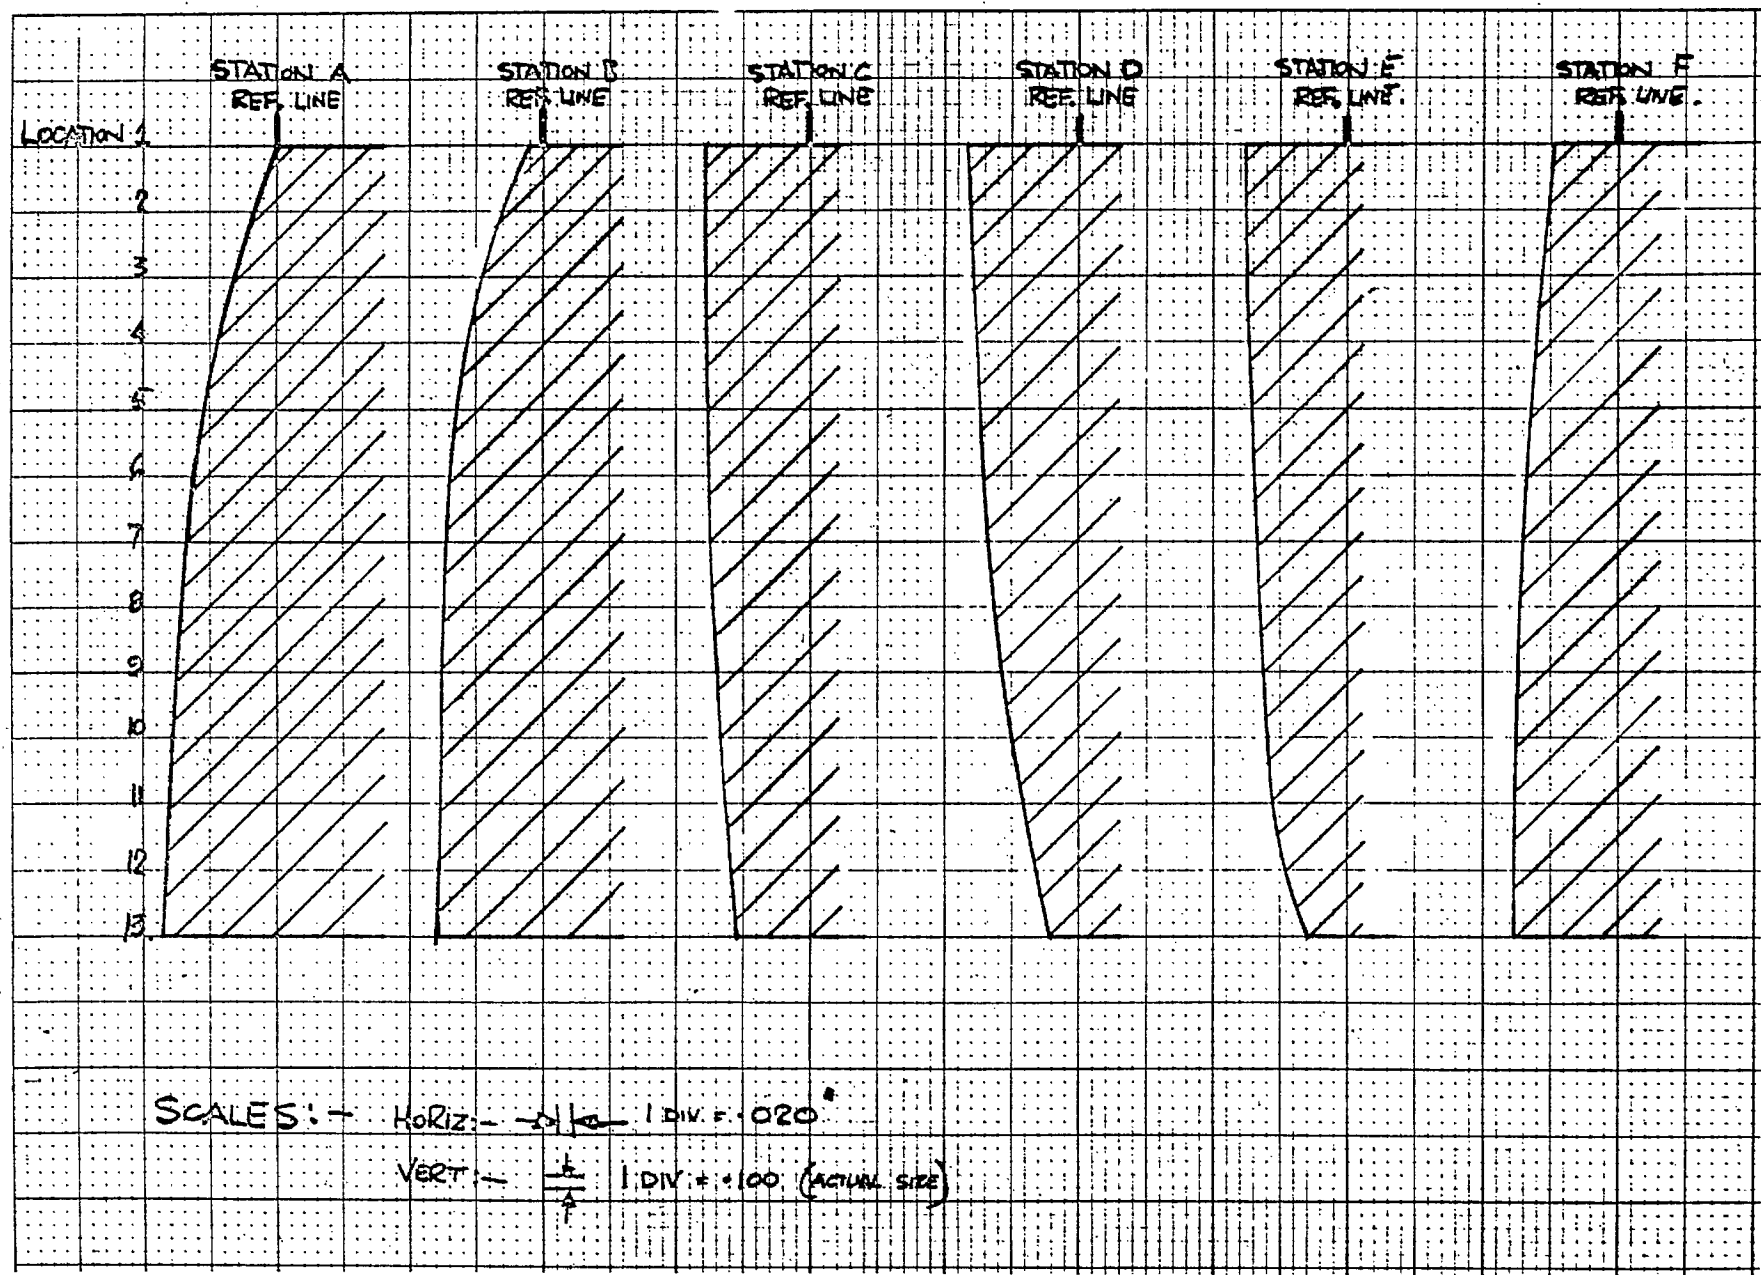
Figure 6. Wheel bore profiles - UTLX 13695 - R1.

The point of greatest deformation (in this case station A, location 1) was used as the bench mark and all the readings were the variations from this point. One set of readings was taken at location 1 going from stations A to F, the indicator was then positioned at location 2 and a set of readings taken from stations A to F. After a total of 78 measurements was recorded in this manner, the indicator was repositioned on the bench-mark to ensure that no accidental movement had taken place of either the table or the wheel. As a double check against the recorded measurements, another set of readings was taken, this time starting at station A location 1 and moving successively along station A to location 13. The table was rotated so that station B was aligned for measuring and a set of readings taken from location 1 to location 13. This procedure was continued until all the previous 78 TIR readings had been duplicated. The two sets of readings coincided within the limits of resolution of the dial indicator. The result from these sets of readings is shown in Table 5. Where there is a discrepancy of 0.001 in. between the first and second set of readings, only the even figure has been recorded.

All those values shown in Table 5 have been plotted graphically, as shown in Figure 6. The curves in Figure 6 show the bore profile through each station and the reference line is in effect the bench mark position.

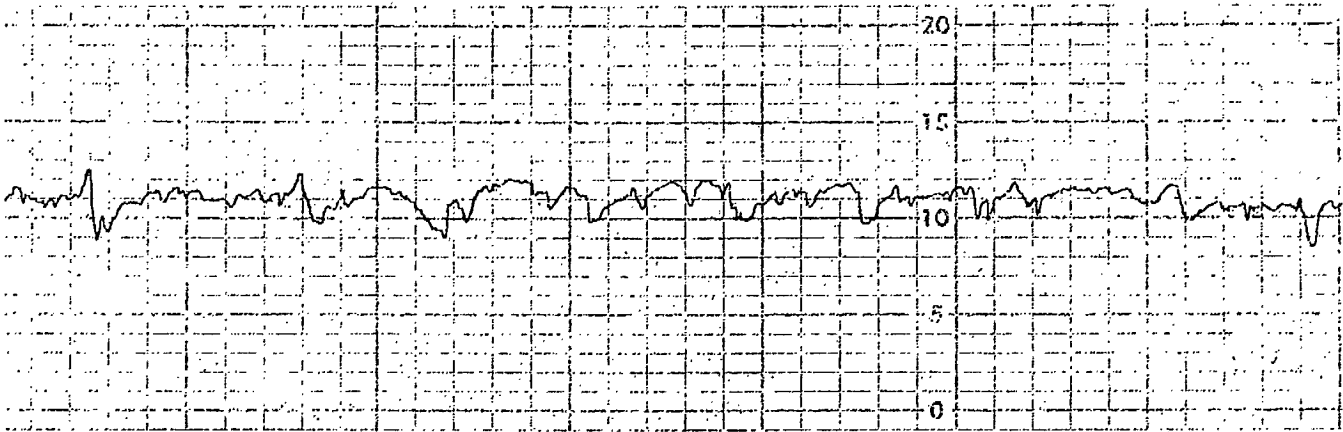
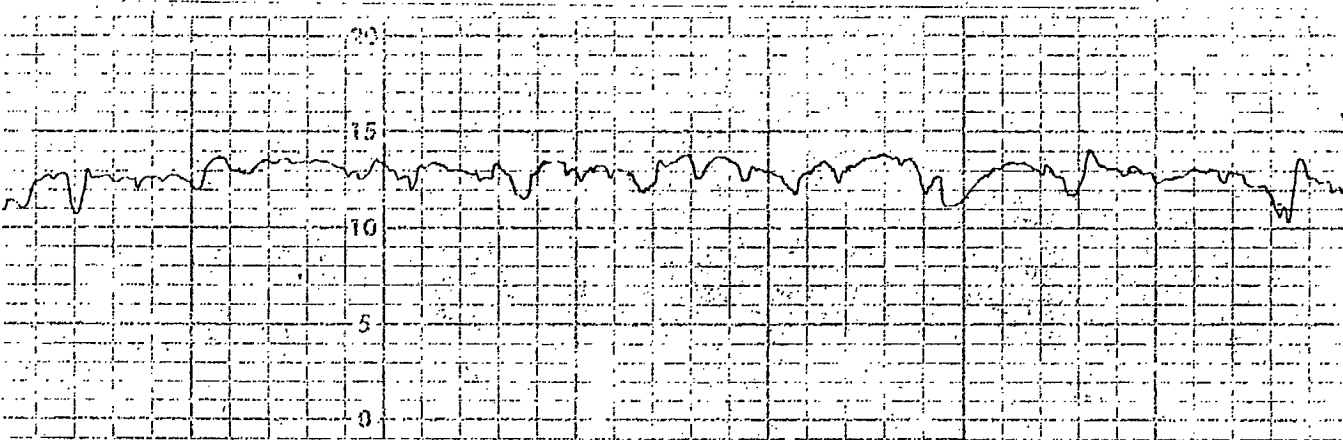
Figure 8. Surface roughness profiles - L1 wheel seat.

The surface roughness readings were made over surfaces that had been assembled under load. It is difficult therefore to assess the surface roughness values in the original machined but yet unassembled state; however, the roughness readings would be no less than those shown in Table 7. The recordings in the transverse direction on wheel seats L1 and R1 are shown for comparison purposes only to illustrate the extent of the longitudinal scratch marks. The scratch marks generated when removing the L1 assembly are more pronounced than on the R1 assembly. If, as previously suggested, the R1 wheel did in fact rock on its seat, then a burnishing effect would take place and this is evidenced by the difference between the two longitudinal direction readings for this wheel. The portion of the seat which was not in contact with the wheel bore clearly shows the even pitch of the toolmarks. A small area that still contained toolmarks on the L1 seat was measured for surface roughness and the value obtained is recorded in Table 7, but there is no way now of knowing what the roughness was prior to assembly.

(a) L1 Wheel Seat - Longitudinal Direction
Magnification 1000 x 20
CLA 42 μ in.

(b) L1 Wheel Seat - Transverse Direction
Magnification 1000 x 20

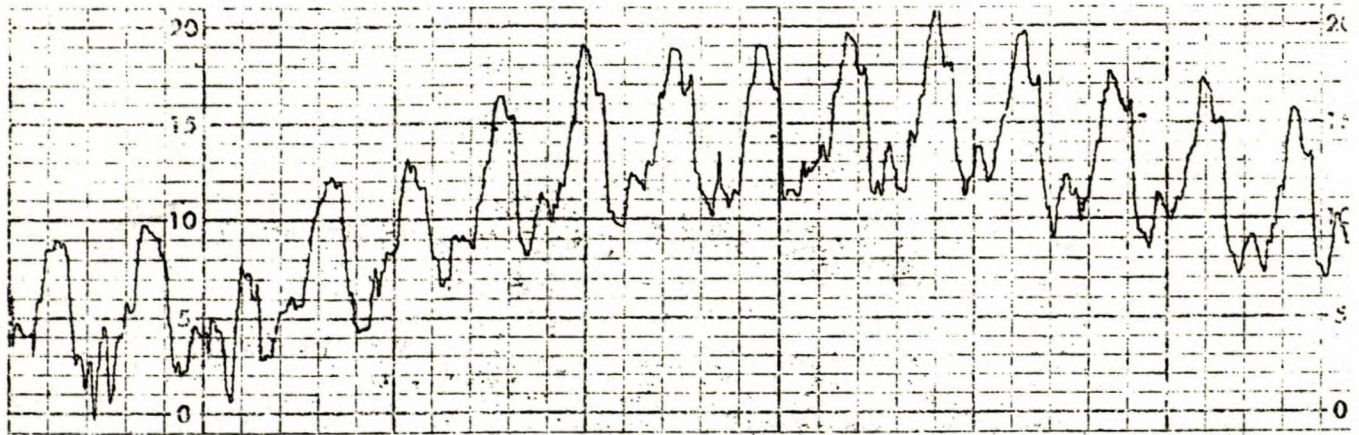
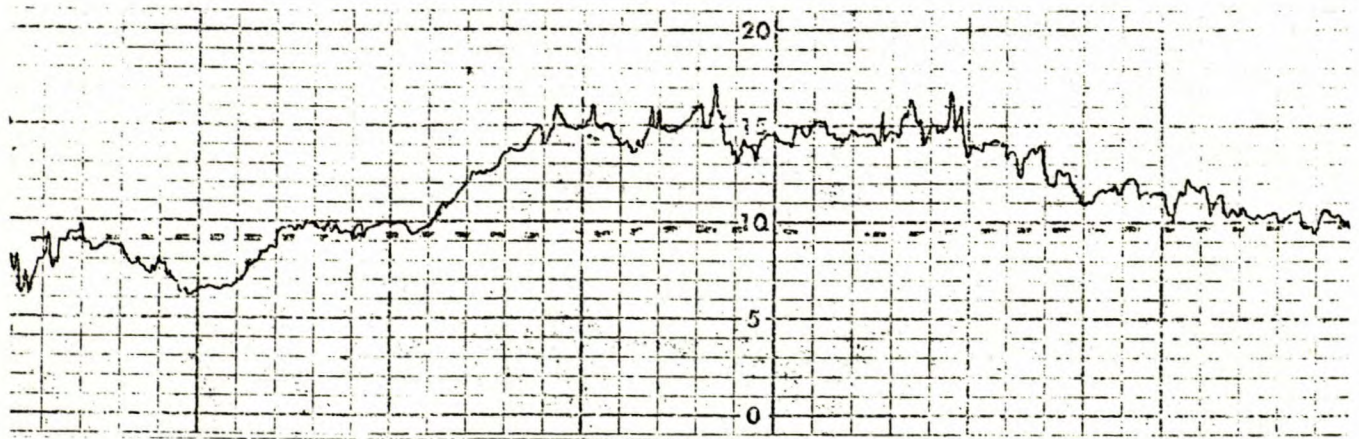
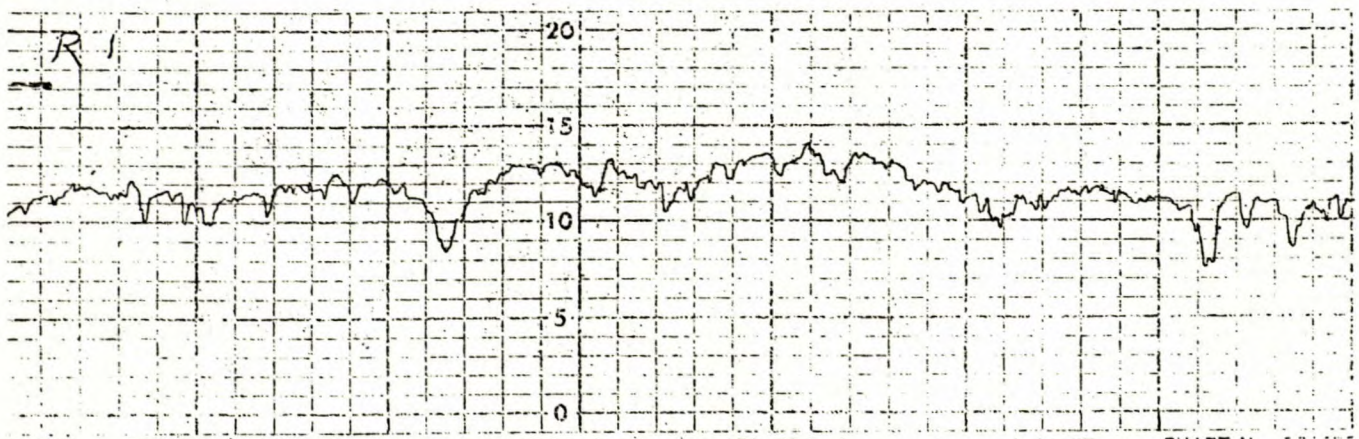
Figure 9. Surface roughness profile - R1 wheel seat.

small horizontal division represents 0.01 in. on the component being measured. A similar graphical pattern of the surface of the R1 wheel seat to the same scales is shown in Figures 9(a), 9(b) and 9(c). On this particular unit a satisfactory portion of the wheel seat extended beyond the wheel, so an extra roughness reading was taken at this location.

- (a) the excessive taper on the wheel seat
- (b) the degree of surface roughness of the wheel seat, assuming that it was the same as that measured on the residual unfitted area.
- (c) the degree of roughness of the wheel bore

(a) R1 Wheel Seat - Longitudinal Direction
(Inner end of seat between locations 14 to 15)
Magnification 1000 x 20. CLA exceeded 200 μ in.

(b) R1 Wheel Seat - Longitudinal Direction
(Centre of Wheel Seat)
Magnification 1000 x 20. CLA 52 μ in.

(c) R1 Wheel Seat - Transverse Direction
Magnification 1000 x 20.

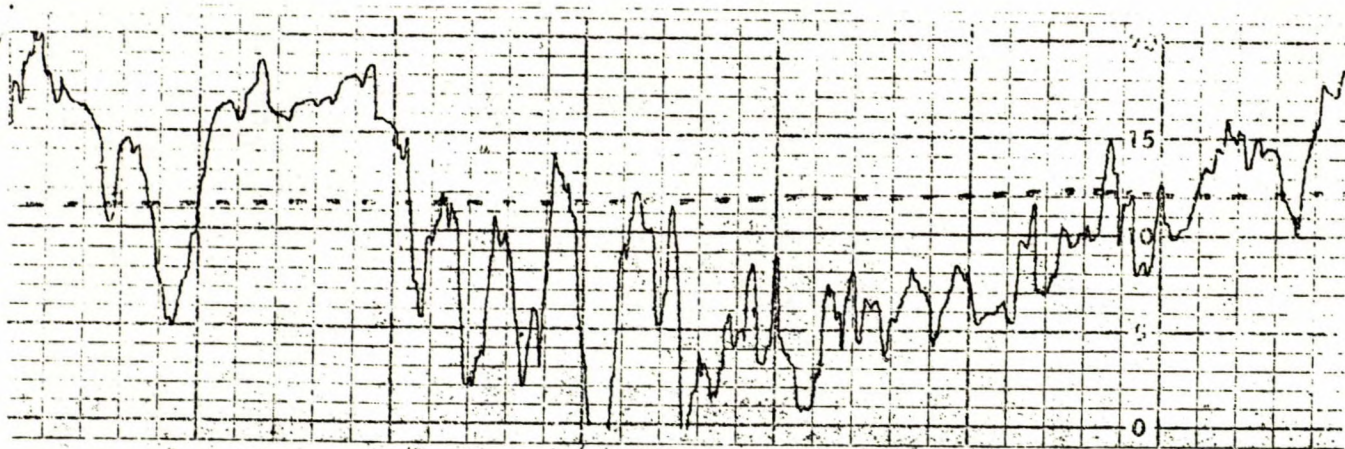
Figure 10. Surface roughness profile - L1 wheel bore.

The roughness readings taken from the wheel bores are illustrated in Figures 10 and 11. The roughness value for the L1 wheel is less than for the R1, but by how much we don't know as the roughness for the R1 wheel was beyond the range of the instrument used. It is interesting to note that a "shadow" of the waviness pattern of the L1 wheel bore is visible on the L1 wheel seat; due to an oxide film on the R1 seat such a pattern is impossible to see. Until such time as quantitative values for roughness are given for wheel bores and seats, the surface finishes

L1 Wheel Bore - Longitudinal Direction
Magnification 1000 x 20
CLA 140 μ in.

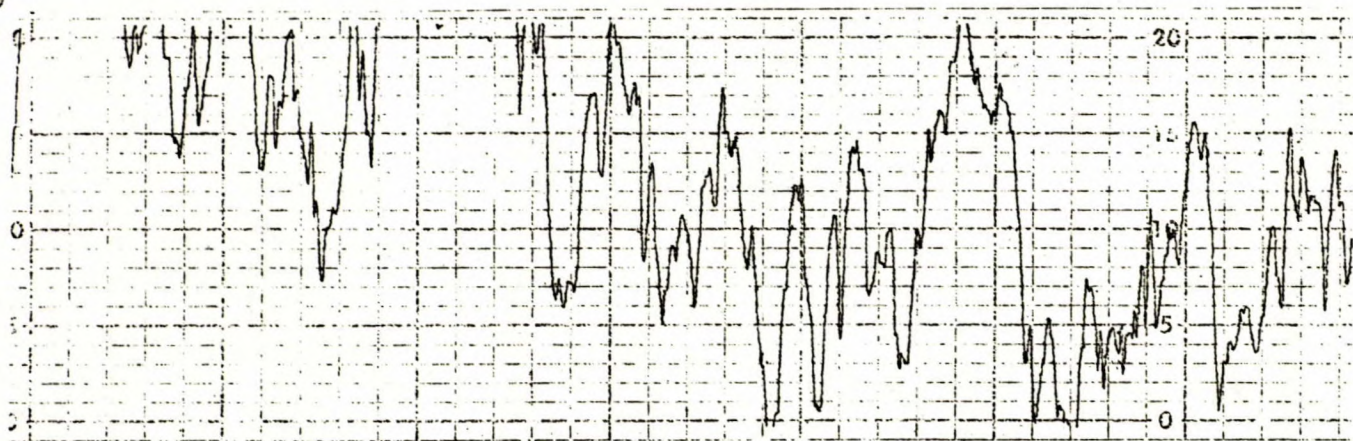
Figure 11. Surface roughness profile - R1 wheel bore.

R1 Wheel Bore - Longitudinal Direction
Magnification 1000 x 20
CLA exceeded 200 μ in.
