MINES BRANCH INVESTIGATION IR 58-18

METALLURGICAL INVESTIGATION INTO THE FAILURE OF A BEATER ROLL BAR

PHYSICAL METALLURGY DIVISION

FEBRUARY 14, 1958

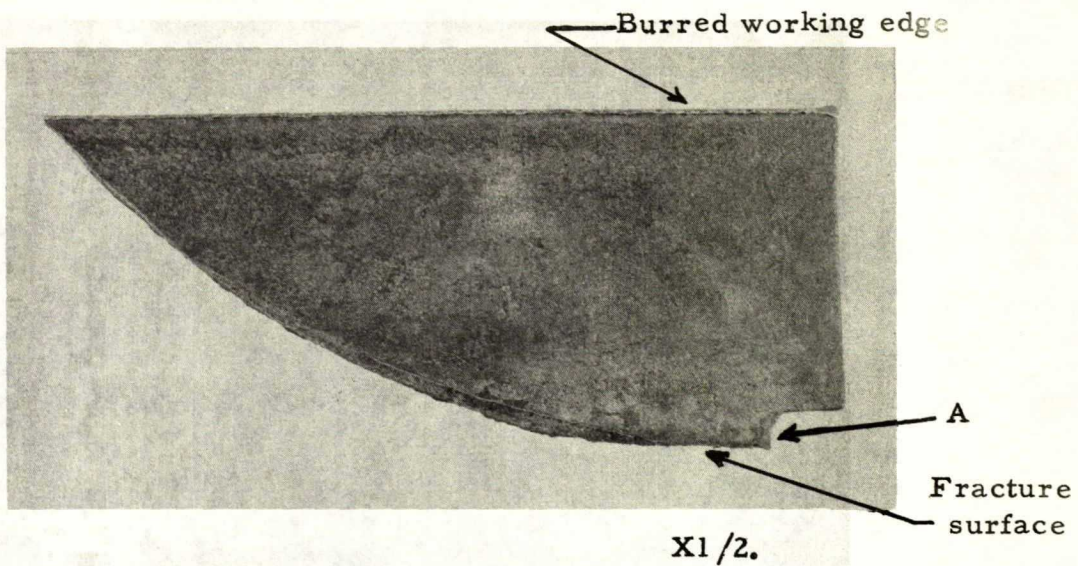
Figure 2 shows the fracture bar under investigation. The general surface condition of the bar was poor, being covered with patches of tightly adhering mill-scale, pitted areas, and long furrow-like markings localized near the fillet. Neither visual nor magnaflux inspection revealed the presence of flaws or cracks.

Fig. 2. - Photograph of fracture bar.
Note the poor surface appearance.
(A = starting point or nucleus of
initial fatigue cracks.)

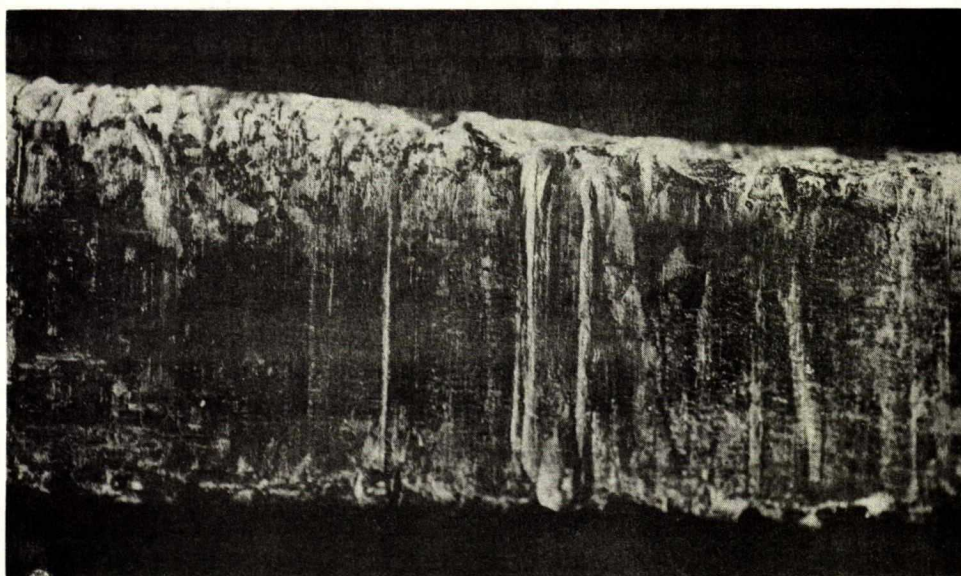
The working edge (Figure 3) showed a relatively smooth streaky surface, typical of flat metal parts rubbing against each other with particles of grit or hard foreign material in between. The smoothness of the working surface and the burred edges are indicative of relatively high pressure on the bar assembly during service.

Fig. 3. - Working surface of fracture bar.
Note burred edges and streaky appearance
of the surface.

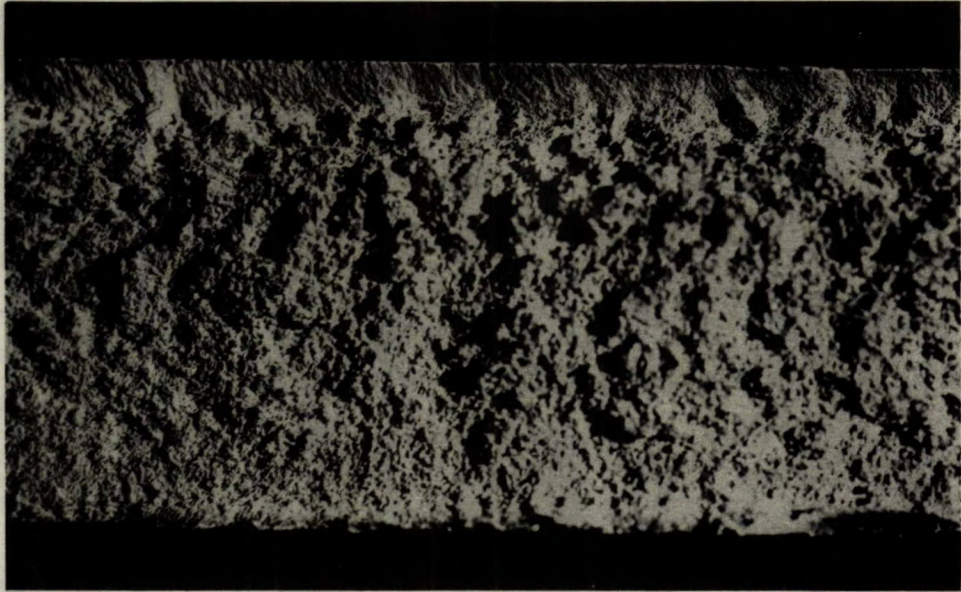
The fracture surface showed a predominantly crystalline appearance, indicative of a brittle-type separation of metal (Figures 4 and 5). There was only a small zone of fracture, adjacent to the surface, which could be identified as fibrous. This was followed by a large typically crystalline fracture as shown in Figure 5.

Fig. 4. - Longitudinal view of fracture surface.
It shows a fine to coarse gradation in fracture
grain size. Note the relatively small zone of
fibrous fracture on the top.

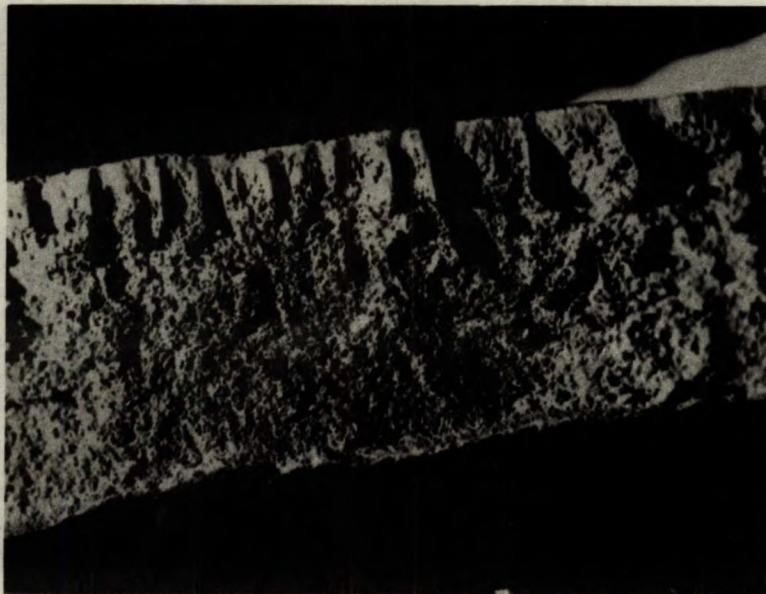
Fig. 5. - Same as Fig. 4, but the fracture
surface is more coarsely crystalline.

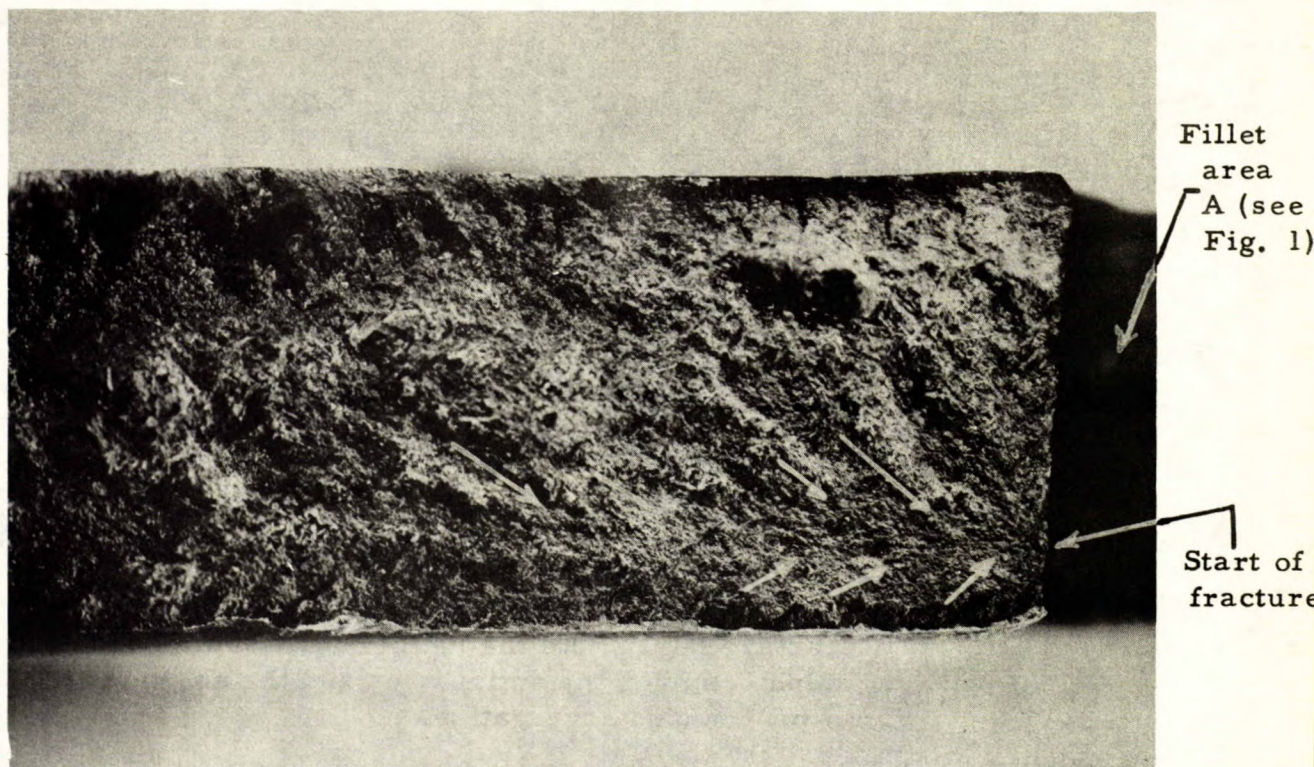
"herringbone" marks (Figure 6) pointing toward the apparent source of failure in the fractured bar. It may be added that, although the markings in Figure 6 do not show a text-book picture, they were clearly visible with the naked eye. The general "herringbone" pattern tends to suggest that crack was initiated in the fillet area at the point marked by an arrow in Figure 6.

and its coarsely crystalline appearance, suggest brittle failure, initiated by a small fatigue crack in the fillet area. The cause of the initial fatigue crack may be attributed to the presence of a pit or a scratch on the surface.

Fig. 6. - Longitudinal view of fracture surface, showing "herringbone" pattern (marked by small arrows) pointing towards the origin of the fracture.

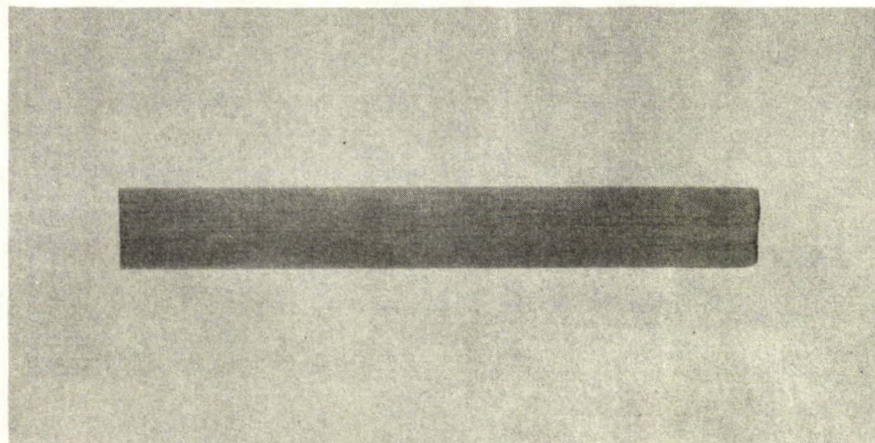
A transverse section of the bar was etched in 1:1 HCl at 165°F for about 30 minutes. The results showed a relatively clean, uniform structure with only a small zone of segregation in the centre (Figure 7).

Fig. 7. - Transverse section deep-etched in 1:1 HCl.

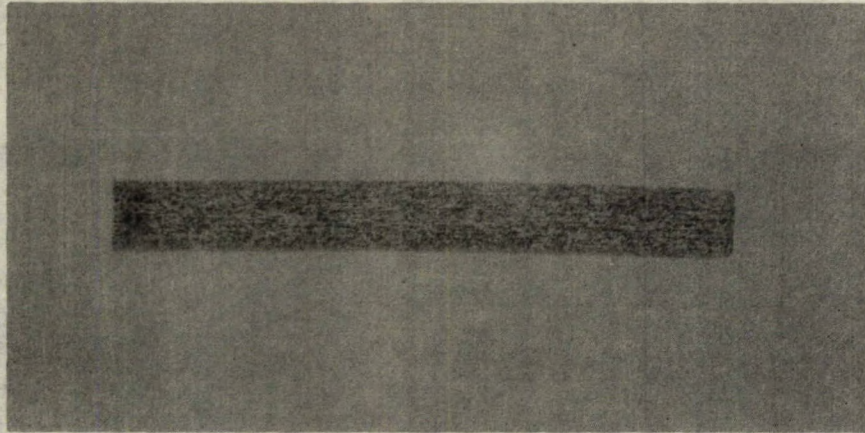
Sulphur printing of a 4 1/2 inch long transverse section did not show any major localized segregation (Figure 8). However, the pattern shows uniform distribution of sulphides over the entire surface, with small areas showing relatively higher concentration.

Fig. 8. - Sulphur print of transverse section of the fracture bar. Note the uniform distribution of sulphides over the entire area and the absence of pronounced segregation.

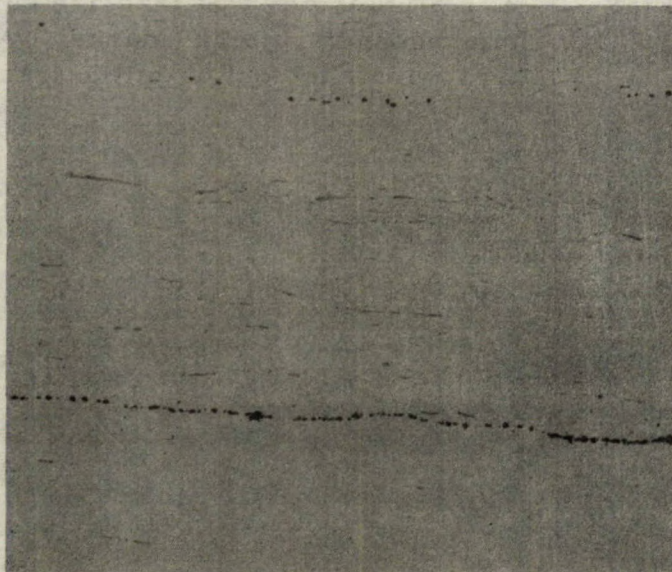
Longitudinal and transverse sections of the fracture bar were cut, mounted in bakelite, and polished for examination under a metallographic microscope. The unetched sections showed the presence of a fairly large amount of non-metallic inclusions in the form of strings of oxides and sulphides (Figure 9). The amount present is considered to be in excess of the normal distribution found in commercial steels. These inclusions may initiate fatigue cracks. Furthermore, numerous large inclusions greatly reduce the ductility of the material (especially in the transverse direction) and this, in turn, adversely affects the impact strength.

Fig. 9. - Note the dark stringers of oxide and light grey sulphide particles.

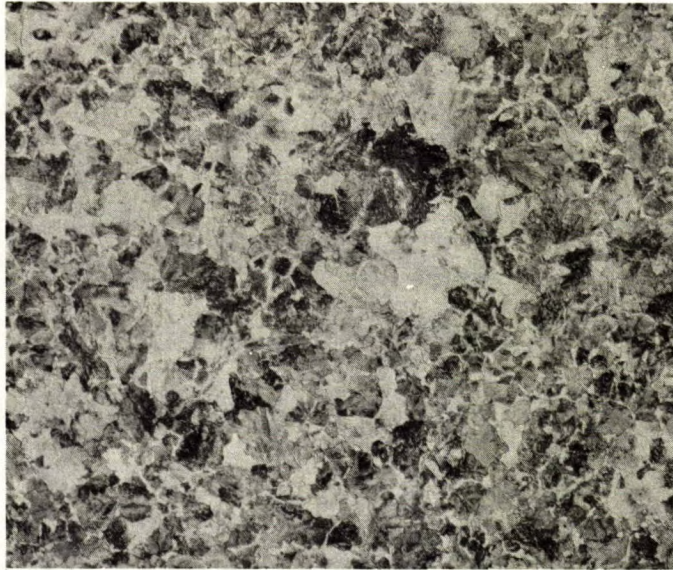
etched with 2 per cent nital. The microstructure (Figure 10) consisted of pro-eutectoid ferrite and lamellar pearlite. The grain sizes of the steel were relatively coarse, indicating the possibility that there had been a high finishing temperature of rolling. Furthermore, the surface of the bar showed appreciable decarburization (Figure 11); that is, there had been a loss of carbon from the surface during heating and rolling operations. The presence of a decarburized layer also substantiates the possibility of high finishing temperature, referred to previously.

Fig. 10. - Photomicrograph of bar, showing network of ferrite (light) and dark lamellar pearlite.

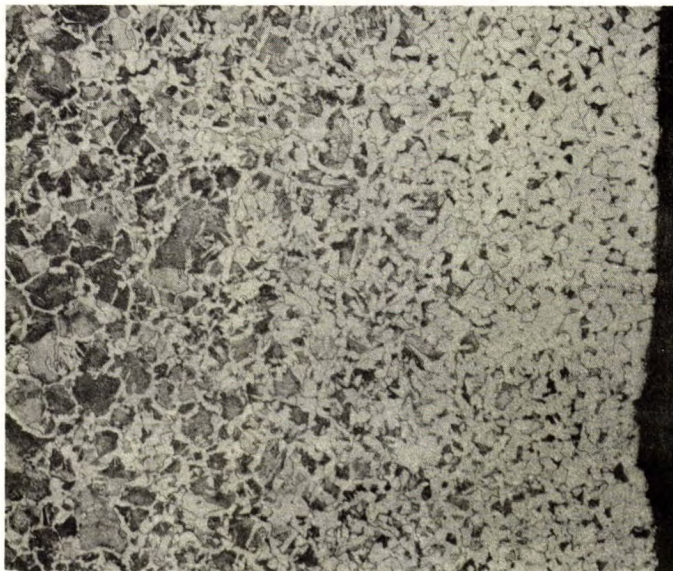
Although decarburization is not considered directly responsible in the present case, it greatly reduced the fatigue resistance of the metal, since fatigue cracks almost invariably start at the surface. In this connection it must be mentioned that laboratory tests (Trans. Am. Soc. Metals, vol. 39, p. 45, 1947) on homogeneous and decarburized specimens have indicated that the fatigue strength of the fractured material is reduced approximately 50% by decarburization. Applying this finding to the present case, the fatigue limit of the fractured bar (see Table 2) may be of the order of 36,000 psi, compared with 56,000 psi had the bar been homogeneous, i. e. not decarburized.

Fig. 11. - Same as Figure 10, but showing decarburized surface (right) gradually merging into base metal (left).

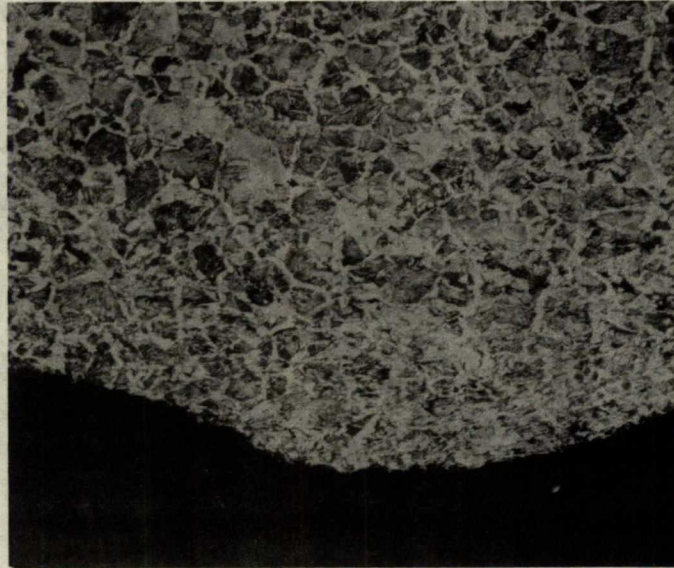
Figure 12, a microstructure of a section taken across the fracture surface, shows distortion of grains. This would seem to indicate a ductile behaviour of base metal under certain conditions of stressing.

Fig. 12. - Photomicrograph of bar across the fracture surface. Note elongated ferrite grains (bottom) as a result of plastic deformation.
