MINES BRANCH INVESTIGATION REPORT IR 58-34

METALLURGICAL EXAMINATION OF THREE BOILER GRATE BARS WHICH WARPED IN SERVICE.

R. K. BUHR

MARCH 5, 1958

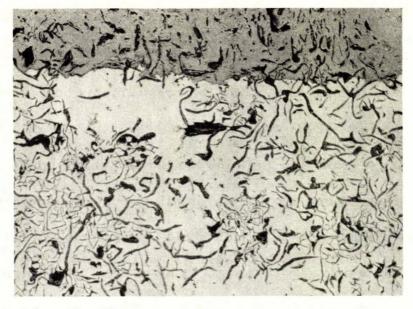
Samples were cut from the thin section of each grate bar and, after suitable preparation, were examined under a microscope. Varying thicknesses of oxide scale were observed on the exposed surfaces of the samples, but little penetration of the scale could be found. Figures 1 and 2 illustrate these remarks.

Fig. 1. - Photomicrograph of surface of Sample B, showing lack of penetration of oxide scale.

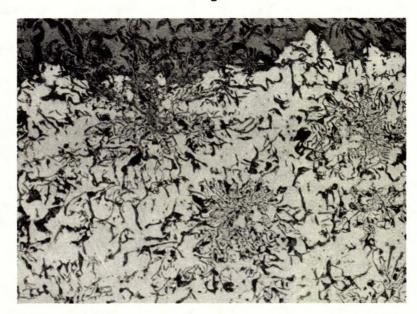
Fig. 2. - Photomicrograph of surface of Sample A, showing some penetration along the graphite flakes.
