MINES BRANCH INVESTIGATION REPORT IR 58-46

A METALLURGICAL INVESTIGATION INTO THE FAILURE
(DECEMBER 1957) OF THE AUBREY-WAVERLEY WATERMAIN BRIDGE
WINNIPEG, MANITOBA

R. C. A. THURSTON and W. A. MORGAN

PHYSICAL METALLURGY DIVISION

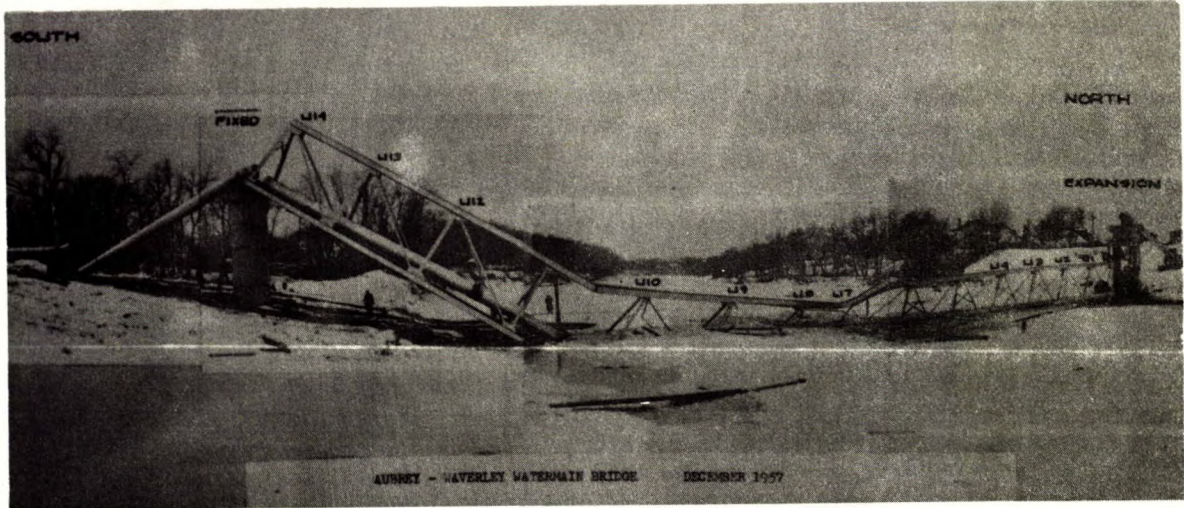
It will be apparent from Figure 1 that the collapsed bridge could be resolved essentially into three sections:

(1) The south section, from U11 to U14, resting with one end on the pier and the other end under the ice; distortion in this section was slight.

(2) The central section, from U10 to U7, of which the lower chord was below the ice; considerable distortion was evident between upper and lower chords.

(3) The north section, from U6 to U0, resting almost horizontally with the U6 end under the ice; very little distortion was apparent.

Fig. 1. - Photographs of bridge shortly after failure.

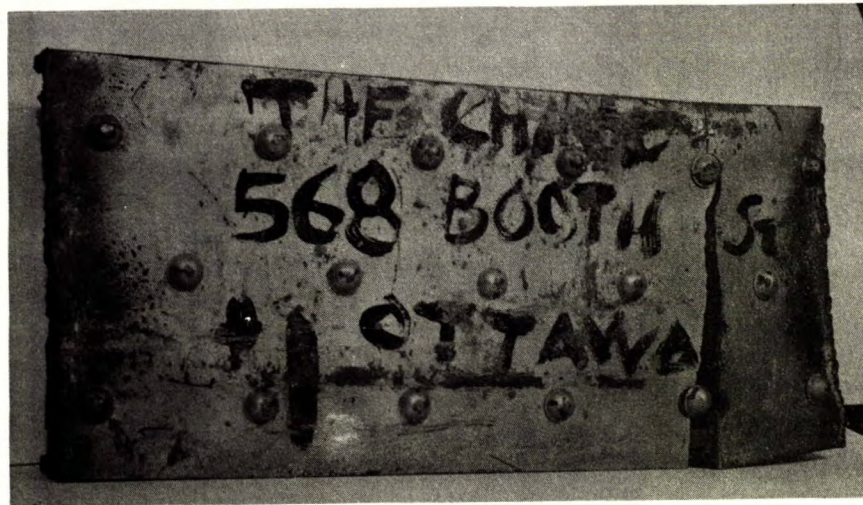
Sample No.	Heat No.	Description	Location	Comments
EH 1	358915*	32 in. length of 15 in. channel (50 lb) with riveted reinforcing plates 3/4 in. and 3/8 in. thick	Lower chord, east side, between U6 and U7 (centre of bridge)	Brittle fracture through 1 flange and 2 rivet holes (see Figure 2)
EH 2	251217*	37 in. length of 18 in. channel (58 lb) with riveted reinforcing plate 1/4 in. thick	Upper chord, east side, between U10 and U11	Brittle fracture through 5 rivet holes; ductile fracture in plate (see Figure 3)
EH 3	251217*	36 in. length of 18 in. channel (58 lb) with riveted reinforcing plate 1/2 in. thick	Upper chord, west side, between U6 and U7 (centre of bridge)	Brittle fracture through 3 rivet holes (see Figure 4)
EH 4	251217*	Short length of channel containing 1 flange and part of web	Upper chord, east side, opposite sample EH 3	Containing portion of longitudinal crack (see Figure 5)
EH 5	251217*	33 in. length of 18 in. channel (58 lb) with riveted reinforcing plate 1/2 in. thick	Upper chord, west side, between U5 and U6	Undamaged sample

Fig. 2. - Sample EH 1 - 15 in. channel.

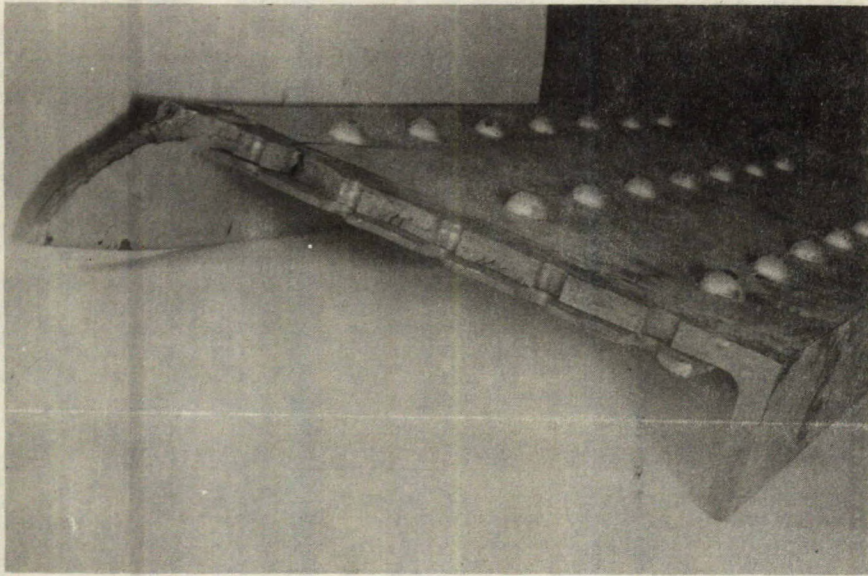
Fig. 3. - Sample EH 2 - 18 in. channel.

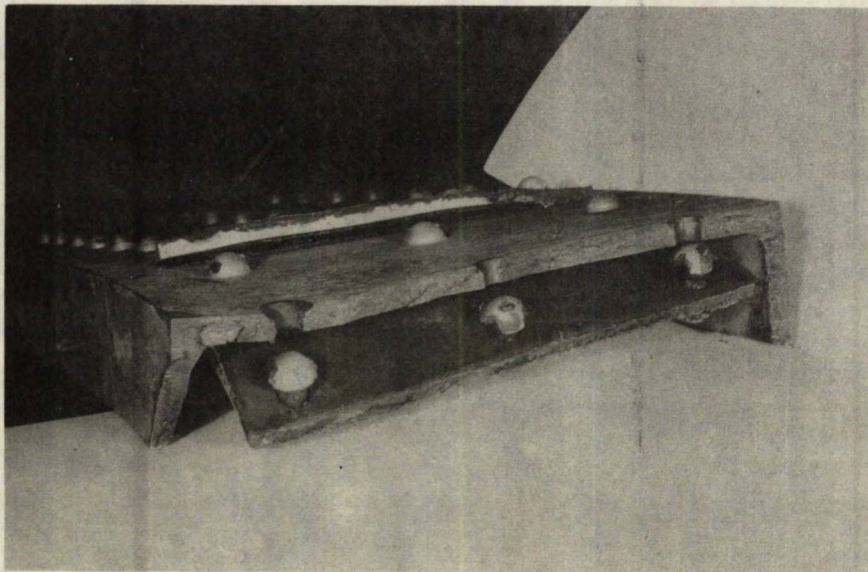
Fig. 4. - Sample EH 3 - 18 in. channel.

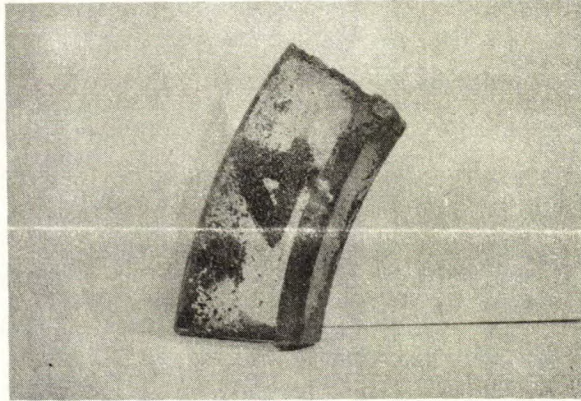
Fig. 5. - Sample EH 4.

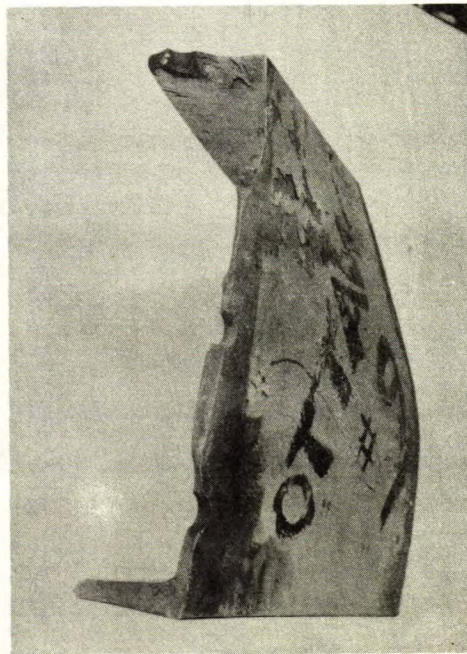
Sample No.	Heat No.	Description	Location	Comments
EH 9	(Algoma steel)	13 in. length of 15 in. channel (33.9 lb)	Lower chord, west side, between U1 and U2	Mixed fracture through 3 rivet holes (see Figure 6)
10	(Not stated)	About 1 sq. foot of water pipe	Centre of bridge	Brittle fracture along one edge

Fig. 6. - Sample EH 9 - 15 in. channel.

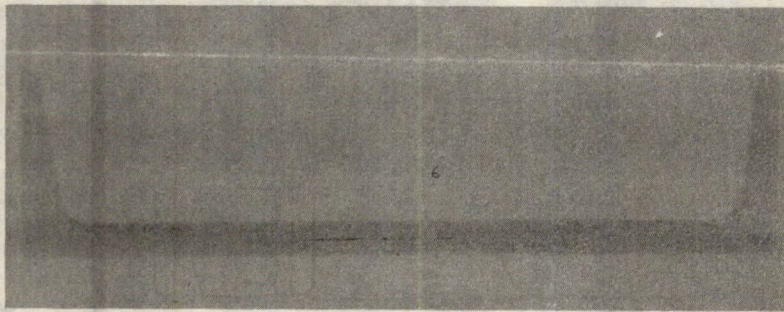
Longitudinal and transverse samples of each piece of steel supplied were prepared for sulphur printing and deep etching. A typical sulphur print is shown in Figure 7, which was taken on Sample EH 6. There is evidence of sulphur segregation at the centre of the web of the channel, but this is considered to be normal for semi-killed structural steel purchased to the C. S. A. G 40.4 specification.

Fig. 7. - Sulphur print of a transverse section of channel EH 6.

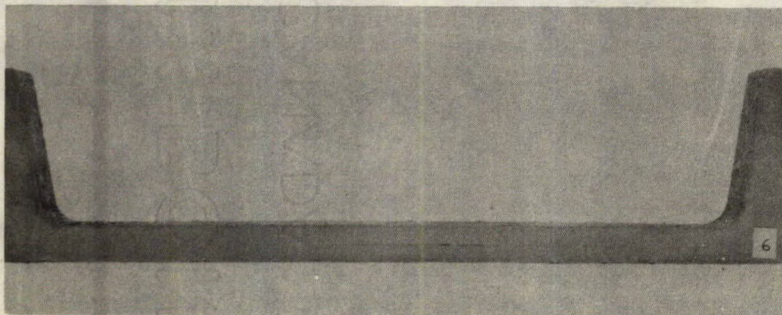
The samples after sulphur printing were deep-etched in 1:1 hydrochloric acid solution at 165°C for 20 minutes. The deep-etched surface of sample EH 6 is shown in Figure 8. The deep etch confirms the presence of segregation of sulphide and other non-metallic inclusions into the centre of the web. The rivet holes pass through this segregated zone, and a deep etch of a section through a rivet hole is shown in Figure 9. The inclusions are concentrated around the circumference of the rivet holes in a plane parallel to the longitudinal surface of the web. At points on the interior surface of the rivet hole, several small laps were visible; an example of this is shown in Figure 10.

Fig. 8. - Deep-etched structure of transverse section of channel EH 6.

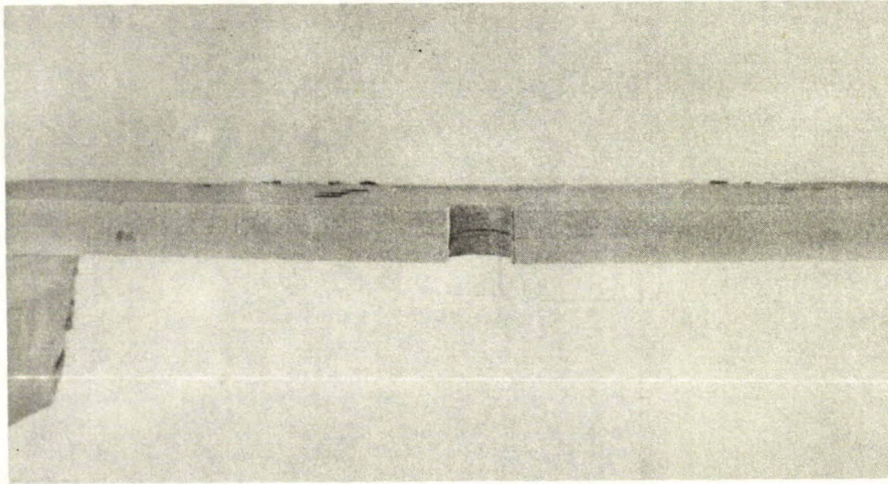
Fig. 9. - Transverse section through a rivet hole, showing the segregated zone.

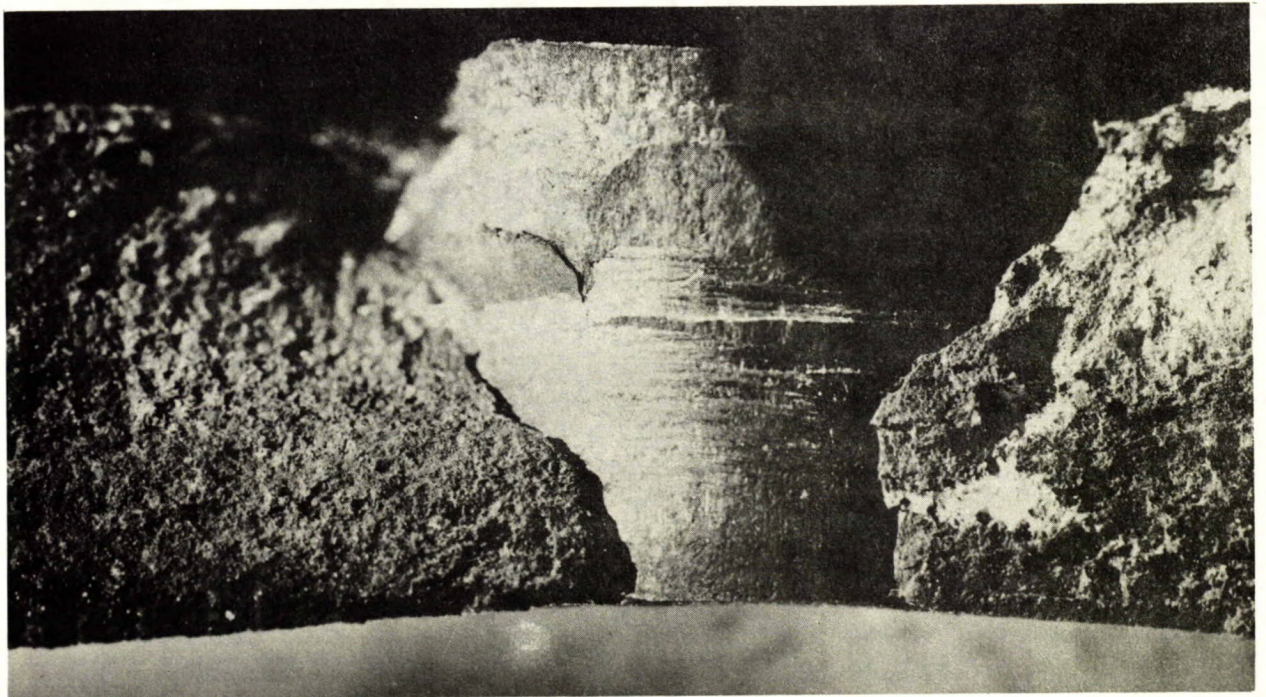
Figure 14 shows the structure of the metal just beneath the inner surface of the rivet hole. The ferrite grains are greatly distorted by the high degree of cold work introduced into this section of the web during the punching of the rivet holes. At the base of the lap shown in Figure 10, fine cracks are present, propagating through this cold-worked region.

Fig. 10. - Small surface discontinuity in a rivet hole.

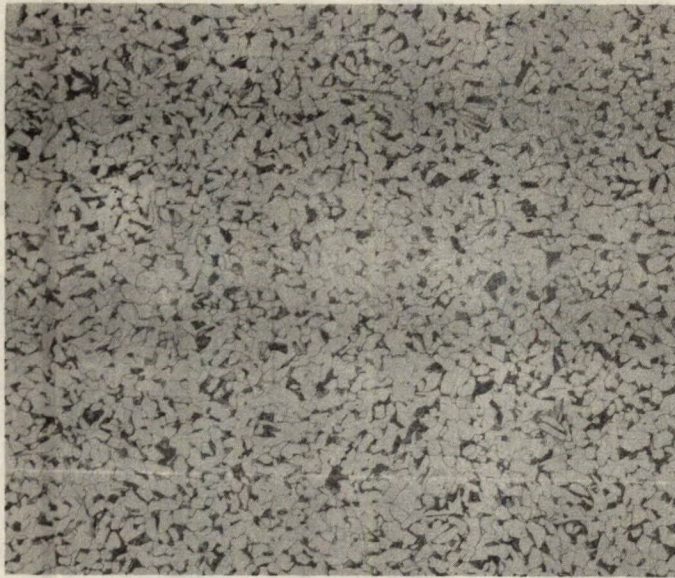
Figure 11 shows the microstructure of sample EH 8, a relatively thin member of angle iron; this sample possesses a fine

ferritic grain size, indicating that its notch ductility would be good at low temperature.

Fig. 11. - Microstructure of sample EH 8.

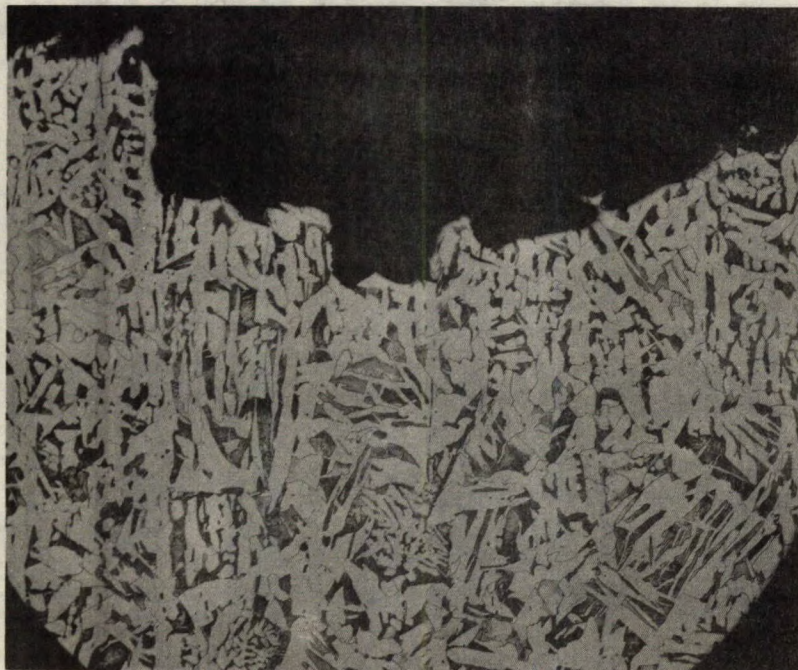
The structure of channel sample EH 3, however, is much coarser, as shown in Figures 12 and 13. This coarser ferritic structure is due to the higher finishing temperature of rolling of the channel (3/4 in. thick) as compared with that of the angle iron. The thinner the plate section, the lower is the finishing temperature, and thus a fine ferrite grain size is produced. Figure 12 shows a section taken across the fracture surface; the fracture is transcrystalline.

Fig. 12. - Microstructure across fractured surface of Sample EH 3.
(X100. Etched in 2% nital.)

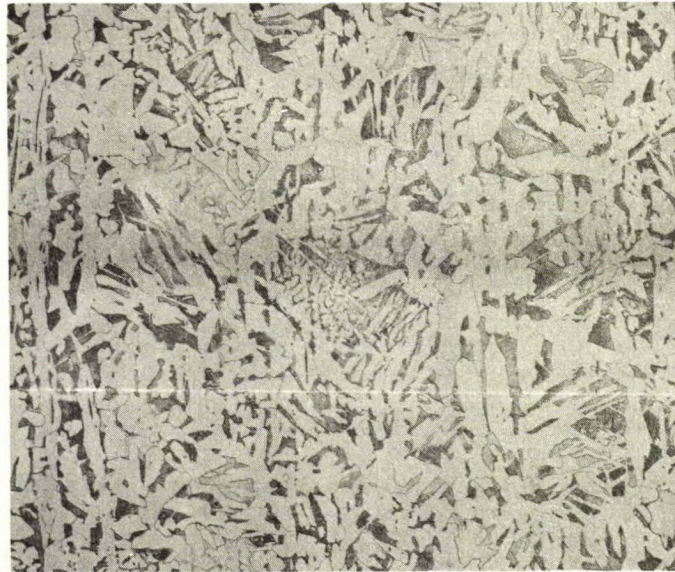
Fig. 13. - Microstructure of sample EH 3.
(X100. Etched in 2% nital.)

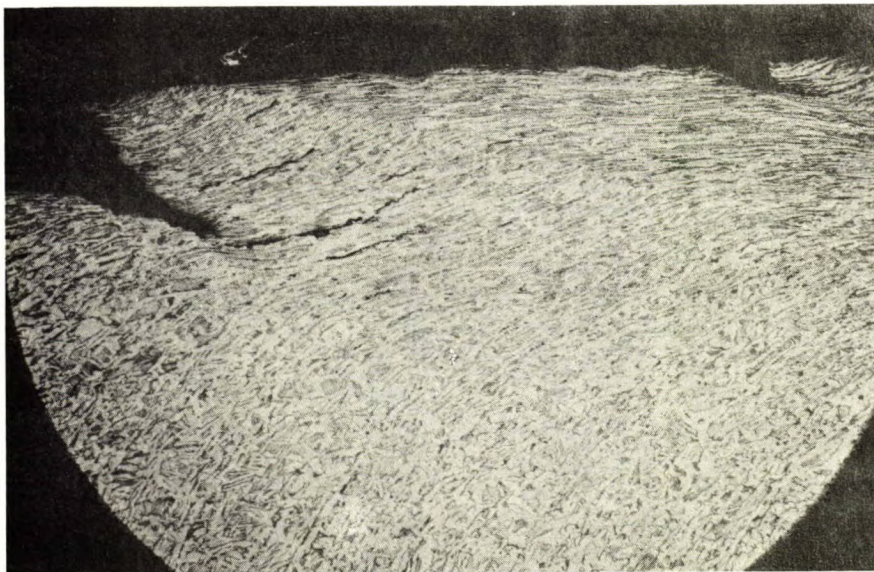
The main fractures occurred in the region of U10-U11 and U7. The fractures in the channel were mainly brittle and passed through a number of rivet holes, whereas the reinforcing plate either bent or fractured in a ductile manner. It was also observed that the rivet holes had been punched but not reamed, and a surface layer of cold-worked metal was visible, together with fine cracks.

The punching operation drastically cold-works the material at the edge of the hole, raises its transition temperature, and thus makes the steel more susceptible to brittle fracture. The degree of embrittlement will depend upon the type of steel and the plate thickness. This condition will be enhanced if fine cracks are also formed, and if subsequent strain ageing occurs due to the application of heat in the vicinity of the rivet hole. In order to improve or eliminate

Fig. 14. - Microstructure of cold worked metal
at the inside of a rivet hole.
(X33. Etched in 2% nital.)

such an undesirable condition, the rivet holes should either be drilled, or reamed after punching, to remove the severely cold worked layer.

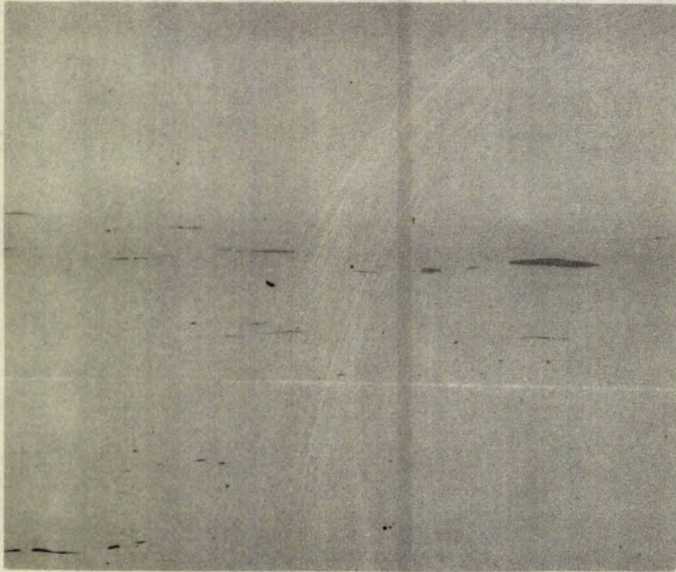
X100.

The unetched structure of a section taken from the centre of the web of sample EH 6 (sulphur print shown in Figure 7) is shown in Figure 15. The inclusions are mainly sulphides with some oxides.

Fig. 15. - Unetched structure near the segregated zone at the centre of the web.

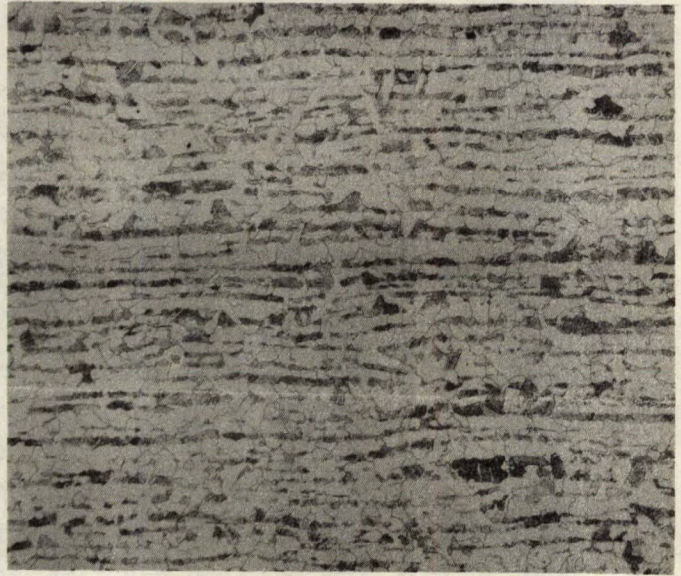
Figure 16 shows the structure of the water pipe, which consists of a finer ferritic grain size than the channel's and shows marked banding. No abnormalities were evident in the pipe material.

Fig. 16. - Microstructure of water pipe.
(X100. Etched in 2% nital.)

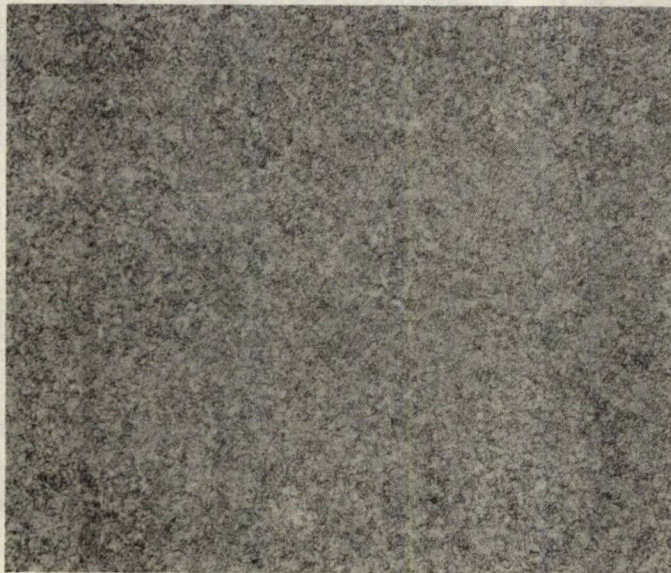
Figure 17 shows the structure of the high tensile bolt which showed no defects that could lead to premature failure.

Fig. 17. - Microstructure of high tensile bolt.
(X100. Etched in 2% nital.)

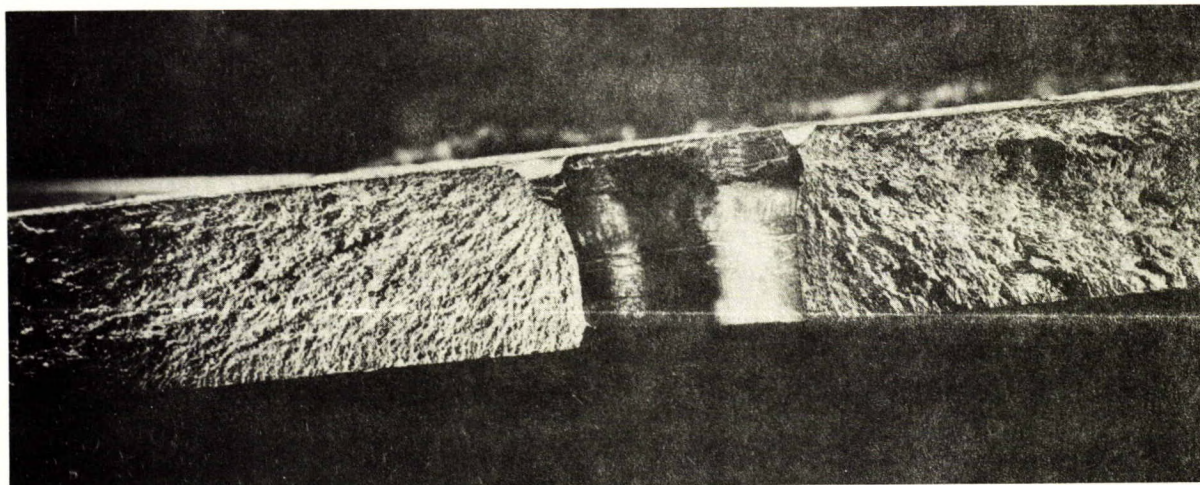
In the examination of the fractured channel, it was evident from the fracture markings or herringbone pattern (Figure 18) that brittle failure originated at a rivet hole in the web and then propagated in both directions transversely across the channel and through other rivet holes. From the results of the Charpy V-notch impact tests, it can be seen that at the estimated temperature of bridge collapse (10°F), the thicker channel material would not absorb more than 5 ft-lb, and would therefore be very susceptible to brittle fracture at a notch, incipient crack, or other stress raiser.

Fig. 18. - Brittle fracture originating at
rivet hole. (EH 2)

In the present case, however, the higher grade steels may not be readily available, so considerable attention should be paid to ensuring good workmanship and the elimination of any design features which may produce regions of stress concentration.
