FILE (PMDIV)

FOR REFERENCE

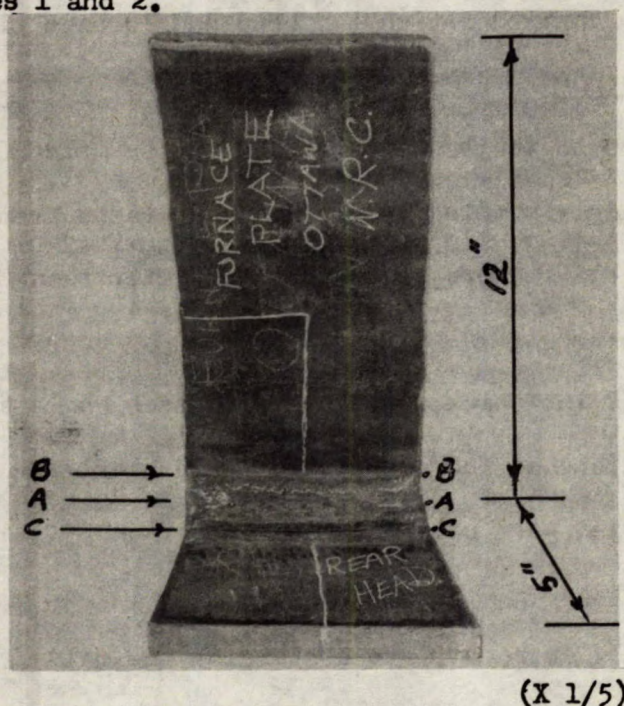
Fig. 1. - Cracked angle, Sample E (furnace plate at top; rear head sheet at bottom). This view illustrates the water surface and fillet weld, "A-A". The cracks in the specimen submitted were located at the toe of the fillet weld, principally in the axis "C-C", although a 1/8 in. 45° crack was also observed at the toe of the weld on the furnace side, axis "B-B".

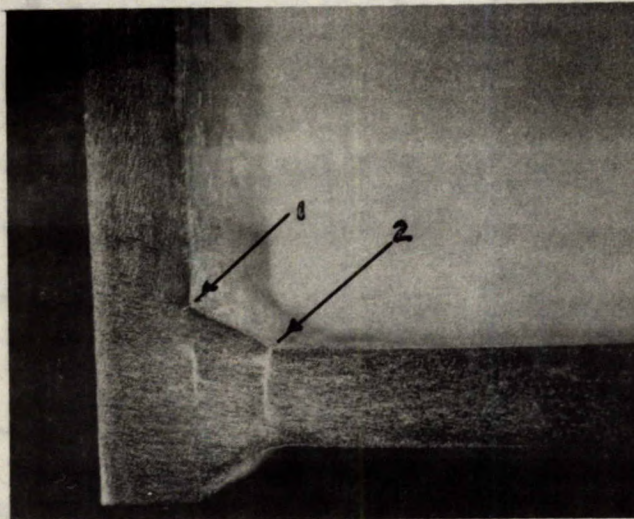
In the particular sample submitted, the crack at the rear tube sheet had extended through four-fifths of the plate section (arrow 2, Figure 3) and the crack at the fillet weld adjacent to the furnace plate was relatively small (arrow 1, Figure 3).

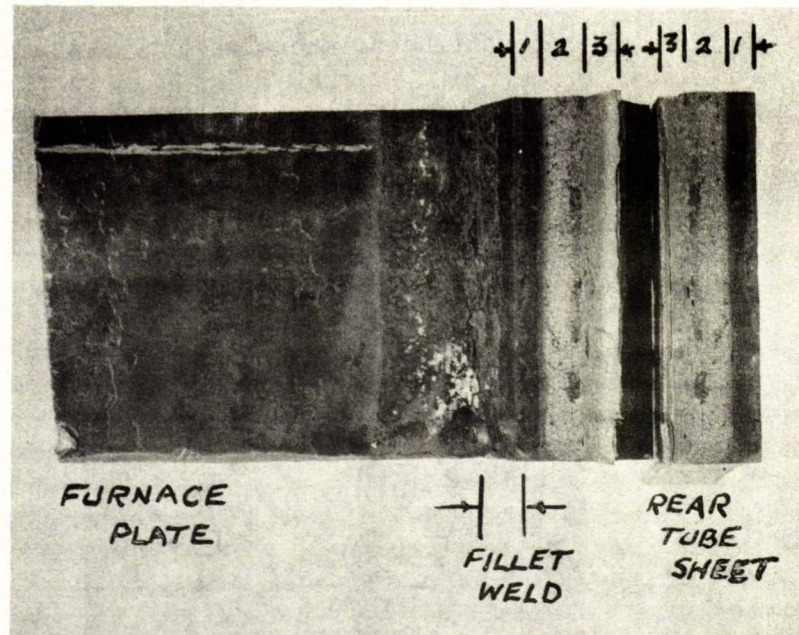
*This section, when inspected by fluorescent penetrant oil, ZL-1-B, "Zyglo", gave crack indications identical to those shown in Figure 3.

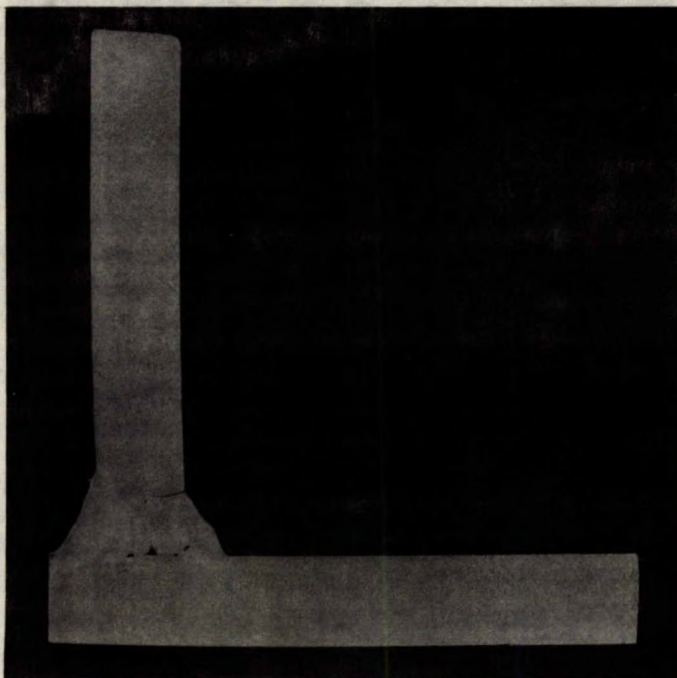
This section was cut, polished, and etched by swabbing with 6% nital to reveal the weld structure in the vicinity of the cracks (see Figure 5).

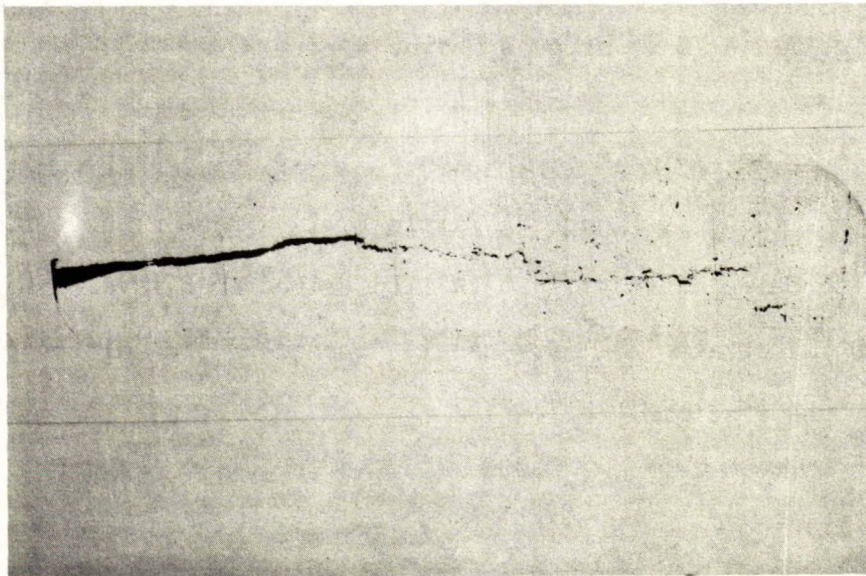
The smooth and oxidized part of this crack (Zone 1, Figure 4) occupies the left half of each photomicrograph; the rough and intergranular part of the crack (Zone 2, Figure 4) is shown in the right half.

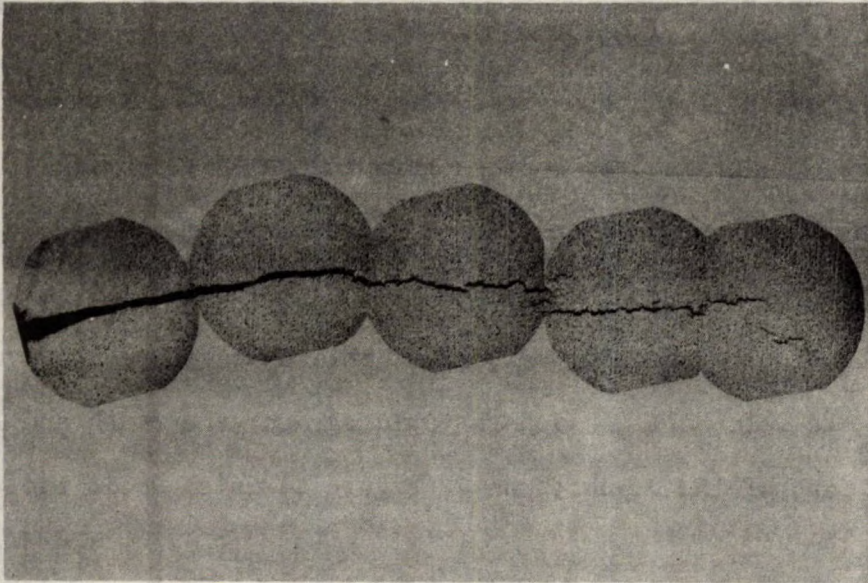
(X18, etched in 2% nital solution)

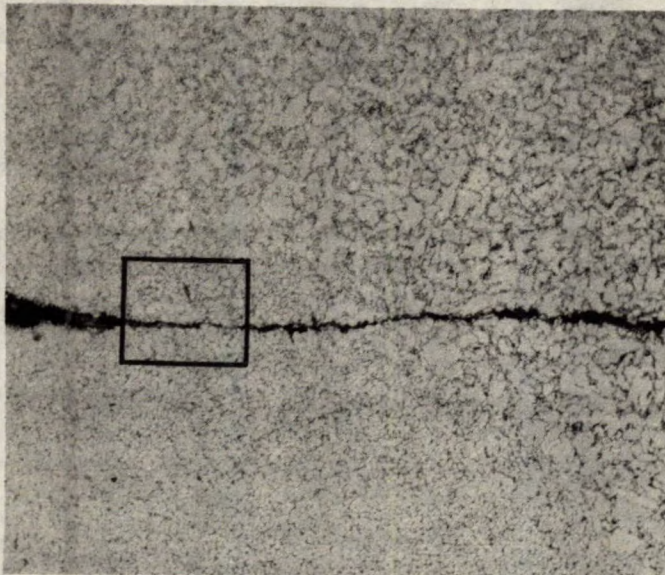
(X100, etched in 2% nital solution)

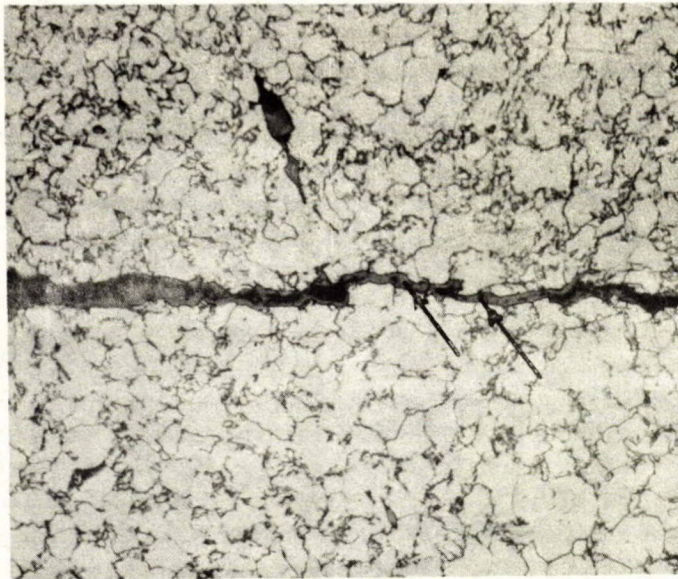
(X500, etched in 2% nital solution)

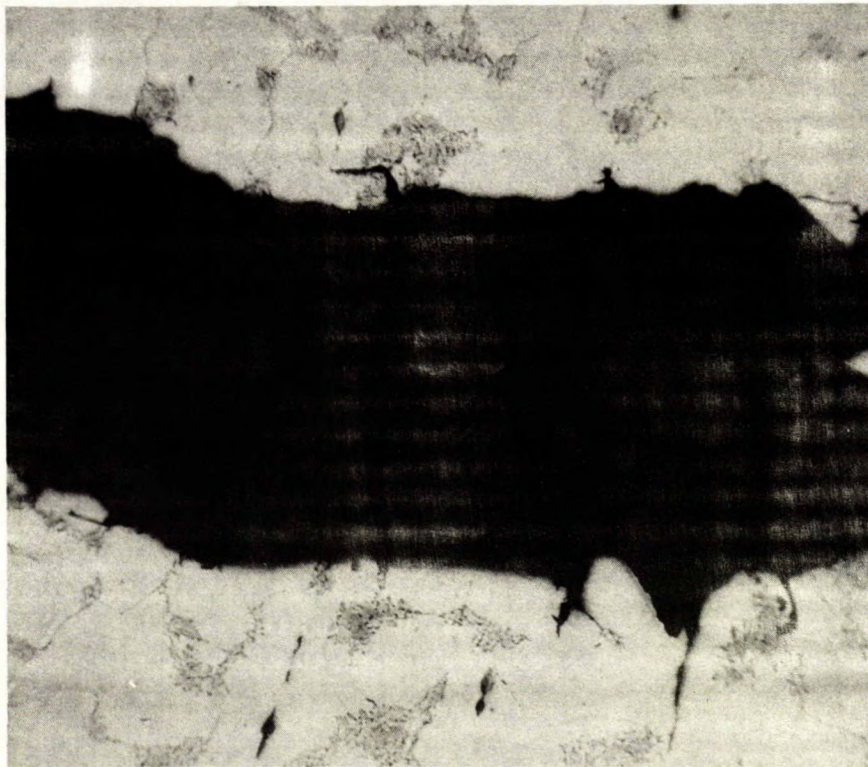
(X200, etched in 2% nital solution)

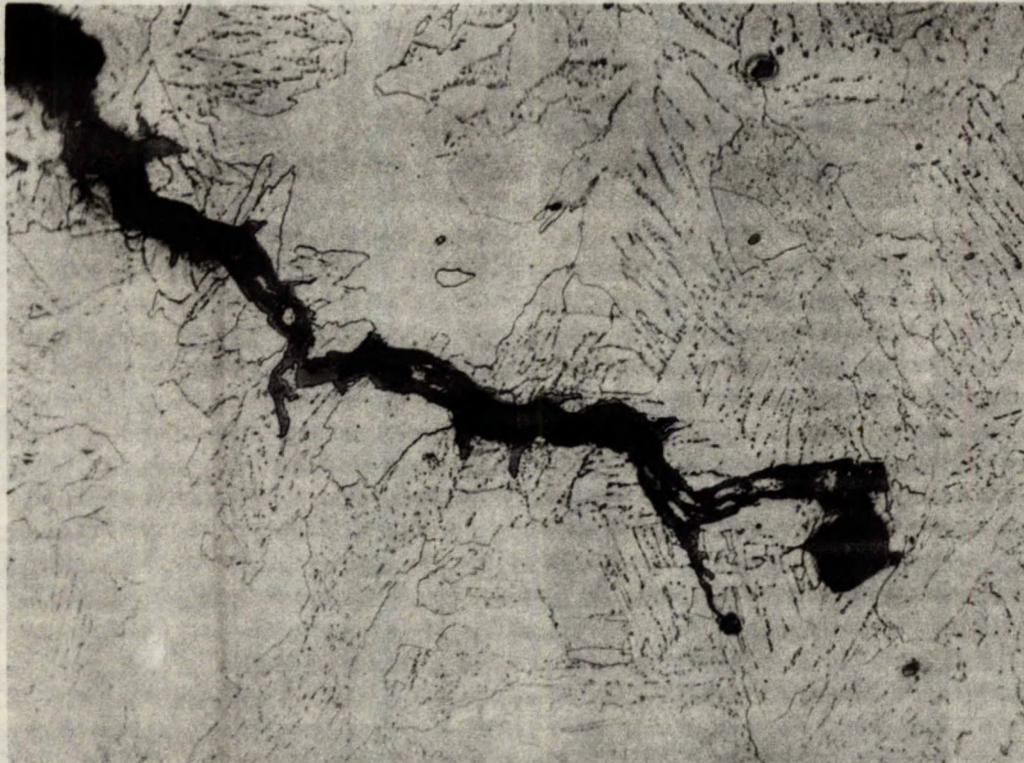
(X750, etched in 2% nital solution)

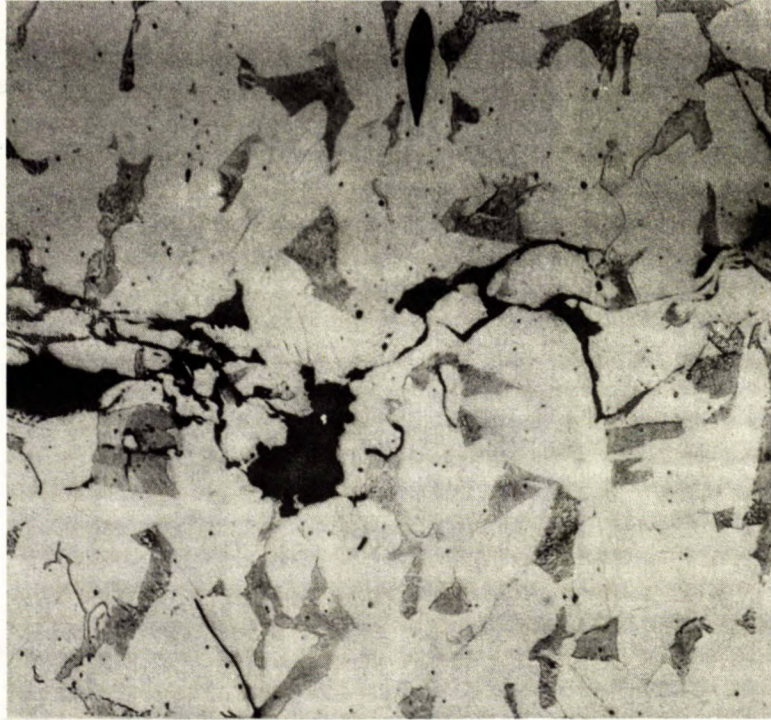
(X200, etched in 2% nital solution)

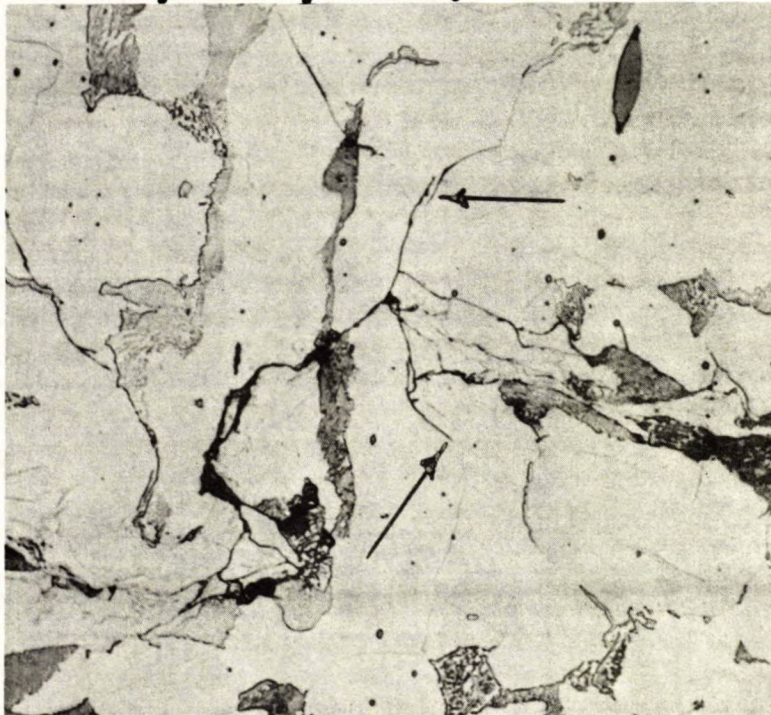
(X750, etched in 2% nital solution)

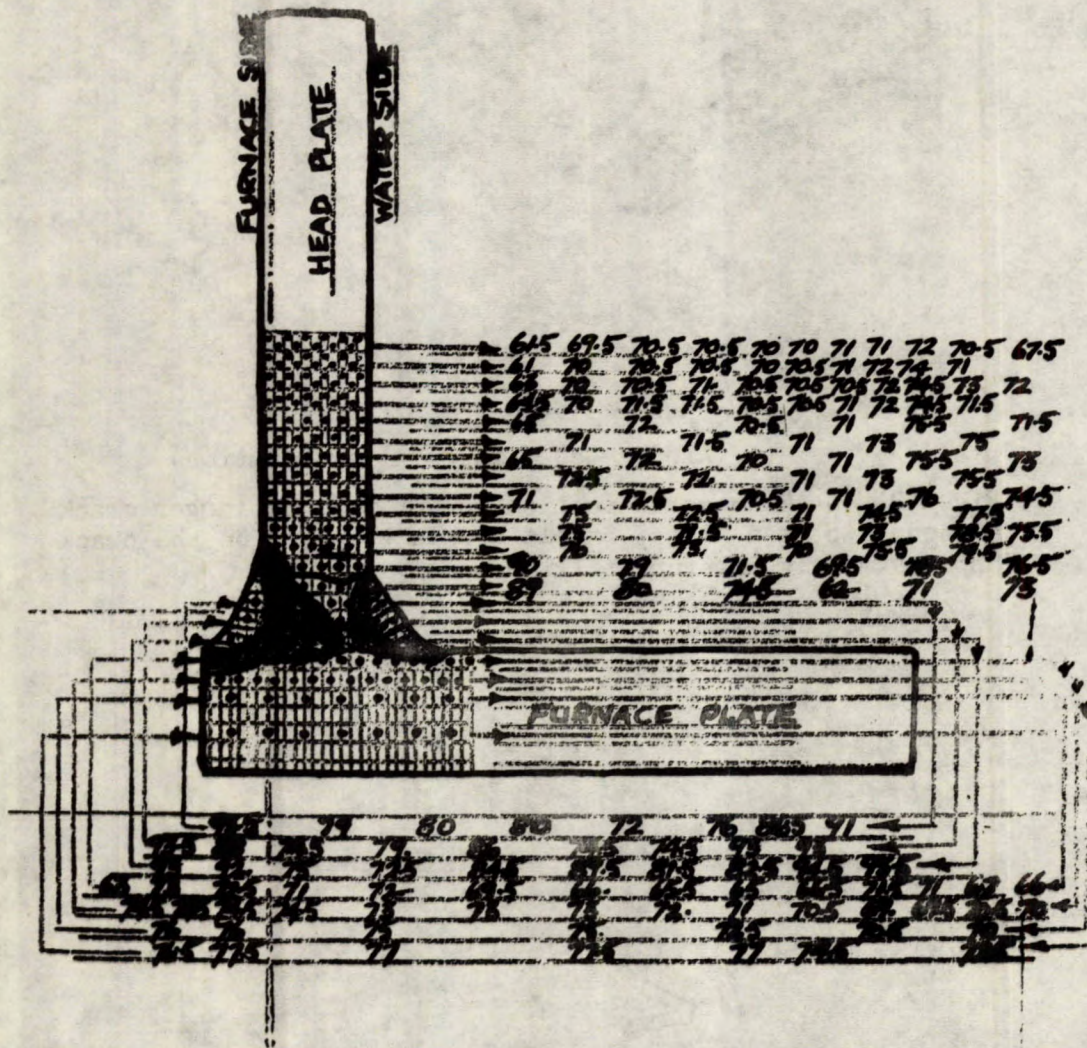
**ROCKWELL "B" HARDNESS SURVEY
THROUGH WELD ZONE OF BOILER**

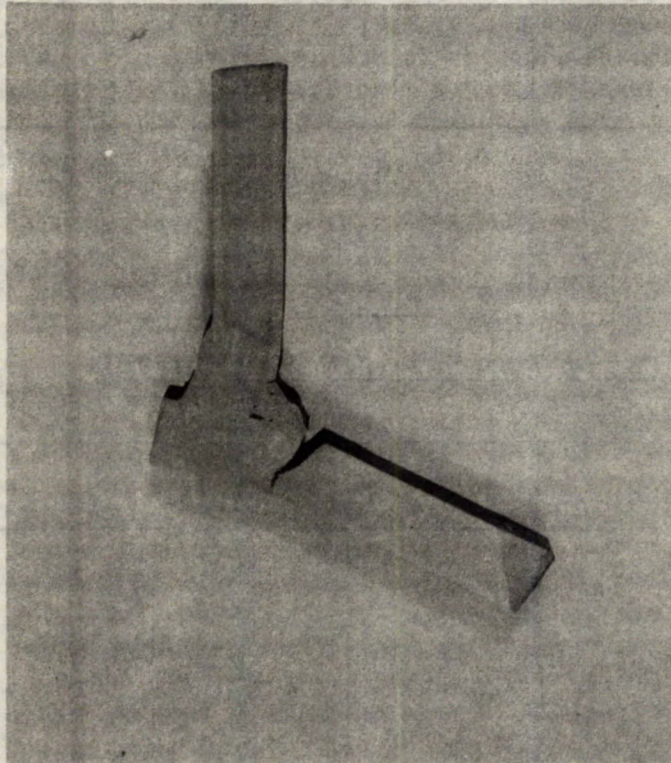
Examination of slices cut from samples A, B, C and D revealed some overlap of the welds in sample A. The appearance of this overlapping area is illustrated in Figure 15.
