Mines Branch Investigation Report IR 58-74

THE CORROSION OF STAINLESS STEEL PIPE, WELDED
BY VARIOUS METHODS, IN MOIST SAND

May 21, 1958

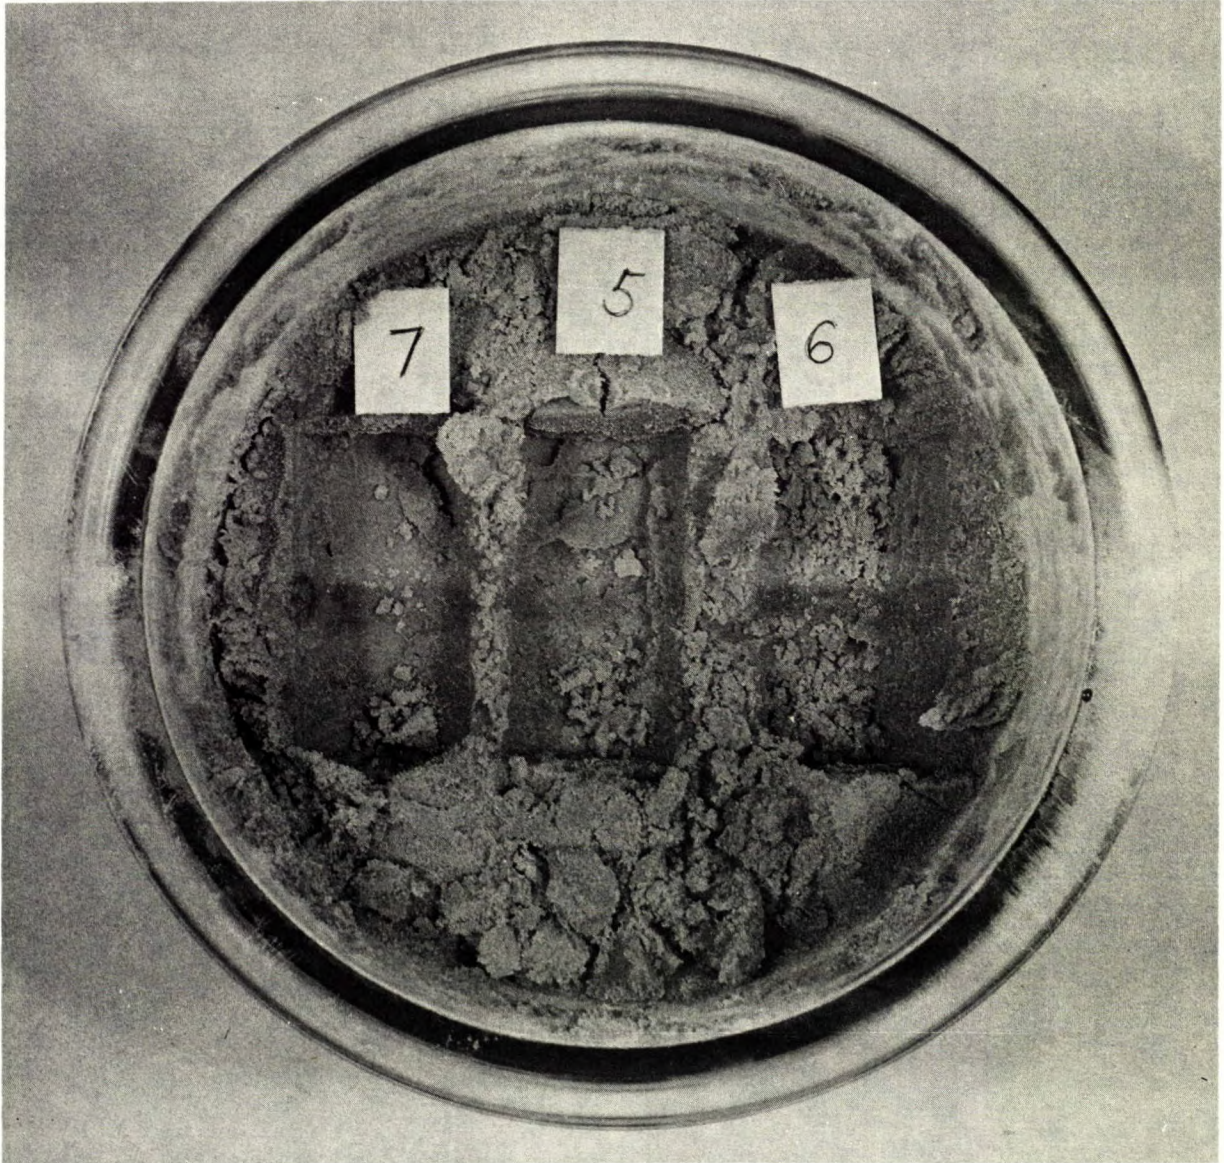
The depressions left in the sand by specimens Nos. 5M, 6M and 7M are shown in Figure 1. The rust stains in the sand are apparent, especially in the case of the pipe which had no wire brushing (No. 7M). Similar depressions left by specimens Nos. 1A and 4M are shown in Figure 2. Specimens Nos. 2A and 3M can be seen still partly embedded in the sand. In this desiccator, the argon-shielded tungsten-arc-welded specimen (No. 1A) had left no stain, while the sand in proximity to the unshielded metallic-arc-welded specimen, No. 4M, had been rust-stained.

Figure 1 - Depressions left in moist sand by specimens Nos. 5M, 6M and 7M.

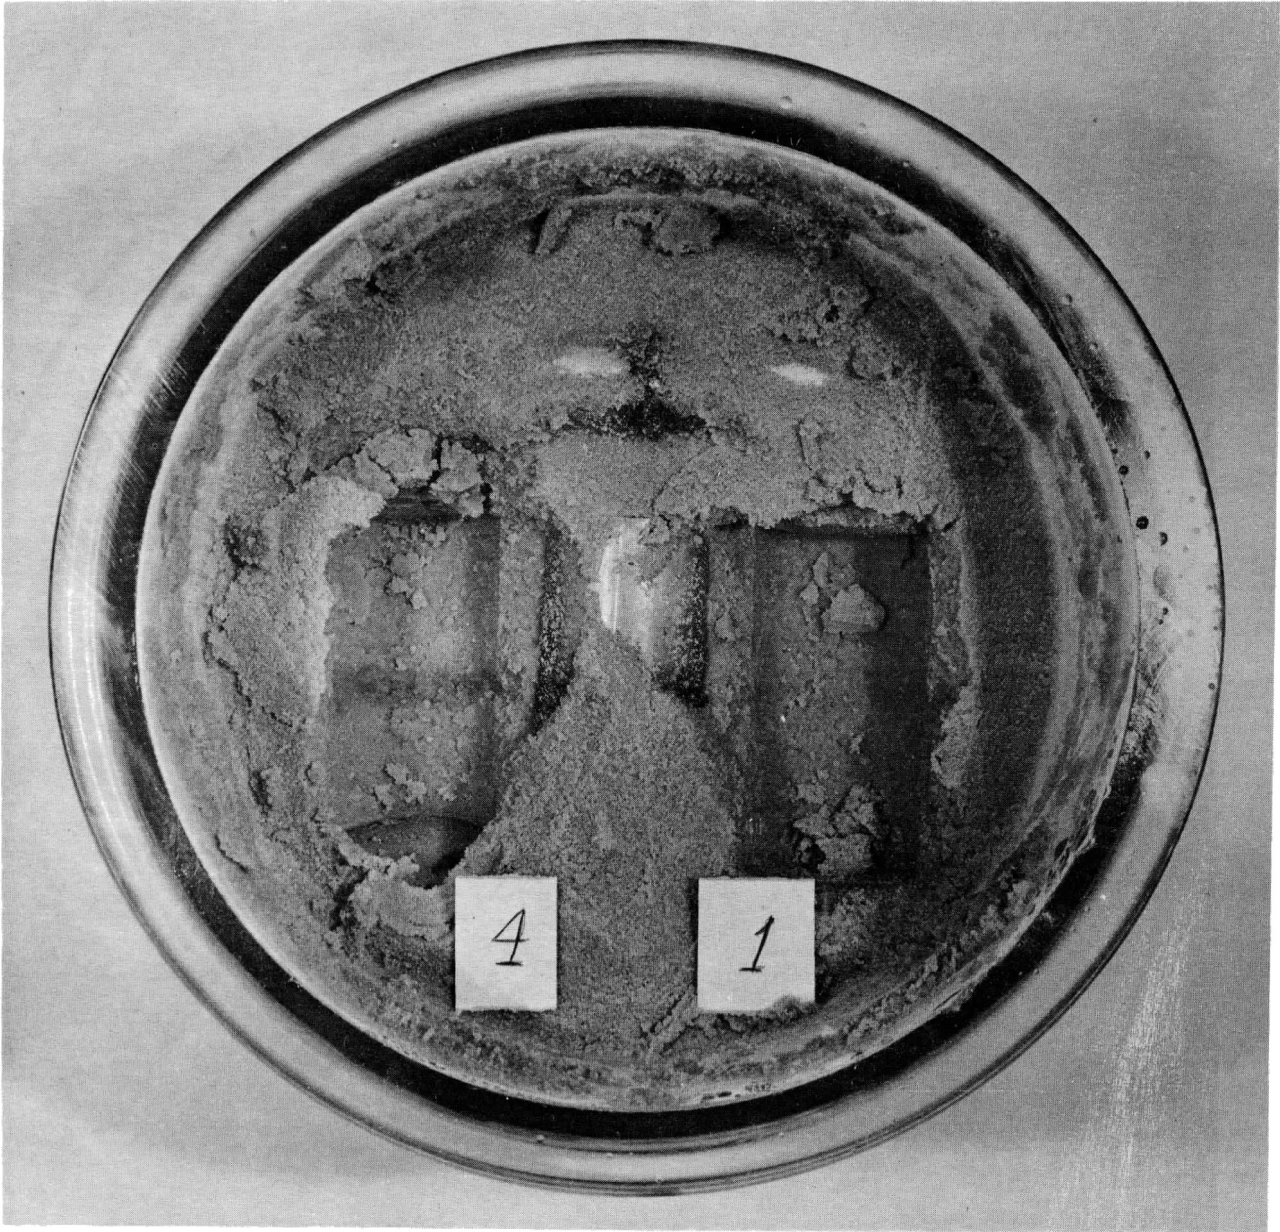
Figure 2 - Depressions left in moist sand by specimens Nos. 1A and 4M. Tops of specimens 2A and 3M also visible.

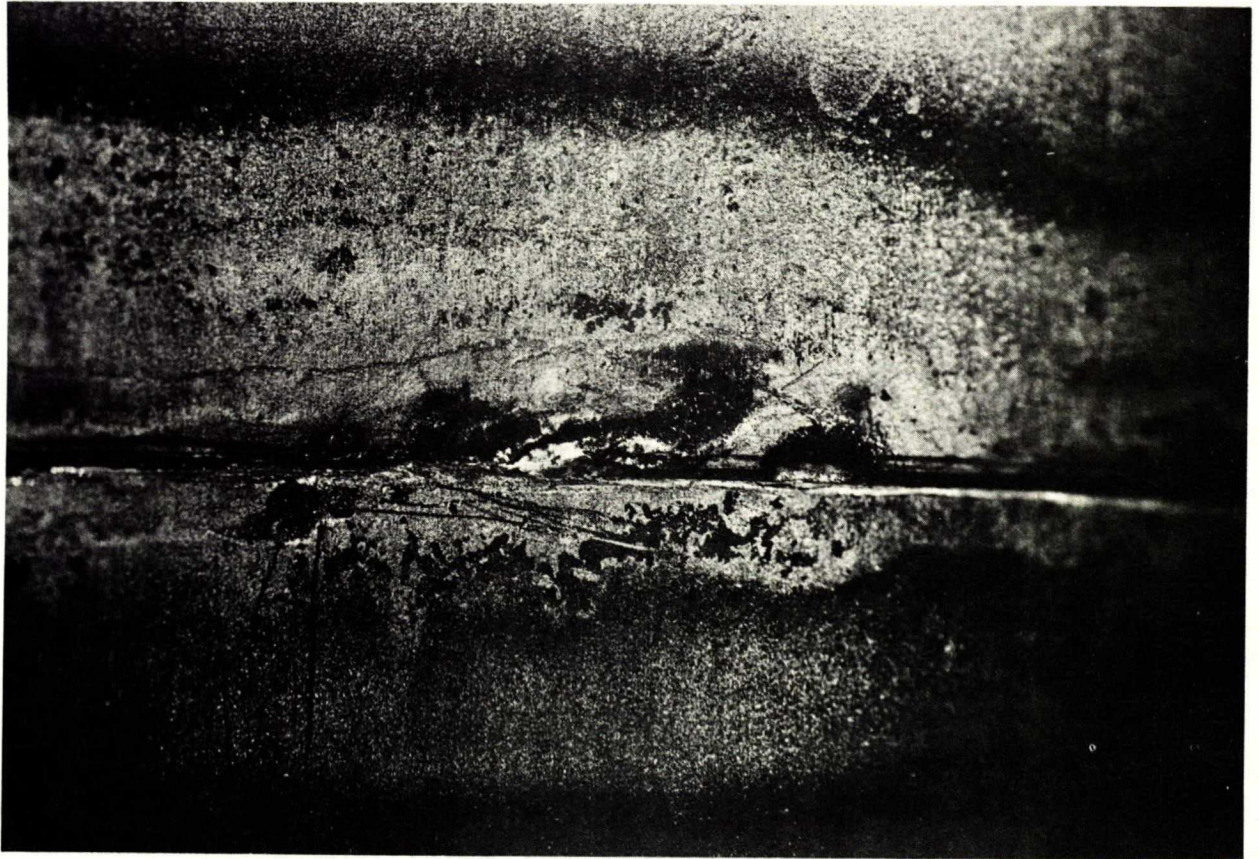
A pit on the interior side of the weld on specimen No. 3M is shown in Figure 3. Another section of the same weld, where the flux has not been scraped away, is shown in Figure 4. Some of the solidified flux adhering to the exterior weld surface can be seen in Figure 5.

Figure 3 - View of interior weld after cleaning (6X).

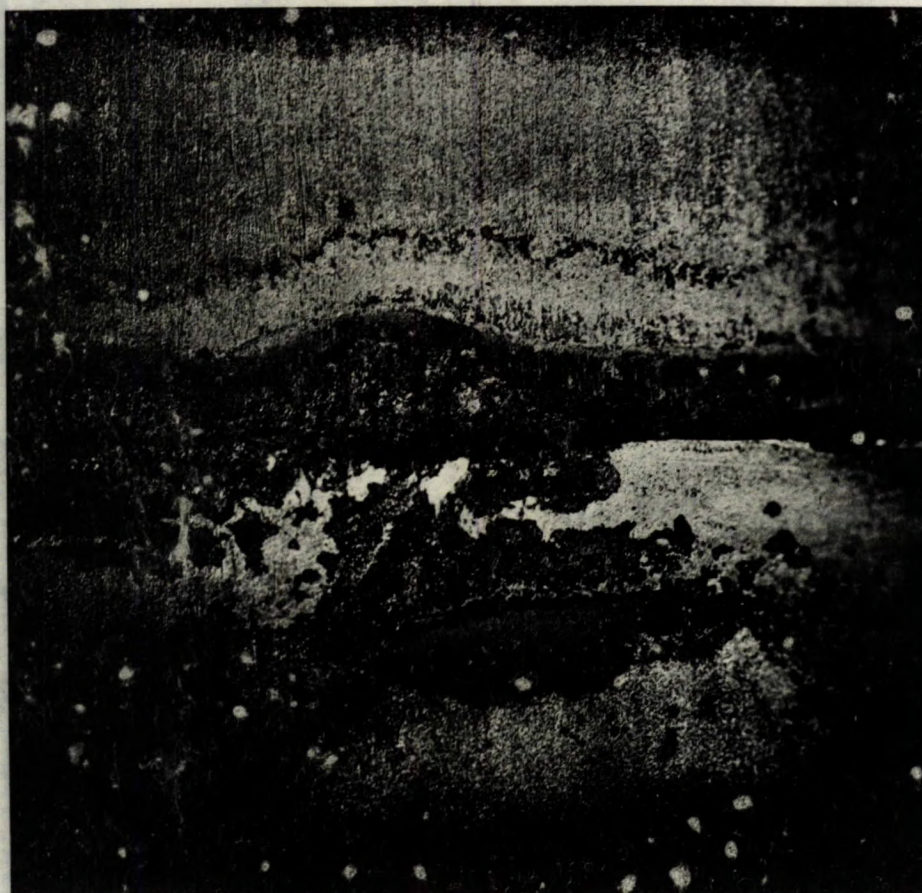
Figure 4 - Another region of same interior weld shown in Figure 3.
Solidified flux and corrosion product not removed (6X).

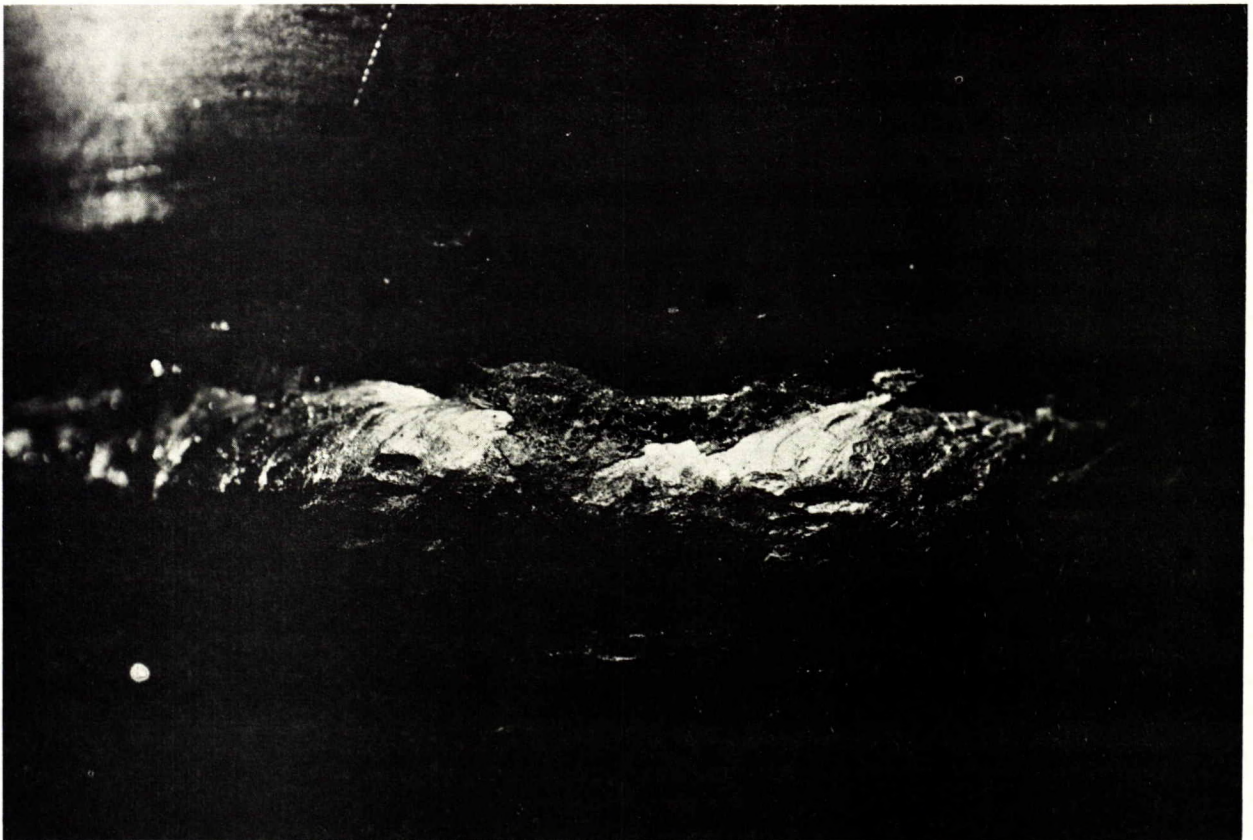
aeration may have enhanced the crevice corrosion of the stainless steel initially attacked by the weld flux. This possibility is supported by the fact that the specimens were more severely attacked from the inside, where there were both air and moisture, than from the outside, and examination of specimen No. 3M in section (Figure 3) shows a large pit under the deposit of solidified flux, which in time might have penetrated the wall of the pipe. The flux deposit on this section of the pipe had a honeycomb structure (Figure 5) ideally suited to crevice corrosion.

Figure 5 - View of exterior weld showing porous structure of solidified flux (6X).
