MINES BRANCH INVESTIGATION IR 58-101

METALLURGICAL EXAMINATION OF A SECTION
FROM A CRACKED MANGANESE STEEL MANTLE

4
495
JULY 3, 1958

R.K. Buhr^{*}

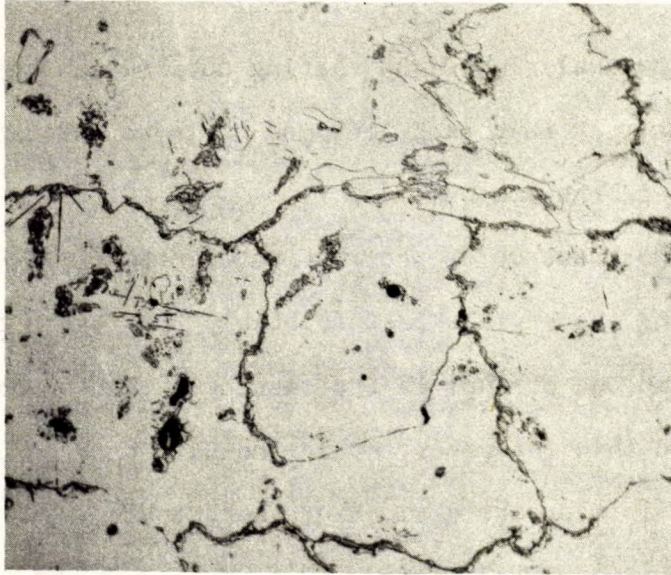
Samples taken from the smallest piece were suitably prepared and then examined by means of a microscope. This showed the presence of a continuous network of carbides at the grain boundaries and massive carbides within the grains at one surface of the casting (see Figure 1). At the other surface, a smaller amount of grain boundary carbide and massive carbide is present (see Figure 2). The photomicrographs also show a larger than normal grain size, indicating a pouring temperature too high for the section size of the casting.

(x100, etched in 6% nital)

Fig. 1. - Field near surface from which cracks originated; showing large amount of carbide present. Note, also, the large grain size.

The presence of the continuous network of grain boundary carbide along one surface is undoubtedly the reason for the cracks. The fact that one surface of the casting is closer to being properly heat treated than the other, would indicate that insufficient time at temperature is a probable cause of the trouble.

1. Large amounts of both grain boundary carbides and massive carbides were found near the surface from which the cracks originated, and are the reason for the cracks.

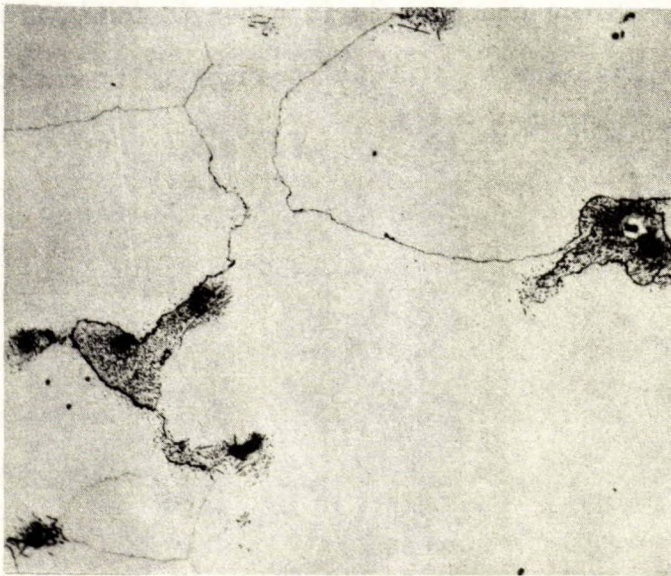
(x100, etched in 6% nital)

Fig. 2. - Field near opposite surface to that of Figure 1, showing smaller amount of carbide present in this location. Note the large grain size.

2. Since one surface is close to being properly heat treated, insufficient time at temperature is probably the cause of the trouble.
