MINES BRANCH INVESTIGATION REPORT IR 58-131

METALLURGICAL EXAMINATION OF FAILED CAP SCREWS FROM MERCURY PUMPS

G. W. SMITH

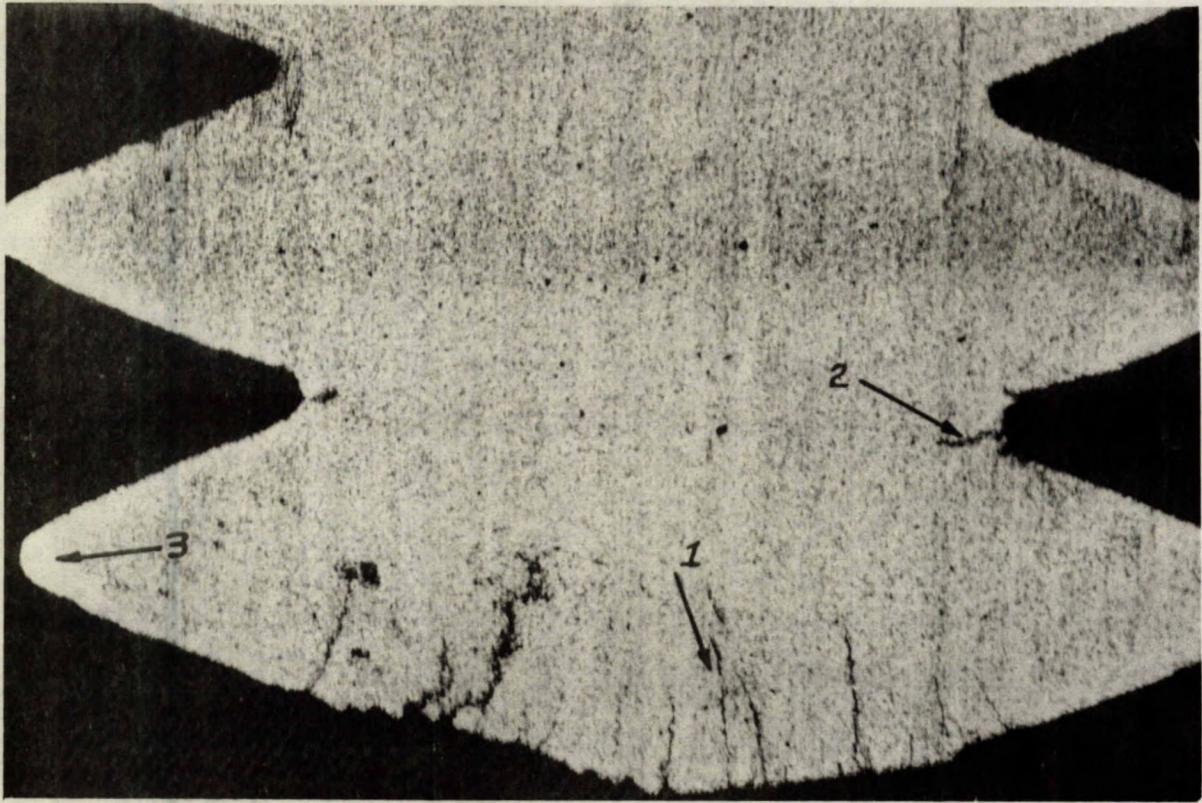
Fig. 1. - Longitudinal section through cap screw.

The fracture surface is shown at the bottom of the photomicrograph in Figure 1. Secondary cracks extending from the main fracture surface are visible (arrow 1). Cracks are visible at the thread roots (arrow 2) and decarburization is visible on the thread surfaces (arrow 3).

The decarburization shown in Figure 1 does not appear to have a bearing on the failure.

1. It is recommended that an 18/8 stainless steel be used, instead of the mild steel, for the manufacture of these screws. The 18/8 stainless steel is resistant to embrittlement caused by hydrogen, caustic soda, or mercury.
2. Monel is not recommended, since it is not at all good in its resistance to corrosion, particularly stress corrosion, in the presence of mercury above 100°C.

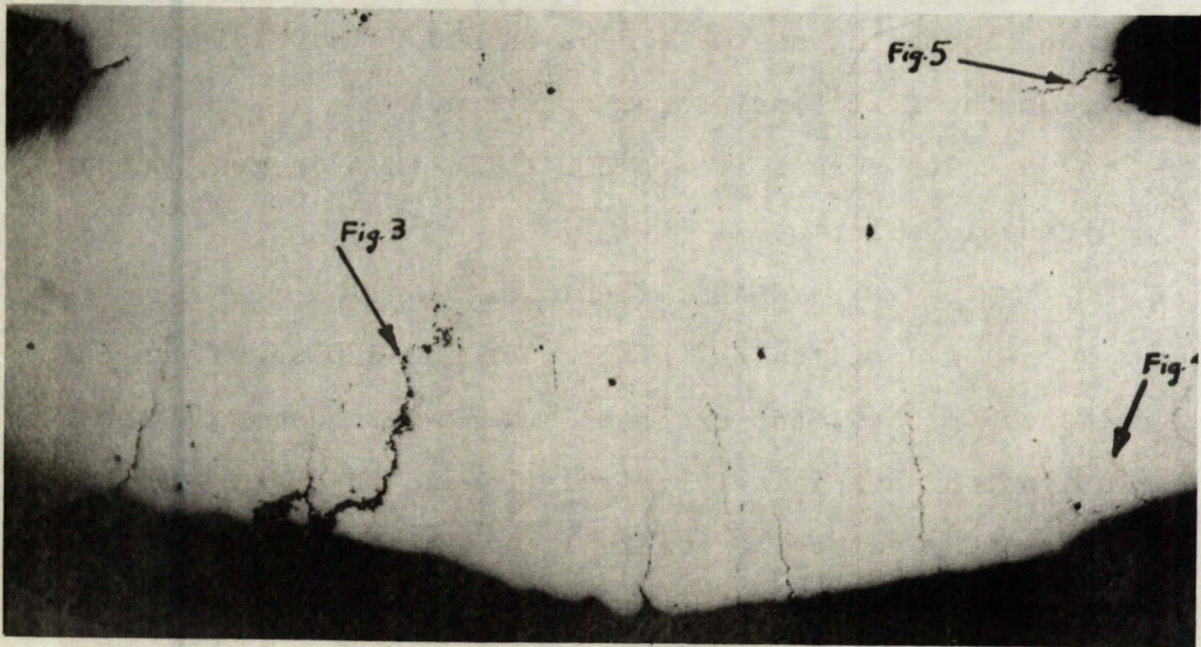
Fig. 2. - Longitudinal section through cap screw.

In Figure 2 are shown the position of the cracks and the location of the areas illustrated in Figures 3, 4 and 5.

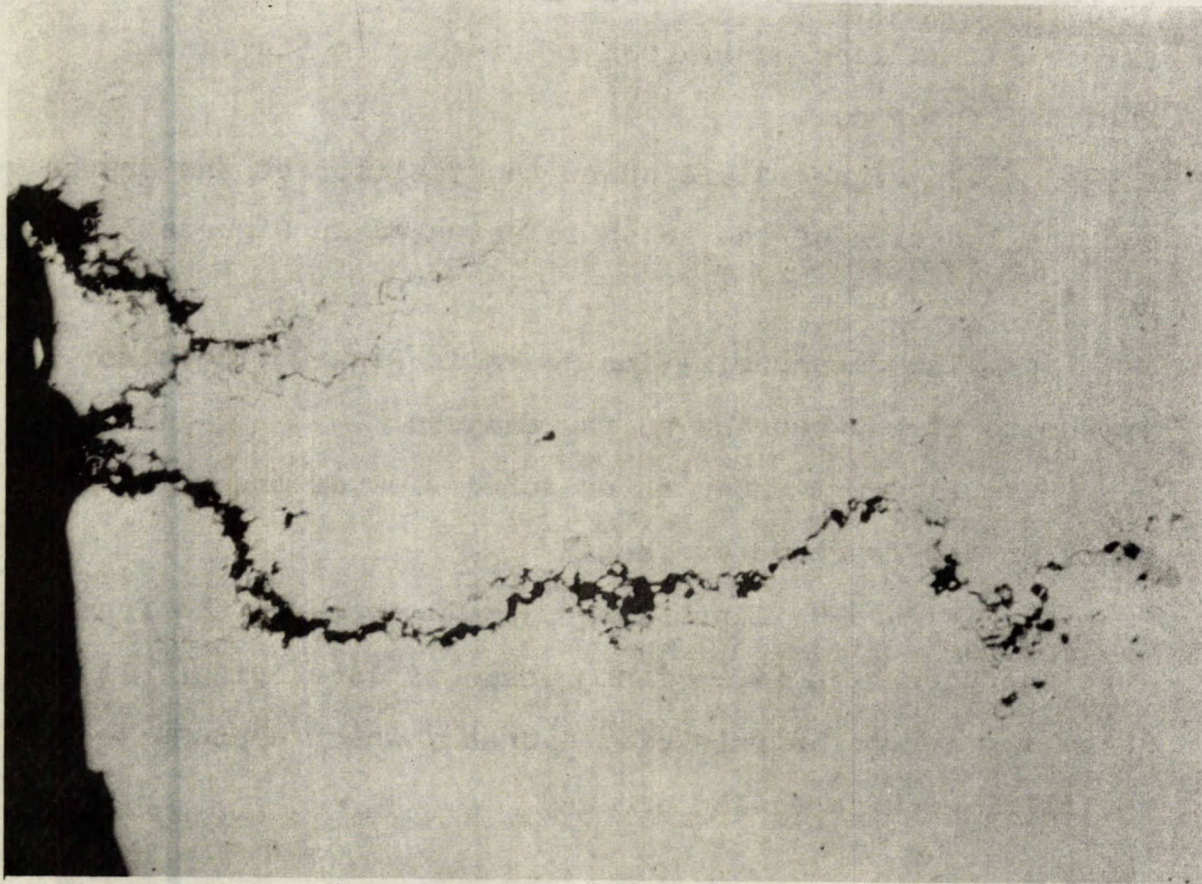
Figure 3 shows an unetched view of the main crack on the fracture surface.

Fig. 3.- Main secondary crack emanating from the fracture surface.

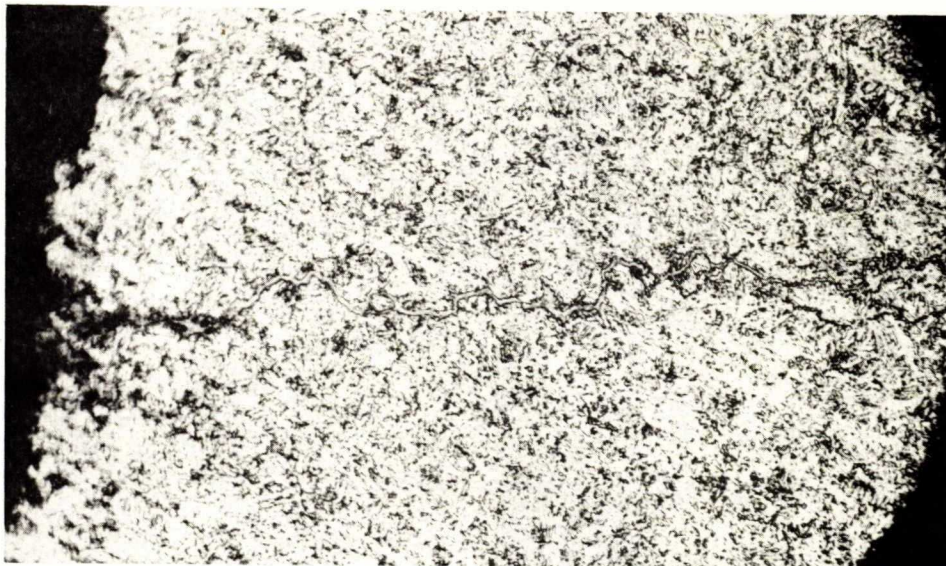
Figure 4 illustrates a small crack on the fracture surface which is in the process of developing. It shows the irregular path of the crack, which appears to be filled with corrosion product.

Fig. 4. - Small secondary crack emanating from the fracture surface.

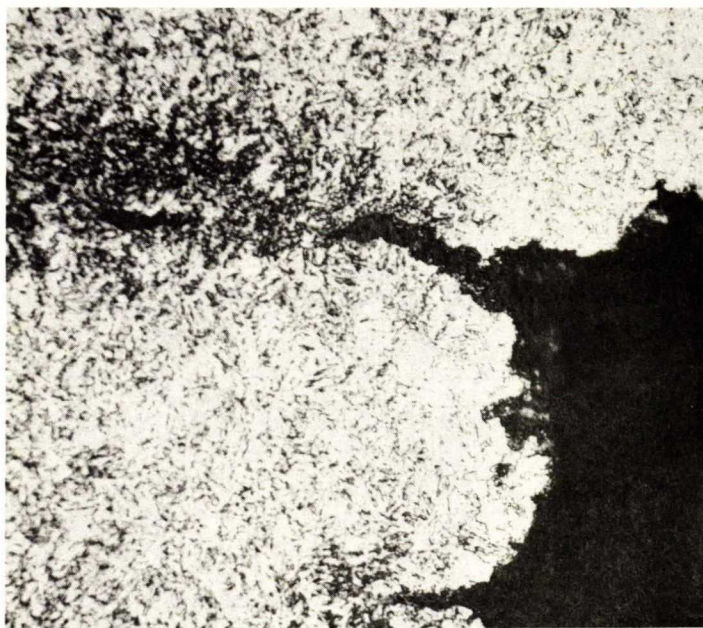
Figure 5 illustrates a crack at the root of a thread.

Fig. 5 - Crack at the thread root shown in Fig. 2.

The concentration of caustic soda in the thread roots may become very high, although the overall concentration is rather low. This concentration may be sufficient to cause initial cracking in this steel.
