MINES BRANCH INVESTIGATION REPORT IR 58-143

EXAMINATION OF PORTIONS OF THREE STEEL PLATES FROM THE M. S. "EAGLECLIFFE HALL"

D. R. BELL

AUGUST 22, 1958

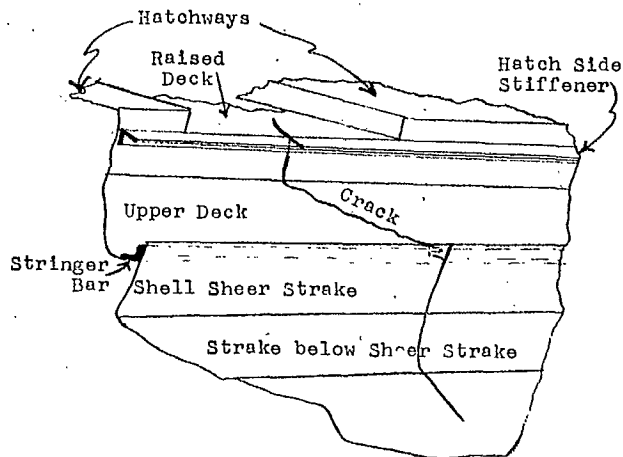
The M.S. "EAGLESCLIFFE HALL" suffered a structural failure when crossing Lake Ontario in ballast in stormy weather. The failure consisted of a crack on the port side which would appear to have originated in a welded butt of the hatch girder stiffener located between No. 2 and No. 3 hatches and to have spread to the adjacent hatch girder butt (welded) located four inches aft of the stiffener butt, thence across the deck stringer plate through a welded butt in the riveted deck stringer angle, and then down the full depth of the sheer strake, through the strake below the sheer strake, and halfway down the second strake below the sheer strake, a total depth of about 10 ft. 6 in. (see Figure 1).

Fig. 1. - Sketch showing location and extent of crack.

Examination showed that the welding of the deck stringer angle butt had penetrated the sheer strake, thus forming a continuous path through the deck stringer angle butt. At the time of the failure air temperature was 20°F and water temperature was 34°F. Samples of the deck stringer plate, sheer strake and strake below the sheer strake were forwarded for examination; these samples are shown in Figures 2 and 3.

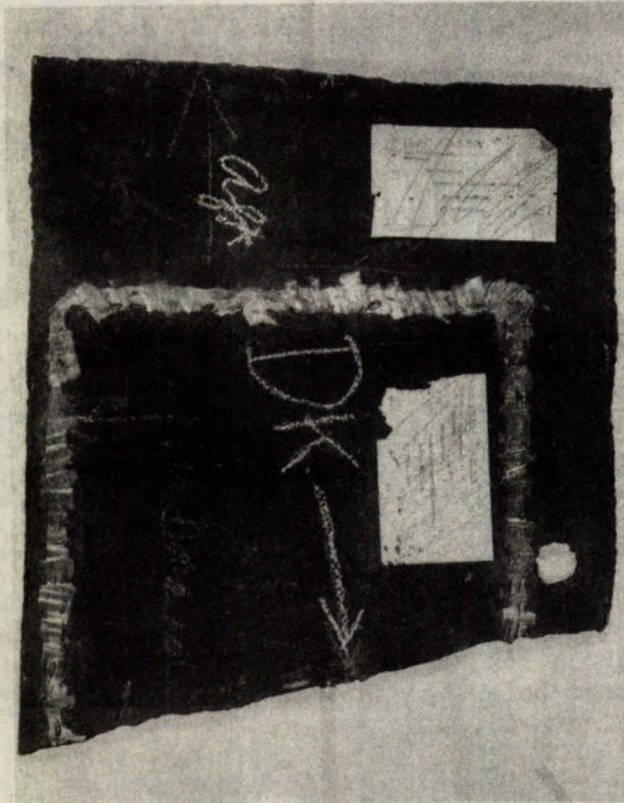
Fig. 2. - Deck stringer plate.

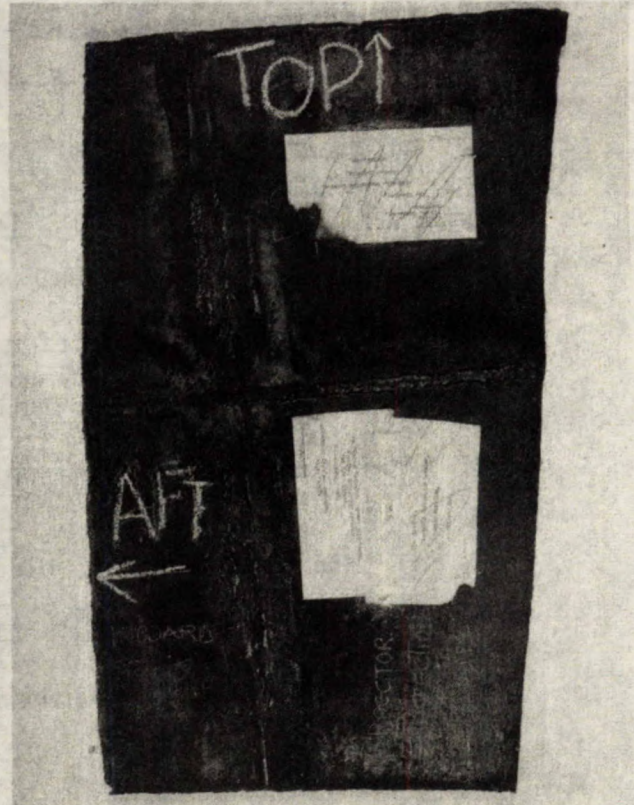
Fig. 3. - Port side shell plate. The portion above the weld is part of the sheer strake, and the portion below the weld is part of the strake below the sheer strake.

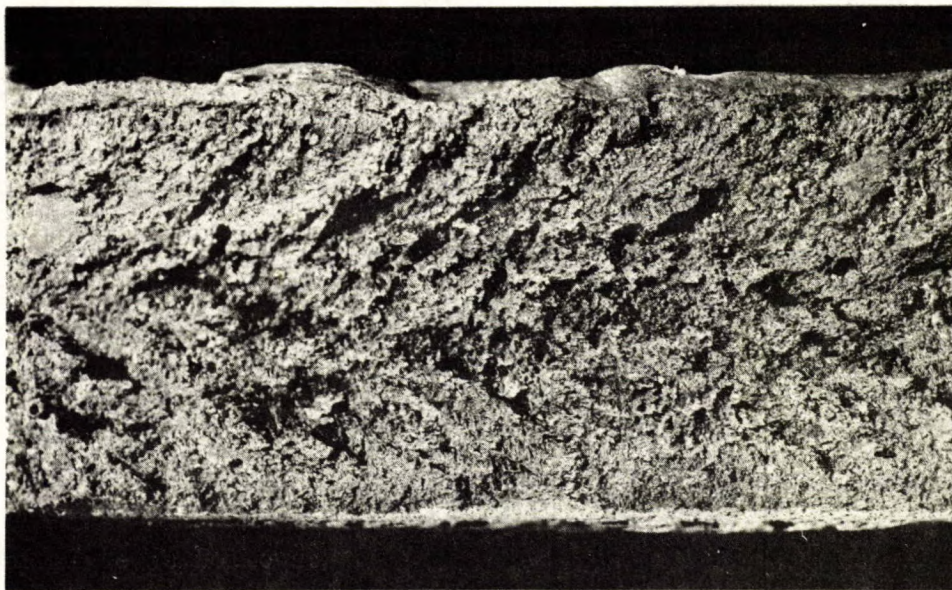
The chevron markings usually associated with brittle fracture of mild steel were observed on the fracture surfaces of all three plates. A typical area is shown in Figure 4.

Fig. 4. - Fracture surface of plate "C". Note obvious chevron markings.

The coarseness of the chevron marking indicates that the fracture occurred at a temperature not far below the transition temperature of the plate. The plate thicknesses varied, plate "A" being 0.415 in.; plate "B" 0.518 in. and plate "C" 0.607 in. thick.

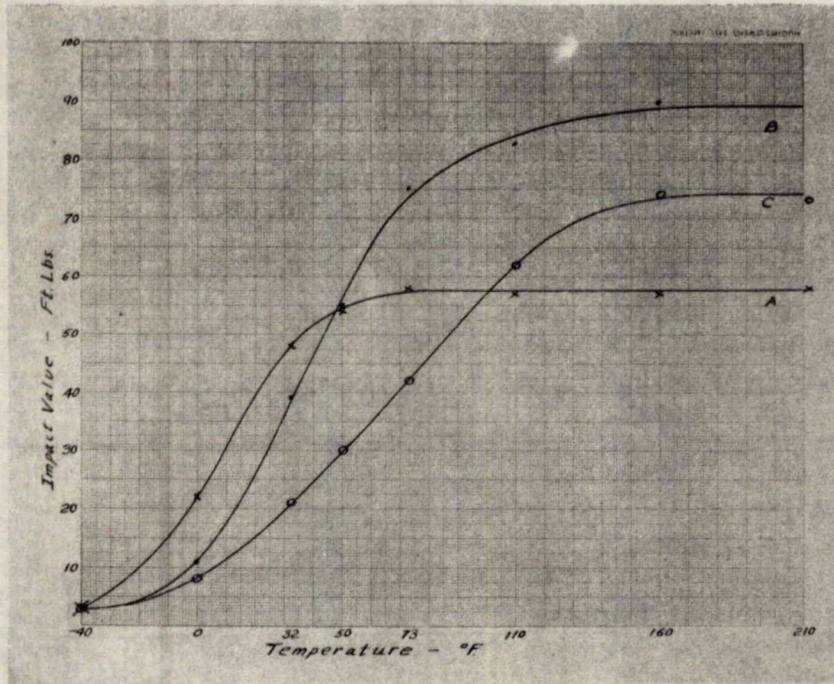
Fig. 5. - Charpy V-notch test results.

It seems reasonable to assume that the temperature of the plates at the time of failure was the same as the air temperature, i.e. 20°F. The 15 ft-lb transition temperature of plate C is essentially the same as the service temperature, and the transition temperatures of plates B and A are fairly well below the service temperature. The fact that the crack propagated in a brittle fashion through plates at a temperature above their 15 ft-lb transition is not unusual. On the contrary, it is well established that it is easier to propagate than to initiate a crack. It would be anticipated that plates A, B and C, when loaded within the elastic limit, could stop a running crack at temperatures of 13°F, 30°F and 35°F, respectively. While the crack-stopping temperature of plate A is below the service failure temperature, the actual load is unknown and, furthermore, the uncertainty of testing is most probably not accurate to $\pm 7^\circ\text{F}$.

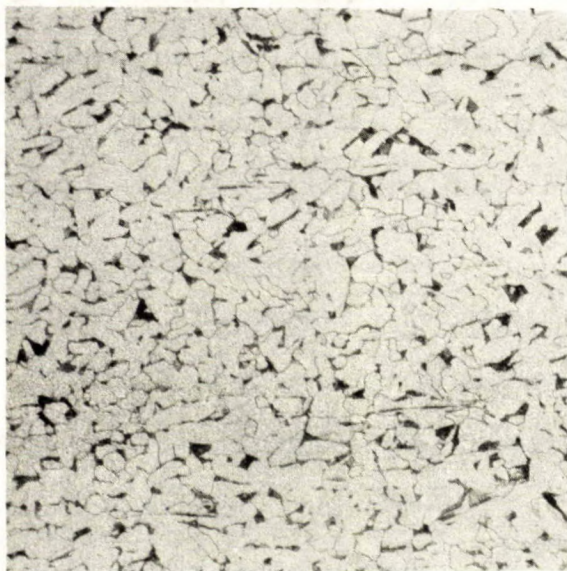
Plate A

Sections of all plates were prepared for microexamination. Neither type nor quantity of non-metallic inclusions appeared abnormal for the grade of material. The microstructure of fine pearlite and ferrite was typical of as-rolled mild steel (Figure 6).

Fig. 6. - Typical microstructures, Plates A, B and C. (X100; etched in 2% nital).
