CANADA  
DEPARTMENT OF MINES AND TECHNICAL SURVEYS  
OTTAWA

MINES BRANCH INVESTIGATION REPORT IR 58-146

METALLURGICAL EXAMINATION OF A STAINLESS  
STEEL IMPELLER WHICH FAILED IN SERVICE

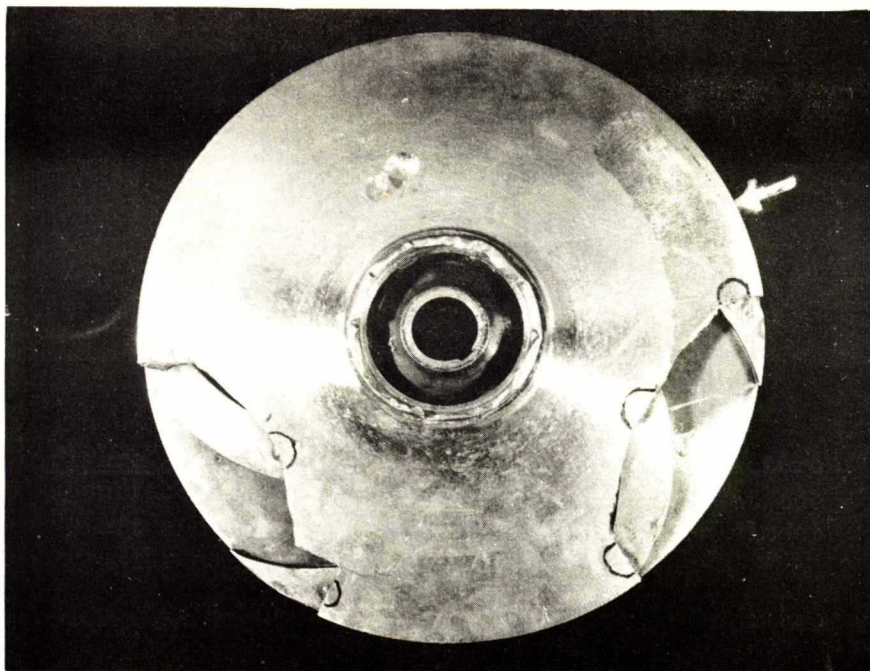
The failed impeller is shown in Figures 1 and 2\*. Visual examination indicated that each of the failures initiated at the periphery near a plug weld. The path of each fracture then progressed in a brittle fashion and in a direction counter to the rotation of the impeller through a second plug weld and advanced almost to a third

plug weld near the periphery. The last portion of each fracture was ductile.

Radiography showed that the impeller contains regions of microshrinkage and numerous round voids. However, none of these defects appeared to be associated with the fracture or with the path of the fracture. The white arrow in Figures 1 and 2 points to a region of microshrinkage at the periphery.

Figure 1. - Plan view of impeller, showing location of the failures. The black semi-circles denote the plug-welded areas.

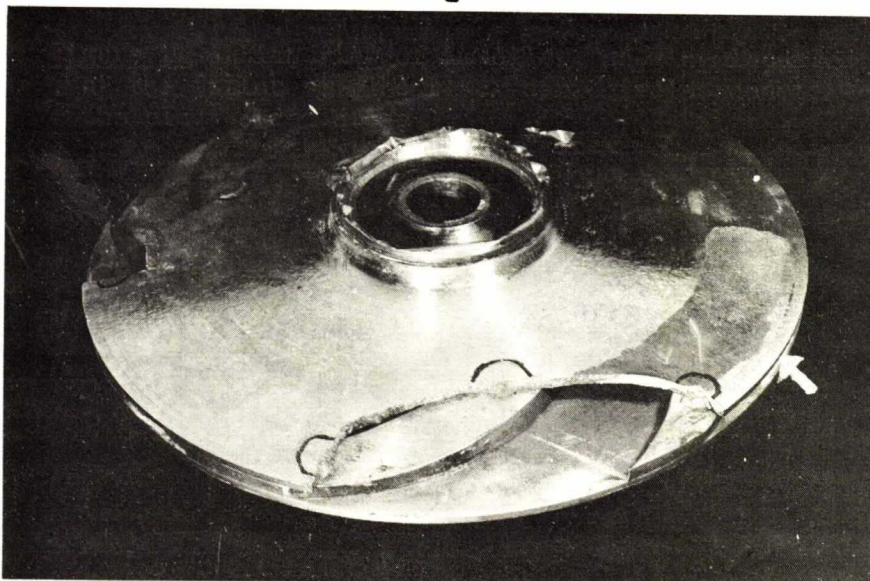
The brittle portions of the fracture surfaces appeared to have been abraded, indicating that the failure had progressed over a period of time during which the mating surfaces had flexed and worn against each other. The only evidence of ductility in the brittle portion of the fracture was a very thin shear lip, about  $6\frac{1}{4}$  in. deep, along the outer edge. No shear lip was present along the inner edge.

Figure 2. - Angle close-up of one of the fracture surfaces. Failure apparently originated at the left and progressed in a brittle fashion almost as far as the plug weld on the right.

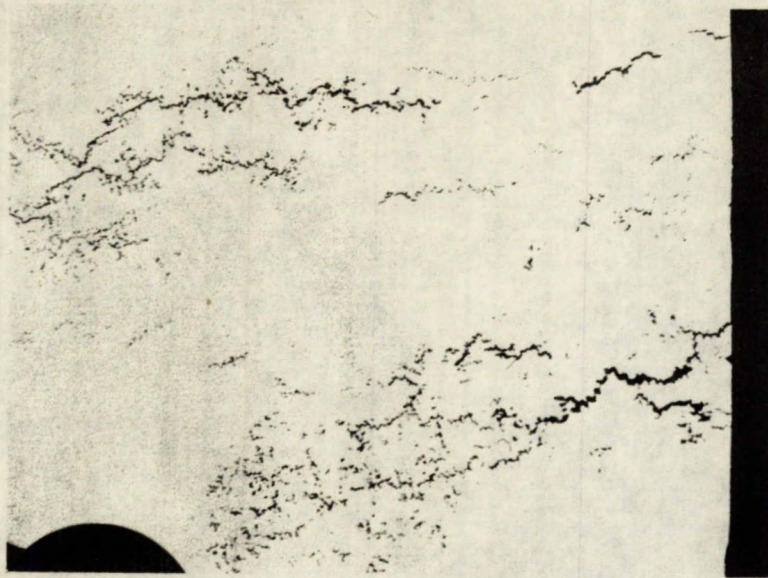
Microshrinkage observed in the areas shown, by an arrow, in Figures 1 and 2 is shown in Figures 3 and 4.

Figure 3. - Microshrinkage extending to outer edge of the impeller at the right.

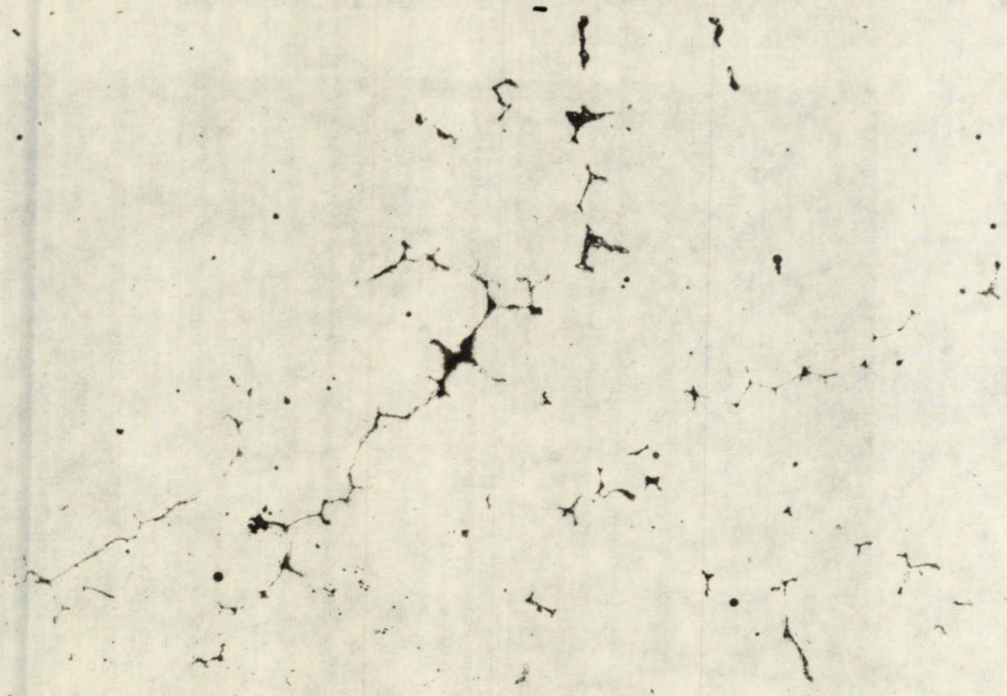
Figure 4. - Enlargement of an area from or near the field shown in Figure 3.
