MINES BRANCH INVESTIGATION REPORT IR 58-147

# METALLURGICAL EXAMINATION OF BOILER SHELL PLATE AND BROKEN RIVETS FROM STARBOARD BOILER OF S. S. WINNIPEG

SEPTEMBER 4, 1958

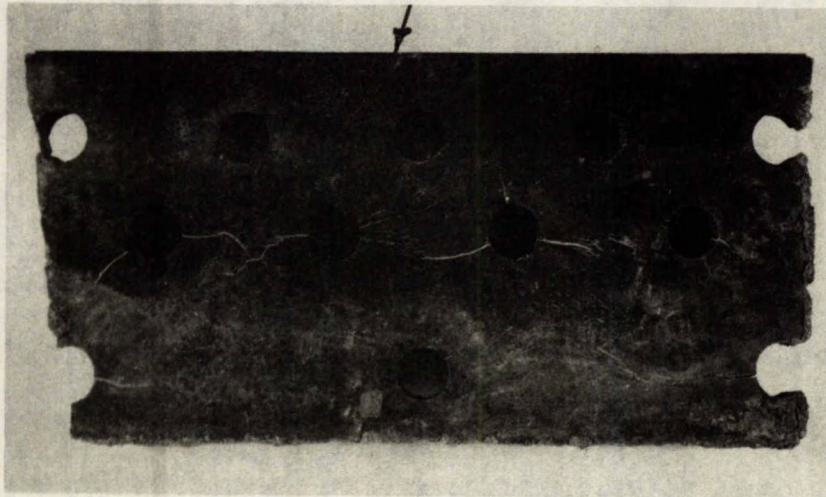
Figure 1. - Water side of shell plate (concave surface). The longitudinal seam is indicated by the arrow (top). Cracking is most extensive along the two outer rows of rivets.

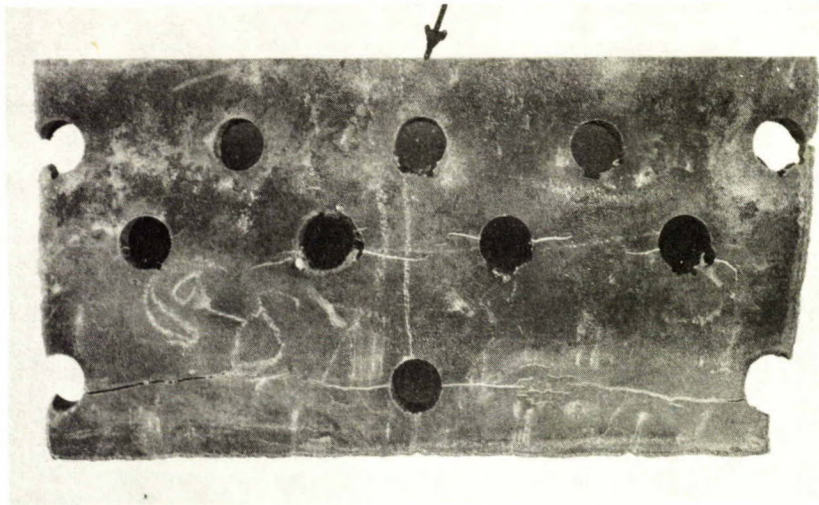
**Figure 2.** - Outer surface of shell plate (convex surface). The longitudinal seam is marked by the arrow (bottom). The cracks are continuous in the ligaments of the outer rows of rivets, but are almost completely absent in the ligaments of the inner row of rivets.

Cracking in the S. S. "Winnipeg" boiler appeared to be most severe along the outer row of rivets, slightly less severe along the middle row, and practically absent at the inner row of rivets. The direction of the main cracks between ligaments was normal to the principal applied stress (the hoop stress).

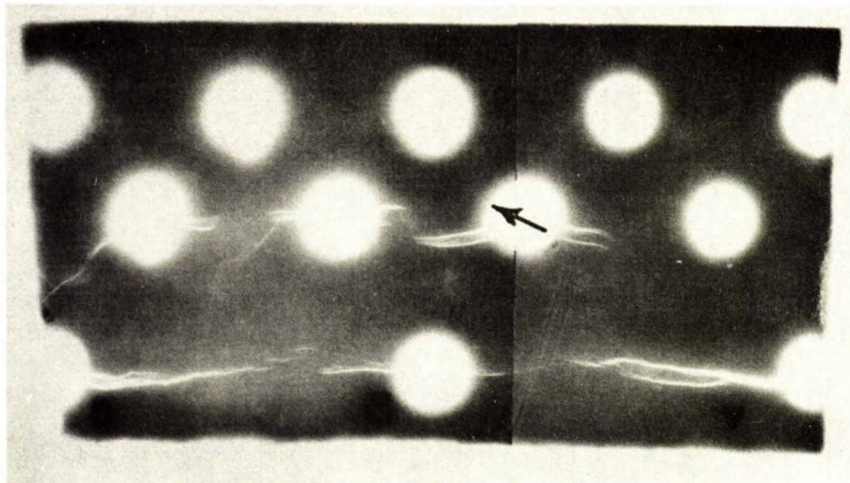
**Figure 3.** - Composite X-ray view of cracked shell plate. The larger cracks are clearly visible; the smaller cracks are more difficult to see than on the original radiograph. The arrow marks the location of one of the radial cracks examined under the microscope.

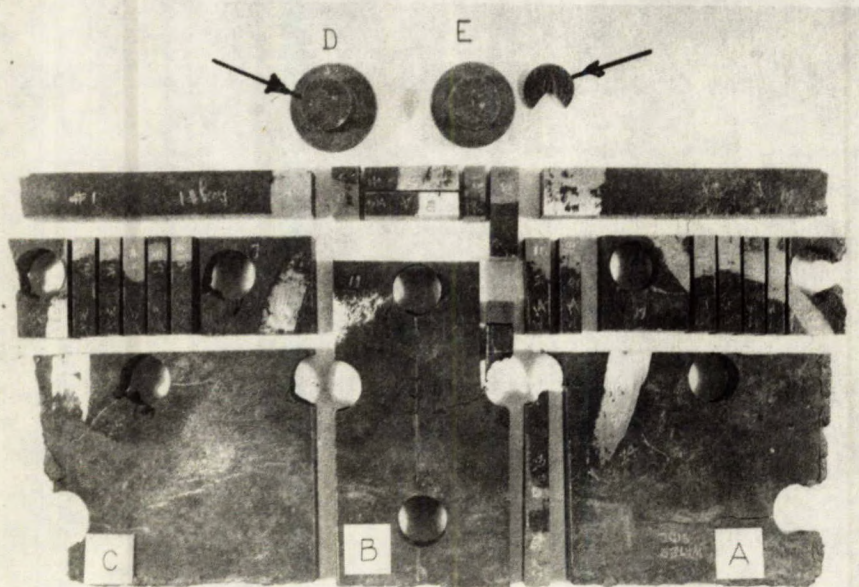
**Figure 4.-** Sectioned shell plate and broken rivets D and E. The metal pieces were numbered 1 to 26, and in the case of Charpy bars those taken adjacent to the water surface were marked W and those adjacent to the outer surface were marked O. The rivet surfaces are indicated by the arrows.

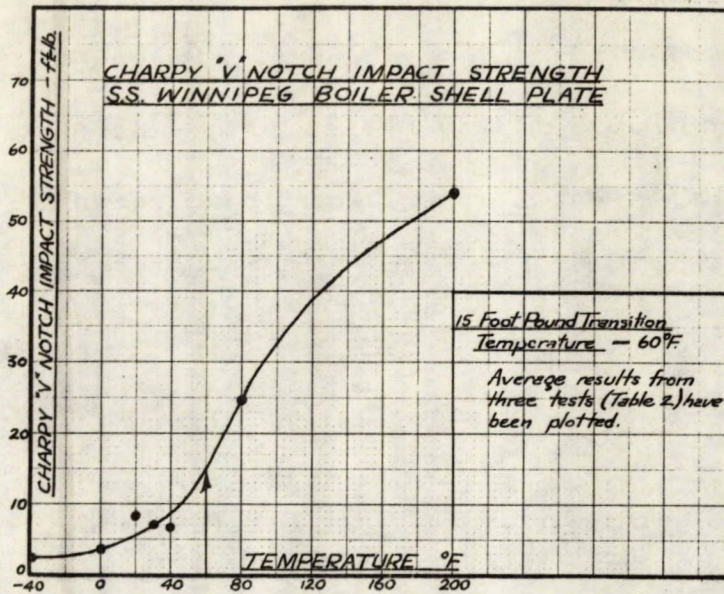
Figure 5. - Charpy V-notch impact strength results, plotted.

The 15 ft. lb. transition temperature measured adjacent to the water side was 60°F and adjacent to the outer side of the shell was 64°F. The transition curves indicate no significant variation in impact strength between the water and outer surface.

The slightly lower impact values obtained at testing temperatures of 30°F and 40°F, compared with values obtained at 20°F, are not considered significant.

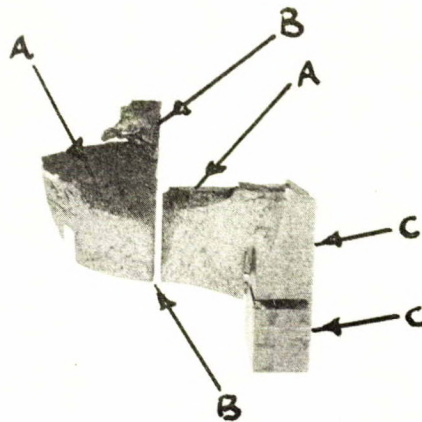
The radial crack, marked by the arrow in Figure 3, was cut out of the plate for microexamination. This crack was not visible without use of magnetic particle or radiographic methods but when sectioned the crack was continuous and the metal separated into two pieces. The appearance of this cracked section is illustrated in Figure 6.

Figure 6. - Radial crack at rivet hole - opened to show crack surfaces.

The arrows A indicate the hole surface, arrows B mark the water side of the plate, and arrows C mark the outer plate surface. The crack surface appeared intergranular.

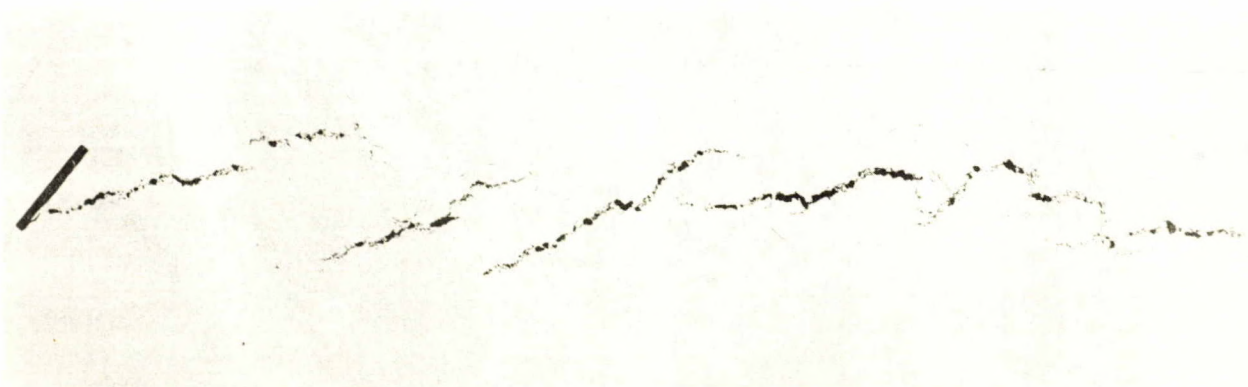
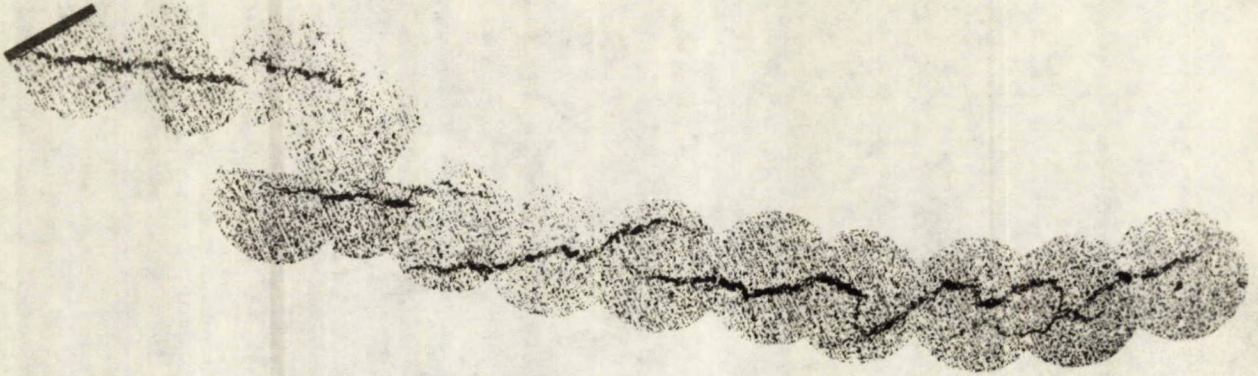
The appearance of a transverse microsection through the radial crack is illustrated in Figures 7 and 8 at 15 diameters. The crack appears discontinuous in the plane illustrated, but is, in fact, continuous and mainly intercrystalline.

Figure 7. - "As polished" radial crack at second row rivet hole. The water side of the plate is shown at the extreme left of the plate. This crack is continuous, connected, and mainly intercrystalline.

Figure 8. - Same area as Figure 7.

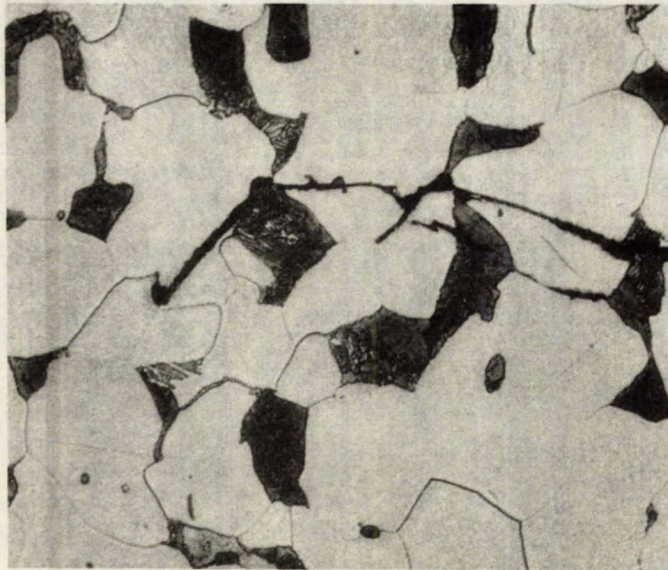
Figure 9. - Secondary intercrystalline crack. The intercrystalline path of the crack is illustrated. Carbide attack is also visible.

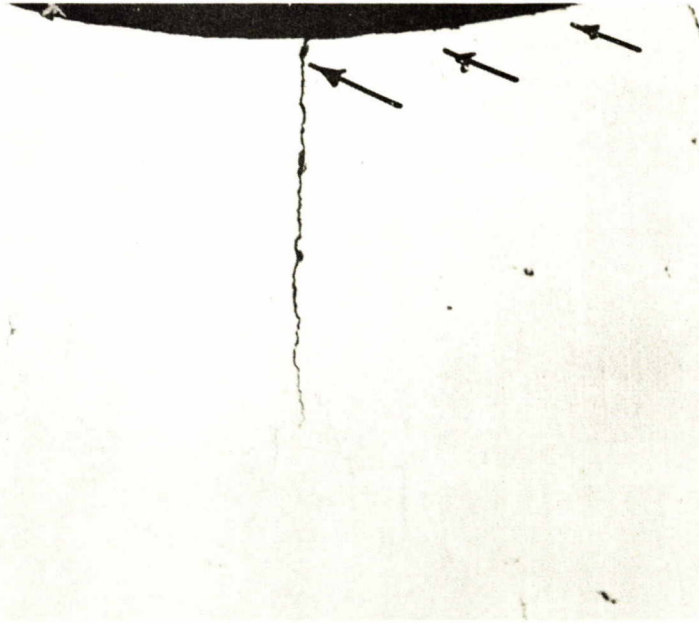
Figure 10. - Radial cracks at rivet hole (arrows). Also, note the numerous small cracks at the tip of the larger crack.

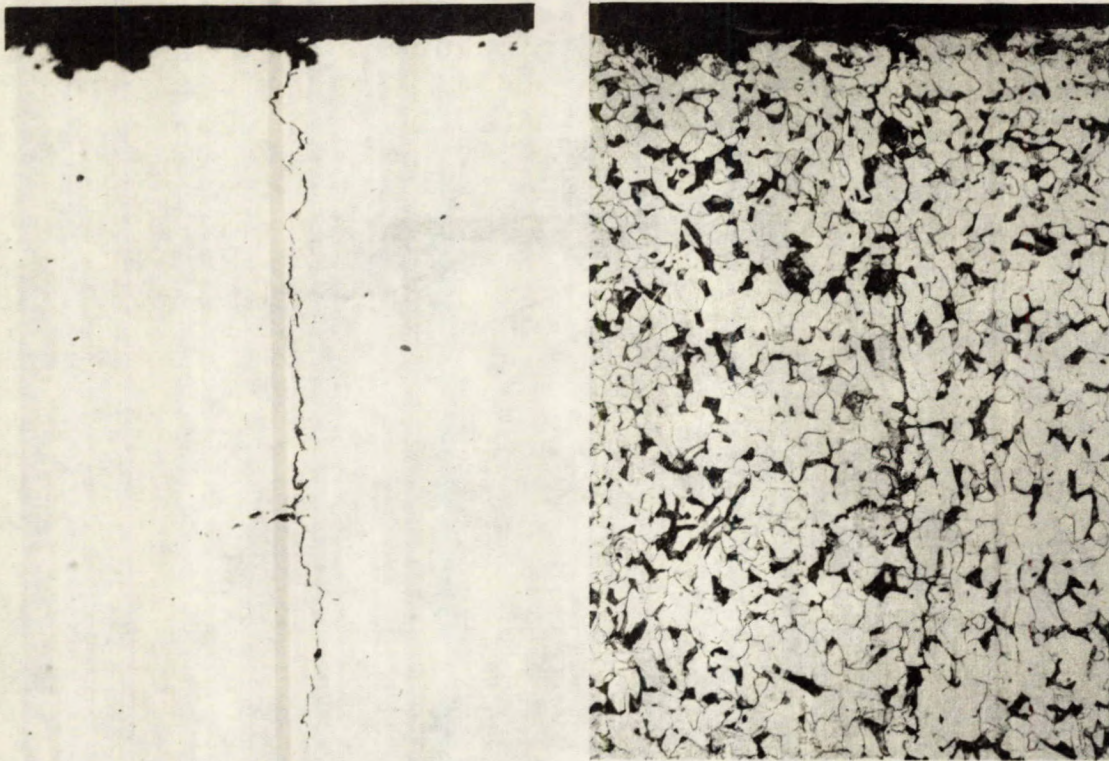
**Figure 11.** - Views of a typical intercrystalline crack extending in a radial direction from a rivet hole. This small crack in an early stage of development is believed similar to those which were normal to the applied stress and propagated to form the large ligament cracks.

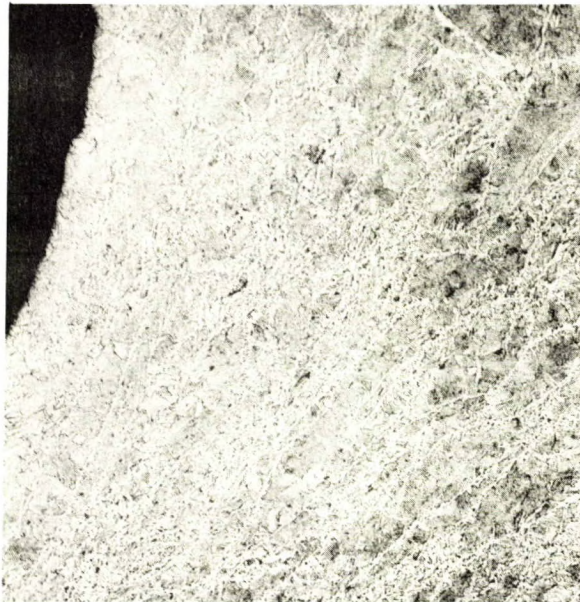
The microstructure of the two broken rivets, illustrated in Figures 12 and 13, consisted of pro-eutectoid acicular ferrite and fine pearlite. There was practically no evidence of cold-worked metal at the fillets between the shanks and the points. The appearance of the microstructures suggests better than average riveting practice.

Figure 12. - Rivet "D" - fillet between point and shank. The driving temperature and the cooling rate after driving were successful in avoiding cold work, grain growth, or a severely quenched microstructure.

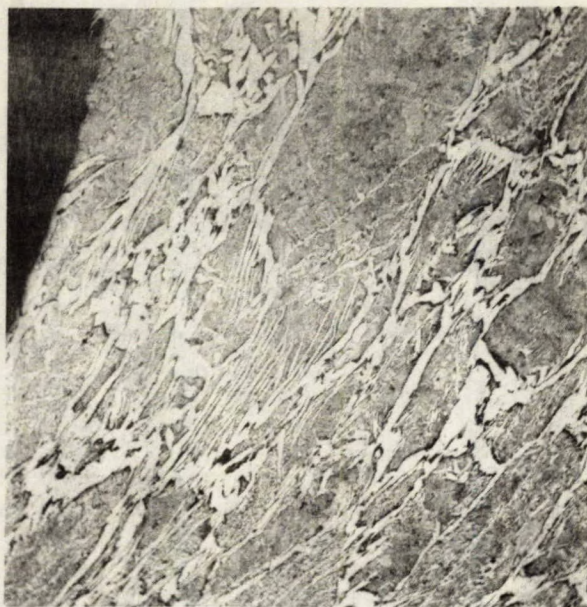
Figure 13. - Rivet "E" - fillet between point and shank. The structure is similar to that of Figure 12, except that this rivet was probably driven hotter than rivet D, resulting in a slightly coarser grain size.

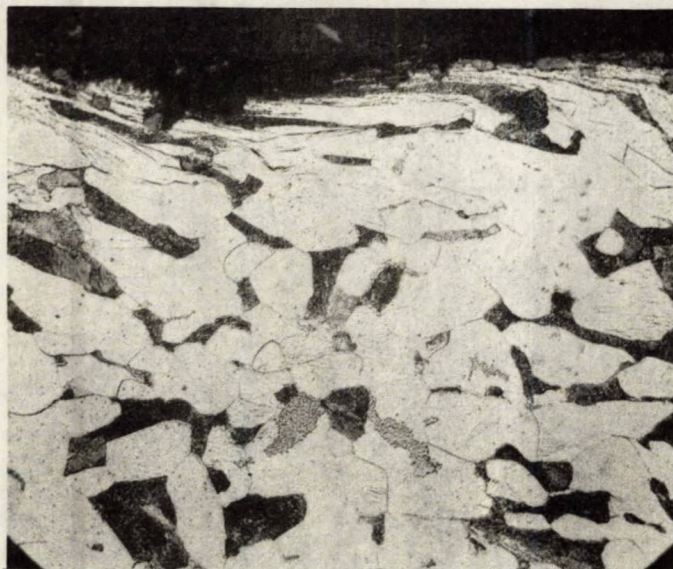
Figure 14. - Cold-worked metal at a rivet hole surface. Traces of cold-worked metal are visible at the rivet hole surface. This amount of cold-work is less than is often observed.

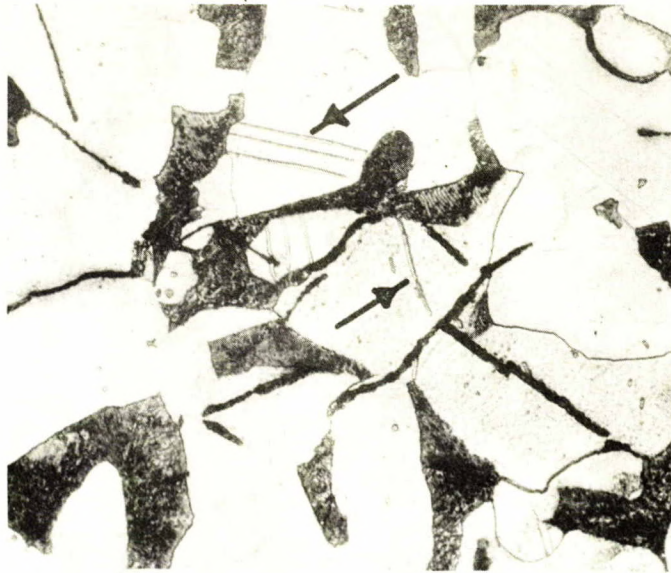
Figure 15. - Intercrystalline cracks and twinning of ferrite grains.  
Twinning of ferrite grains is marked by the arrows.

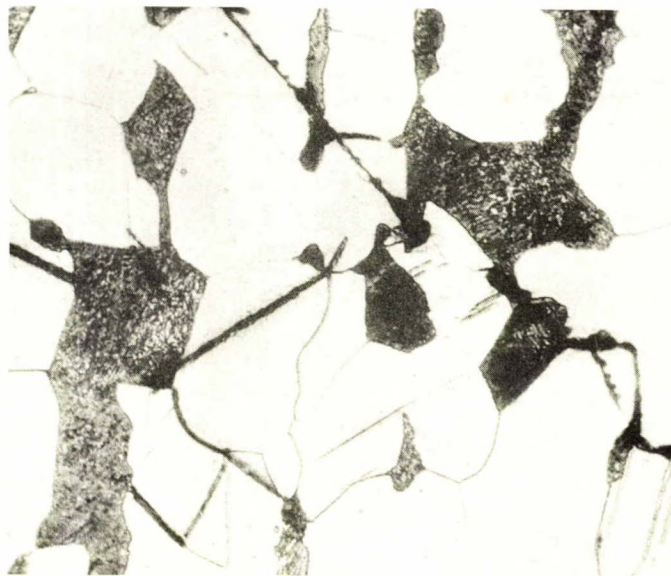
Figure 16. - Twinning and corroded cracks in ferrite grains. The  
transcrystalline appearance of these cracks in ferrite grains was  
exceptional.

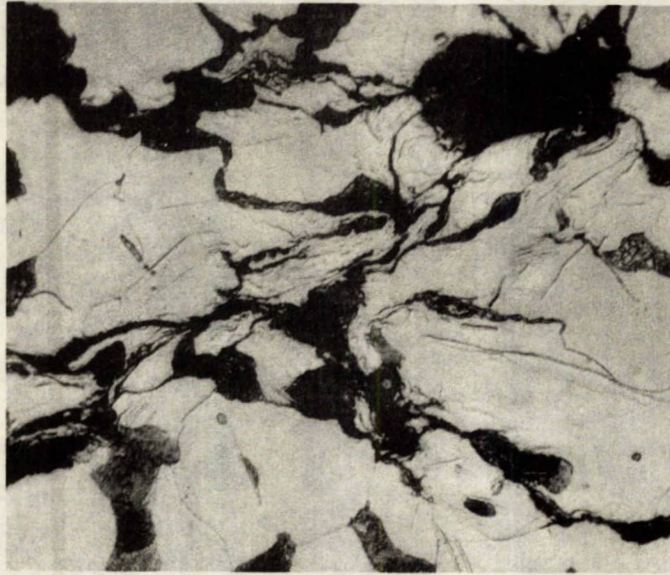
Figure 17. - Cold-worked metal between branches in the deeper part of the crack. The presence of this cold-worked metal suggests working of the plate after crack propagation had severely reduced the ligament section.

3. The cracks in the plate are mainly intercrystalline, and typical of caustic cracks. After the cracks extended into the ligaments, local areas of metal adjacent to the cracks were subjected to stresses beyond the yield point, as evidenced by small areas of cold-worked metal adjacent to the deeper part of some cracks.

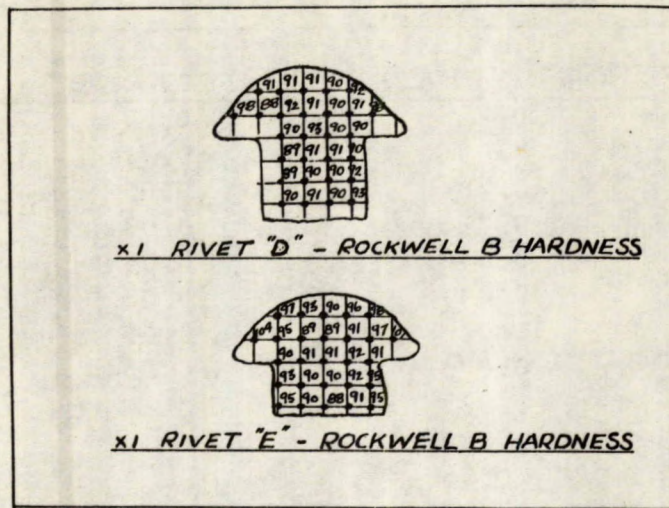
The results of Rockwell B hardness surveys on longitudinal rivet sections are shown in Figure 18. These hardness values are normal.

Figure 18. - Rockwell B hardness values on longitudinal sections of rivets "D" and "E".
