MINES BRANCH INVESTIGATION REPORT IR 58-153

INVESTIGATION OF FRACTURE OF 30 IN. WIDE FLANGE I-BEAM FROM WELLAND CANAL BRIDGE NO. 18

D. R. BELL

OCTOBER 14, 1958

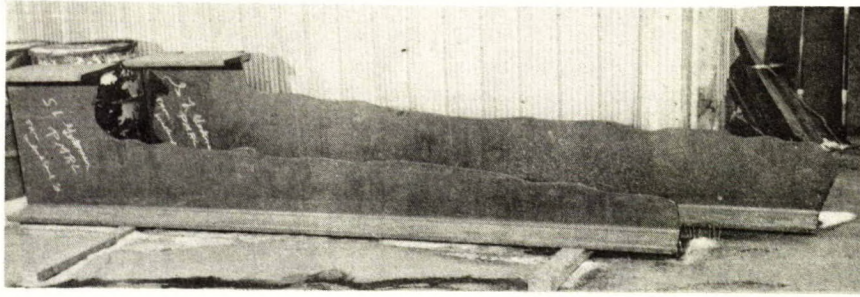
Figure 1. - Pieces of beam, as received.

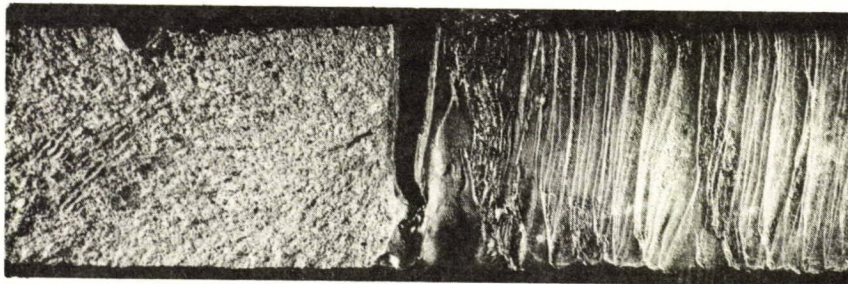
The flame cut notches were very rough and irregular (Figure 3), with extremely deep grooves cut near and at the internal corners of the notches (Figure 4). The fracture surface was relatively smooth (Figure 5), with very little evidence of the chevron pattern usually associated with brittle fracture. A slight chevron pattern was found on the fracture surface of the upper flange on the side opposite to the notched side (Figure 6). These chevron marks pointed to the flame cut notch as the origin of the failure.

The chevron marks, although scant, were sufficient to indicate clearly that the fracture origin was at the corner of the flame-cut notch in the flange. In addition, the presence of brittle untempered martensite in this area is a convincing argument in favour of so locating the fracture origin. It is apparent that the flame cut notch provided the "trigger" for the fracture. It is also evident, from the existence of untempered martensite associated with the notch, that the flame cutting was performed with neither pre-nor post-heating of the area. Also, the extreme roughness of the flame cut surface and

the presence of deep grooves in the corners of the notches deserve the most severe condemnation.

Figure 3. - Origin of fracture. Note roughness of flame cut surface. XI.

1. Improve the notch geometry, eliminating sharp internal corners and providing generous radii of curvature instead. The notch should approach a semi-circular form as nearly as possible.
2. Flame cutting technique should be improved, e.g.:
 - (a) Use a template to reduce the surface roughness.
 - (b) Avoid cutting deep grooves.

(c) Preheat the area, particularly if the ambient temperature is low.

3. Grind off the flame cut surface to a depth of 0.020 in.

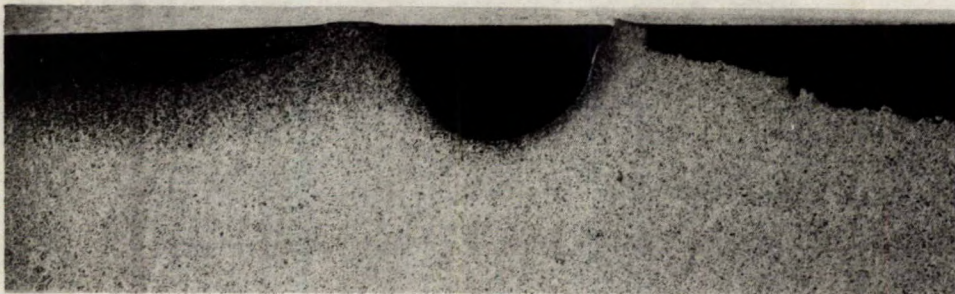
Figure 4. - Section through fracture origin area. Note deep flame cut groove.

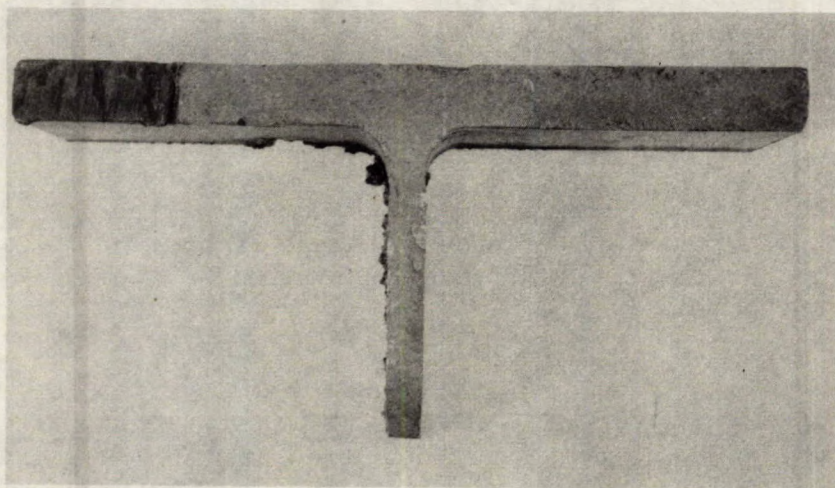
Figure 5. - Fracture origin at corner of flame cut area at left of flange. Note apparent "fine grain".

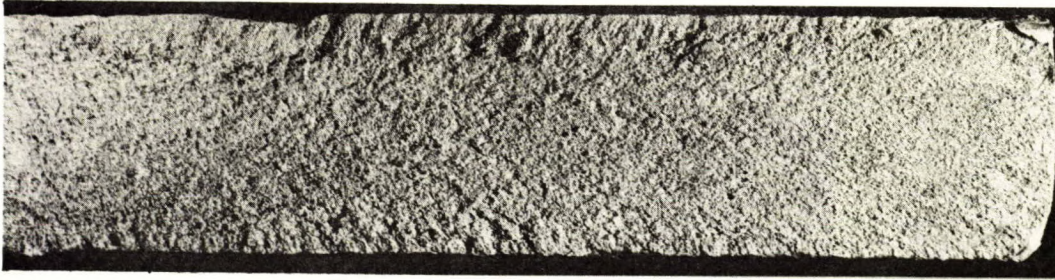
Figure 6. - Fracture surface on upper flange.
Note fine chevron markings pointing
to fracture origin on other side of
flange.

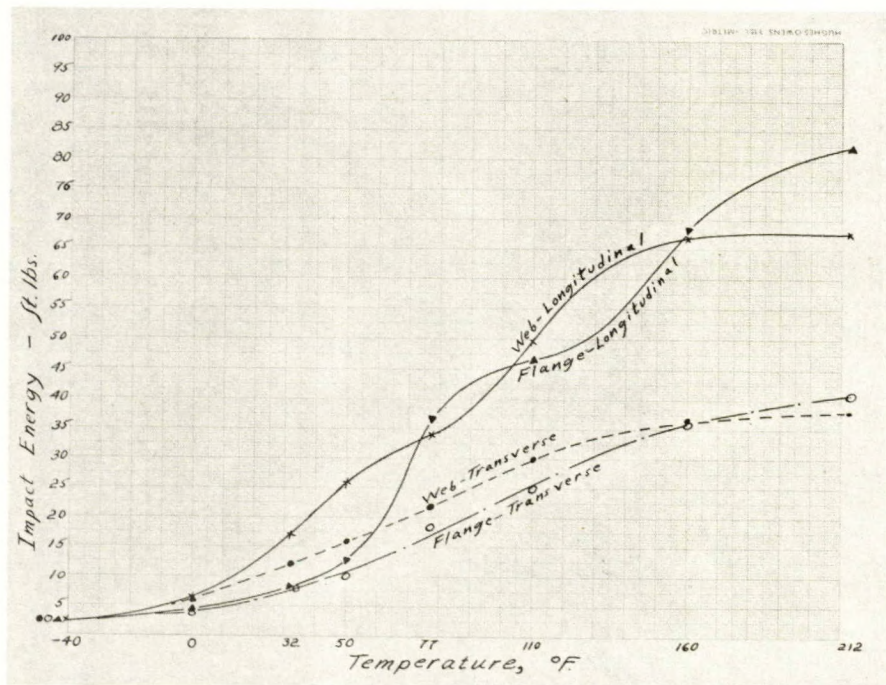
Full thickness, 8 in. gauge length tensile test bars were cut, in the longitudinal orientation, from both flange and web and, in the transverse orientation, from the web. The results of the tensile tests are shown in Table 1. Charpy V-notch bars in both the longitudinal and the transverse orientation were prepared from both the flange and the web. Numerical results of these tests are given in Table 2. The results are shown graphically in Figure 7. The 15 ft-lb transition temperatures, read from the curves of Figure 7, are shown in Table 3.

The mechanical properties, chemical analysis, and general microstructure of the beam are normal for as-rolled semi-killed mild structural steel intended to conform to ASTM A-7. The transition temperatures determined were all well above the stated service failure temperature of 11°F , so that brittle fracture could be anticipated under appropriate conditions. The very considerable difference in microstructure between flange and web indicates a considerable difference in cooling rate, caused presumably by the difference in thickness of these two portions of the beam (flange thickness $1\frac{1}{8}$ in., and web thickness $\frac{3}{4}$ in.). In turn, this differential cooling rate in such a large beam would be expected to give rise to residual stresses of some magnitude.

Figure 7. - Charpy V-notch impact test results.

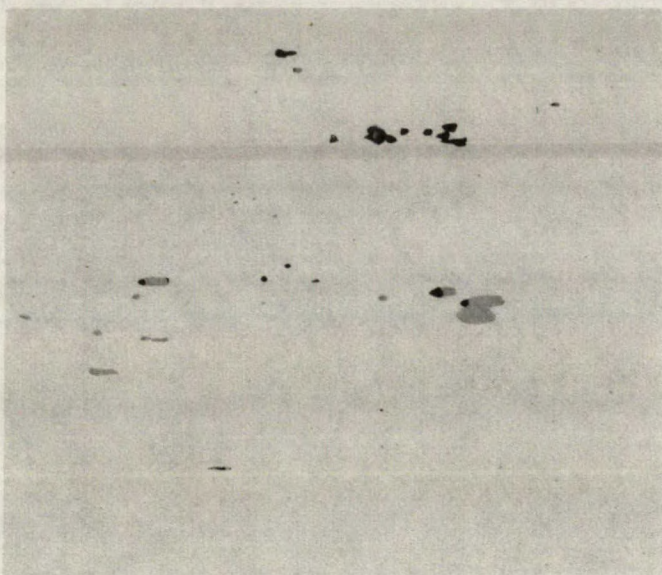
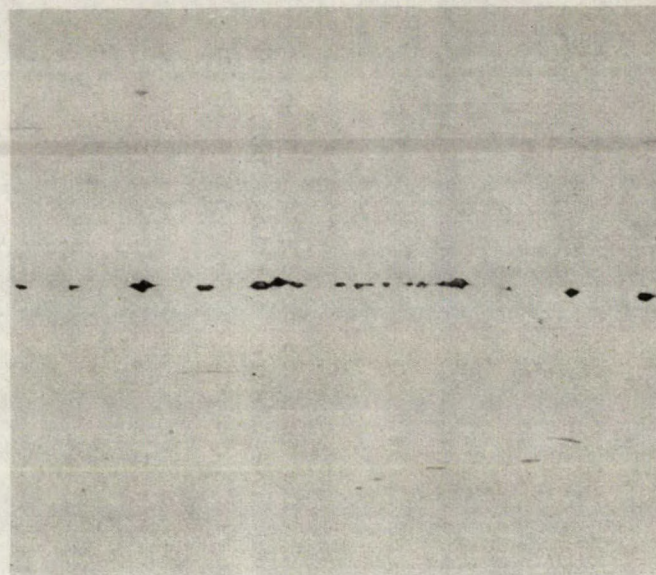
Longitudinal and transverse samples from both flange and web were prepared for microexamination. No abnormalities in either content or type of non-metallic inclusions were noted. The inclusions were somewhat thicker and shorter in the flange than in the web, as would be anticipated (Figure 8). A very considerable difference in coarseness of microstructure between the flange and the web was found (Figure 9). The fracture was seen to be typical of most brittle fractures, being principally transcrystalline cleavage with some shear and intercrystalline cleavage. A rather extensive heat-affected zone was found adjacent to the flame cut surface (Figure 10). Considerable martensite was found in this zone (Figure 11).

Figure 8. - Typical non-metallic inclusions.

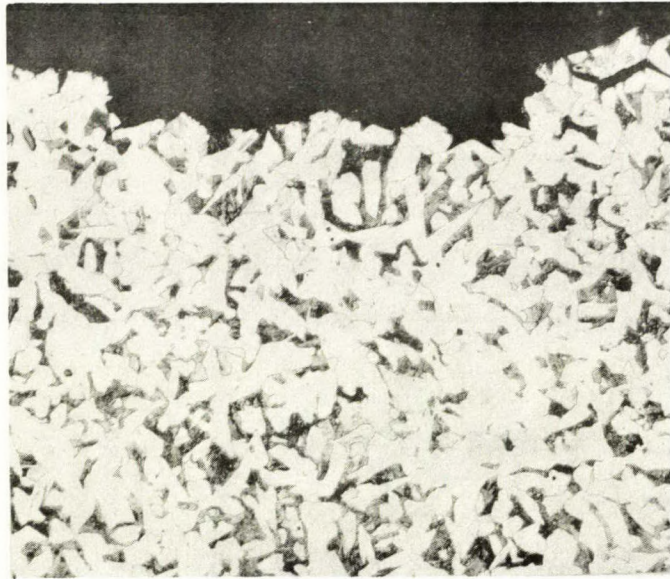
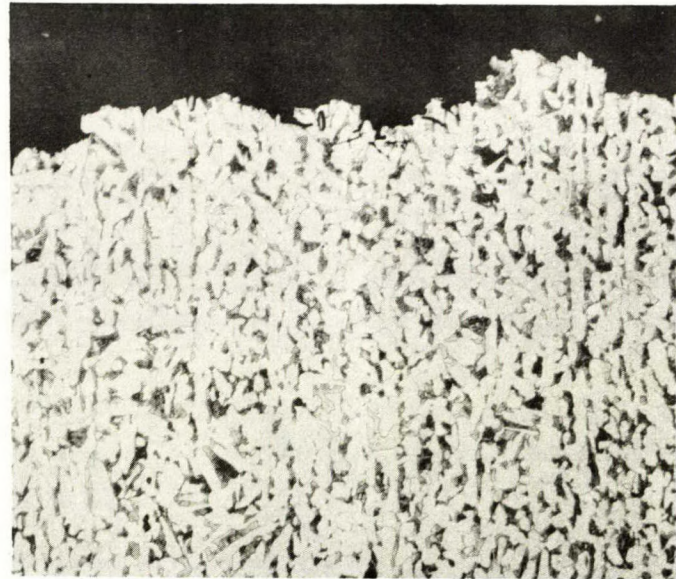
Figure 9. - Note the marked difference in microstructure.

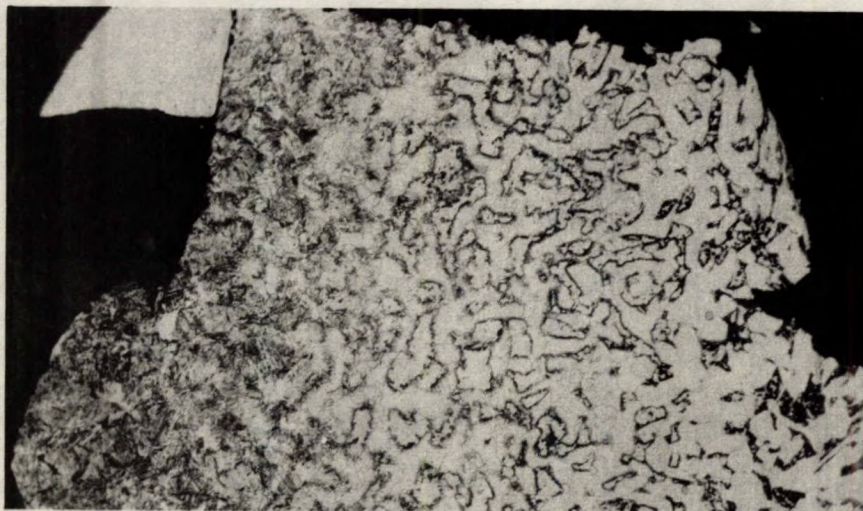
Figure 10. - Section through flame cut surface (left) and fracture (top), showing heat-affected zone.

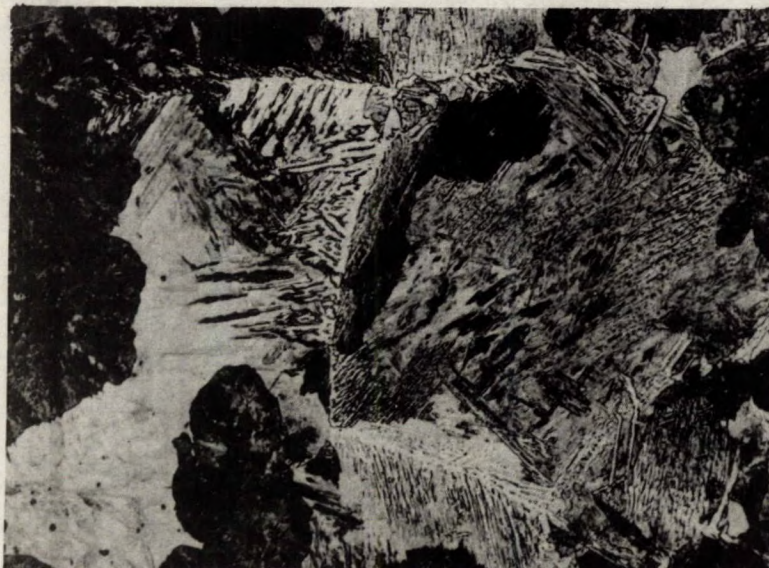
converted from the Knoop hardness values, show the hardness at 0.001 in. from the surface to rise to a maximum of R_c 46 (BHN 440), from a hardness of approximately R_b 74 (BHN 135) away from the heat-affected zone in the flange.

Figure 11. - Same section as above, near flame cut surface, showing brittle untempered martensite and bainite.
