MINES BRANCH INVESTIGATION REPORT IR 58-170

# METALLURGICAL EXAMINATION OF A BANSHEE AIRCRAFT WING HINGE FITTING

SEPTEMBER 30 , 1958

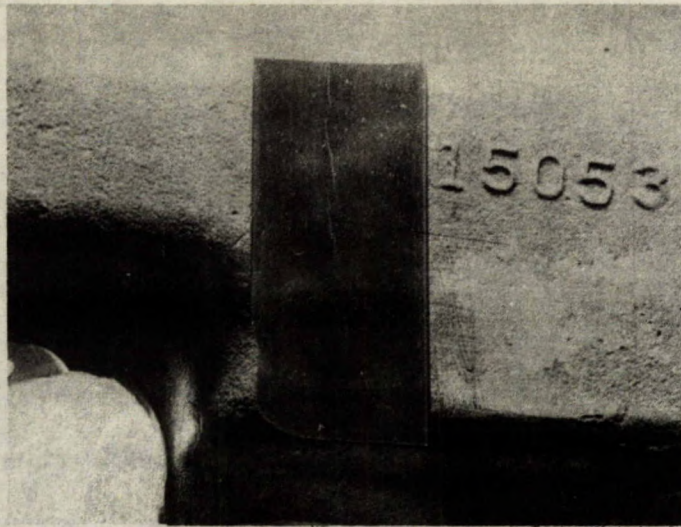
The appearance of the transverse defect, after removal of 0.060-inch of metal, is illustrated in Figure 1.

(X4/5)  
Figure 1. - Transverse fillet defect after removal  
of 0.060 in. of metal by grinding.

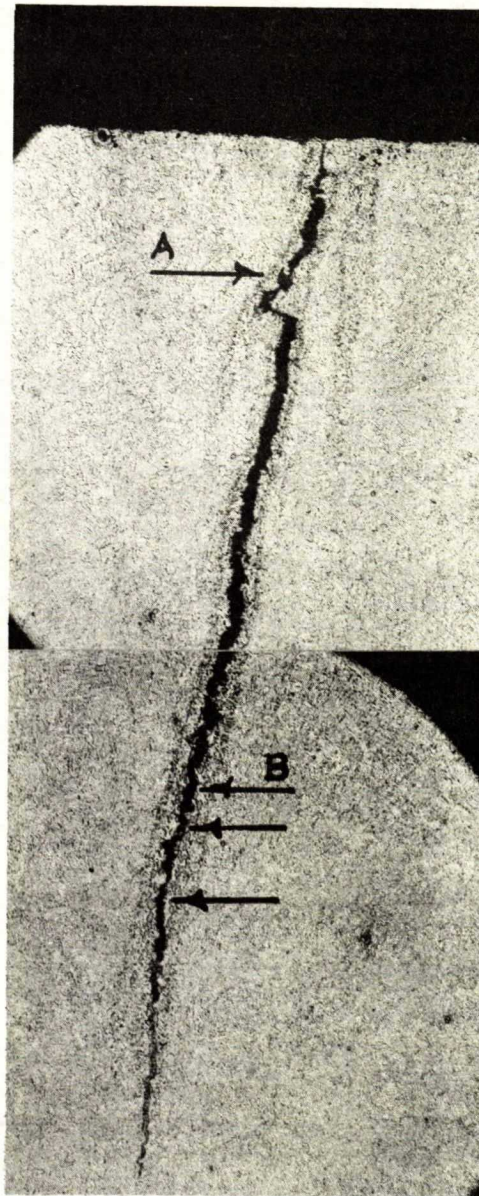
The appearance of the tip of the defect is illustrated in Figure 2. The presence of decarburized metal and spheroidized oxides along this crack shows that the defect originated during manufacture -- not in service. The appearance of the defect suggested that it was a forging lap which had opened during heat treatment\*.

The original defect had not progressed in service but its total depth was of the order of 0.110 in.

Figure 2. - Tip of transverse defect - transverse section.  
The crack is approximately 0.050 in. deep in this section, but 0.060 in. of metal had been removed previously. Decarburization (arrows) and oxides show that this defect originated during manufacture. The crack has not propagated in service.

At the ground surface, visible at the top of Figure 2, the lap consisted of three branches. The crack followed one branch, then

changed direction and followed the longest branch of the defect.

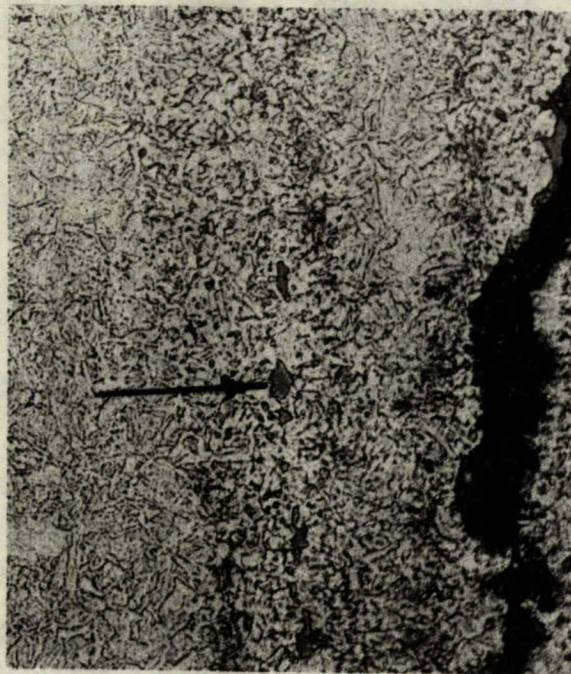
Figure 3. - Area "A" - transverse defect. This photomicrograph illustrates the defect which has cracked and one branch of the defect which has not cracked (arrow).

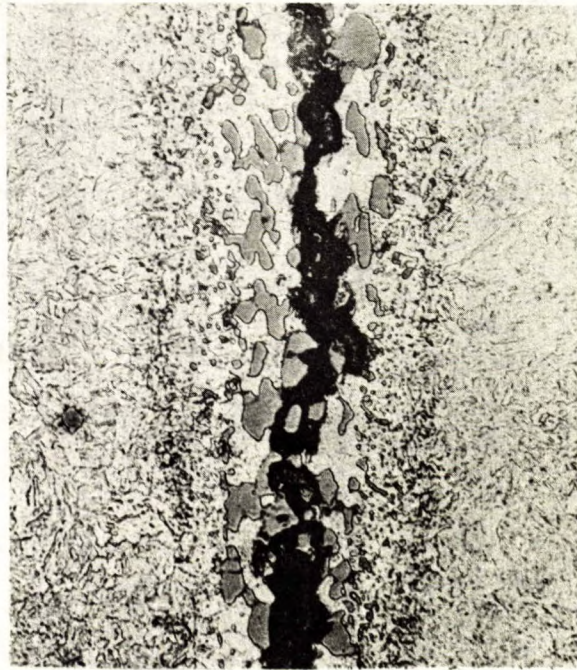
Figure 4. - Area "B" - transverse defect. The appearance of the oxides suggests that the defect formed during forging. Decarburization is visible adjacent to the crack.

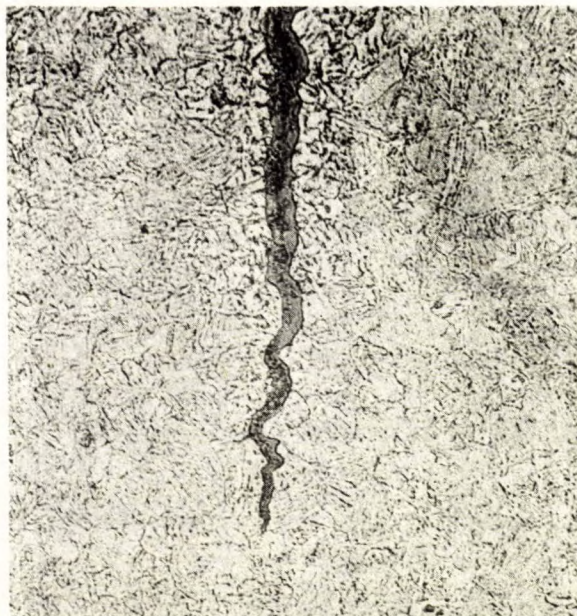
\*The fact that the crack did not extend beyond the lap and the presence of oxide on the crack surfaces (Figure 5) indicate that the crack formed prior to service.

Figure 5. - Tip of the transverse crack. The presence of decarburization and high temperature oxide close to the tip of the crack indicates that in service the crack did not propagate.
