MINES BRANCH INVESTIGATION IR 58-172

# EXAMINATION OF TWO DEFECTIVE MANGANESE STEEL CASTINGS

R. K. BUHR

PHYSICAL METALLURGY DIVISION

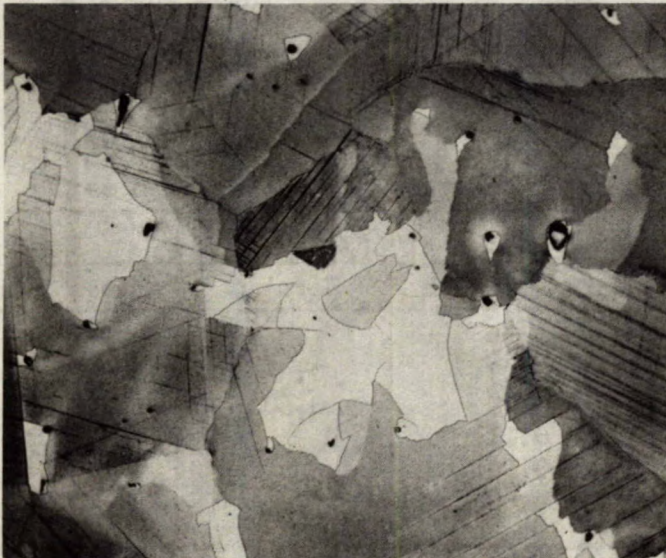
Examination of suitably prepared specimens under a microscope showed that sample #1 had a reasonably fine grain size (Figure 1), but, when viewed at higher magnification, numerous areas were found where a continuous film of fine grain boundary carbide could be resolved (Figure 2). Sample #2 was found to be quite coarse-grained and contained a heavier grain boundary carbide precipitate, as well as small isolated islands of carbide within the grains but near the grain boundaries. Figure 3 illustrates these last remarks.

Figure 1. - Microstructure of sample #1 showing relatively small grain size.

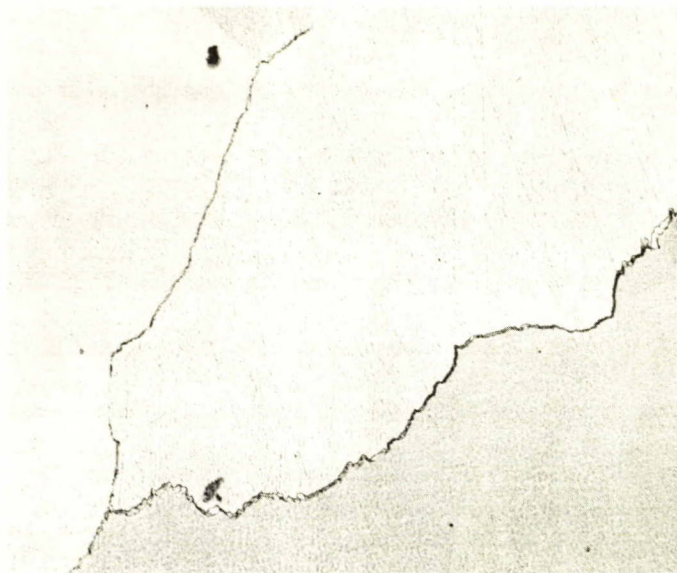
**Figure 2.** - Higher magnification view of sample #1, showing presence of fine continuous film of grain boundary carbide.

The cracking found in both castings is most probably due to the presence of grain boundary carbides. The brittle nature of the carbides could allow for the rapid initiation and propagation of cracks. The only remedy for this is a proper heat treatment. Either a higher austenitizing temperature or a longer soak at the temperature will have to be used. If chromium additions are also increased, then suitable changes in heat treatment will have to be further investigated.

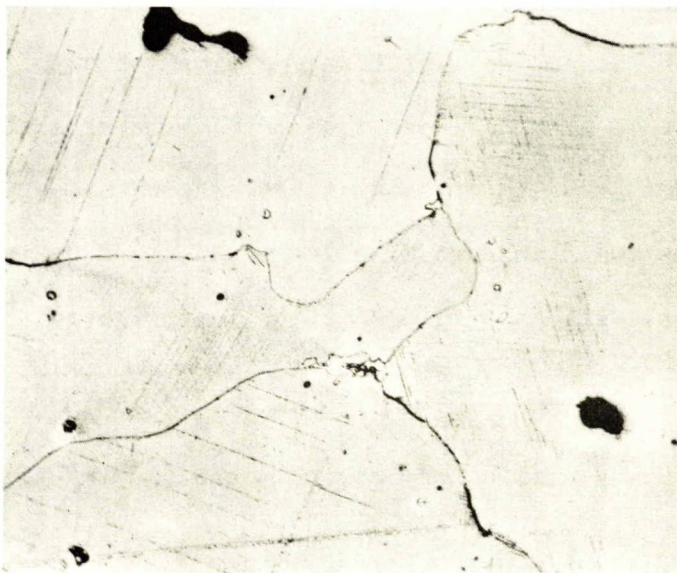
**Figure 3.** - Photomicrograph of field in sample #2, showing relatively large grain size, grain boundary carbides, and small isolated islands of carbides in the grains.
