MINES BRANCH INVESTIGATION REPORT IR 58-174

FAILURE OF PUMP CYLINDER CASTING

R. F. KNIGHT

OCTOBER 15, 1958

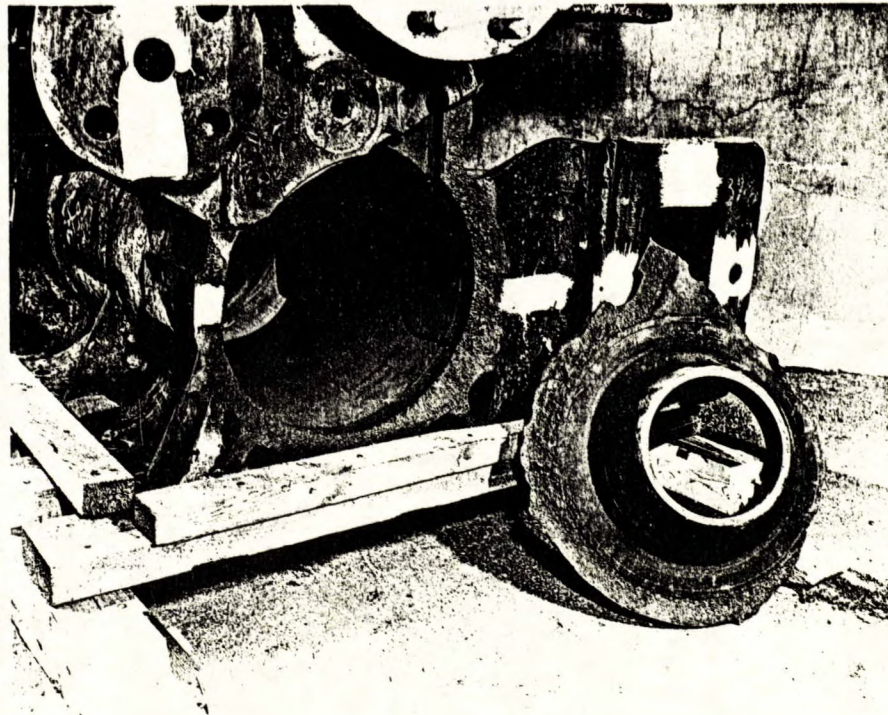
Fig. 1. - Photograph of failed pump cylinder.
Area between arrows shows black material in fracture surface.

The fracture surface appeared normal for cast iron except for several large black covered areas which had the appearance of slag. A section was cut through one of these black areas and the defect was seen to be large. A photograph of the section is shown in Figure 2.

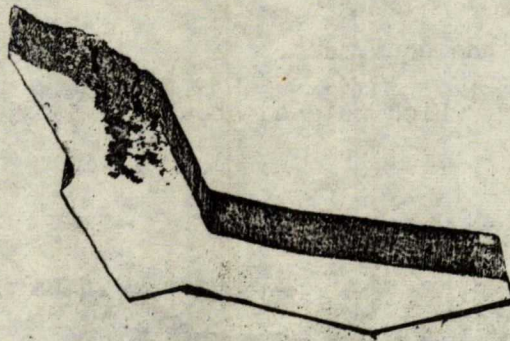
Fig. 2. - Photograph of section through fractured end of casting where black material was evident.

X-ray diffraction studies of the black material revealed it to be mainly magnetite (Fe_3O_4) with a trace of Fe_2O_3 .

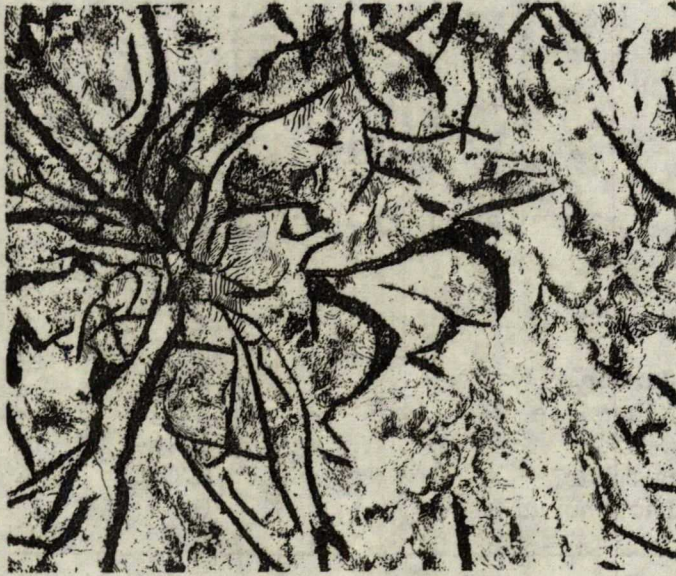
Fig. 3. - General structure BHN 131 shows large graphite flakes and some steadite (phosphide eutectic-mottled area).

The high silicon content of the casting is the primary reason for the large size of the graphite flakes. The phosphorus content was high, but this is to be expected in a casting of this age. The black material found on areas of the fractured surface was seen to be extensive. X-ray diffraction revealed it to be slag, undoubtedly formed in melting and entrapped on solidification of the casting. Microscopic examination revealed no indication of a fatigue failure, and no flaws other than the slag.

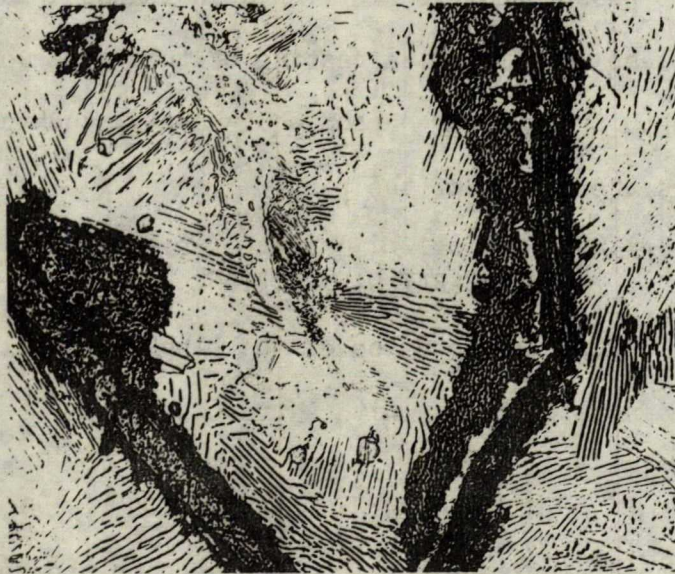
Fig. 4. - Graphite (dark), pearlite (lamellar structure), and steadite (speckled).

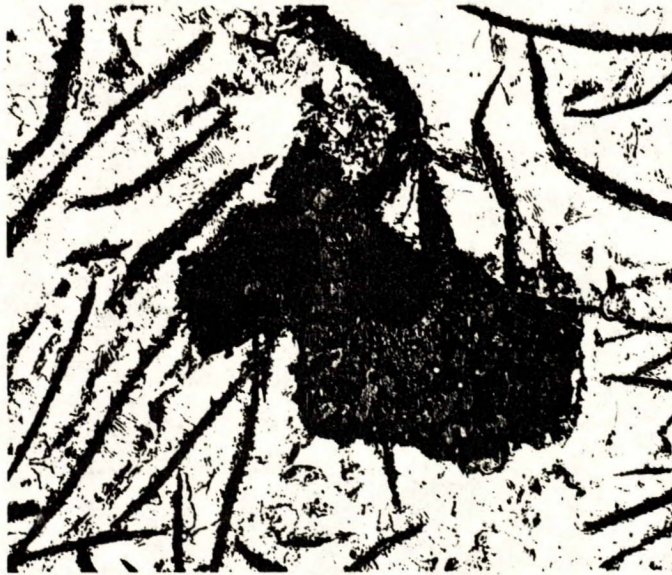
Fig. 5. - Shows an area with an entrapped slag particle.

The presence of entrapped slag and coarse graphite flakes served to weaken the casting, but since it had a service life prior to failure of thirty years, and since the examination revealed no evidence of fatigue, it is felt that the primary cause of failure was overloading.
