MINES BRANCH INVESTIGATION IR 58-181

EXAMINATION OF CAST ALUMINUM ALLOY COVERS FOR
CIRCUIT-BREAKER AND MOTOR-STARTER ENCLOSURES

OCTOBER 23, 1958

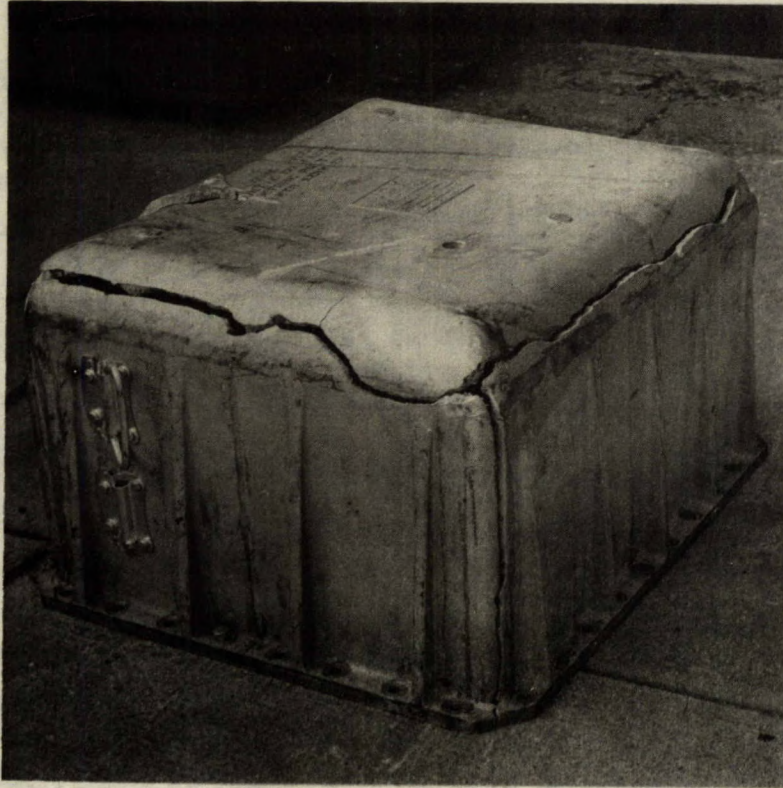
The explosion testing method consisted of detonating a charge inside the motor starter enclosure with the cover in place. Figures 1 and 2 show two views of the parts of the broken cover reassembled approximately into their original positions. It will be seen that the cover failed along the junctions of adjacent faces. One side was broken in half, the top had several shorter cracks and one small piece of the top was broken out (see Figures 1 and 2).

Fig. 1. - View of the parts of the broken circuit-breaker cover reassembled roughly in their original relative positions. Note that failure has occurred at the junction of each face. There are several smaller cracks in the upper face.

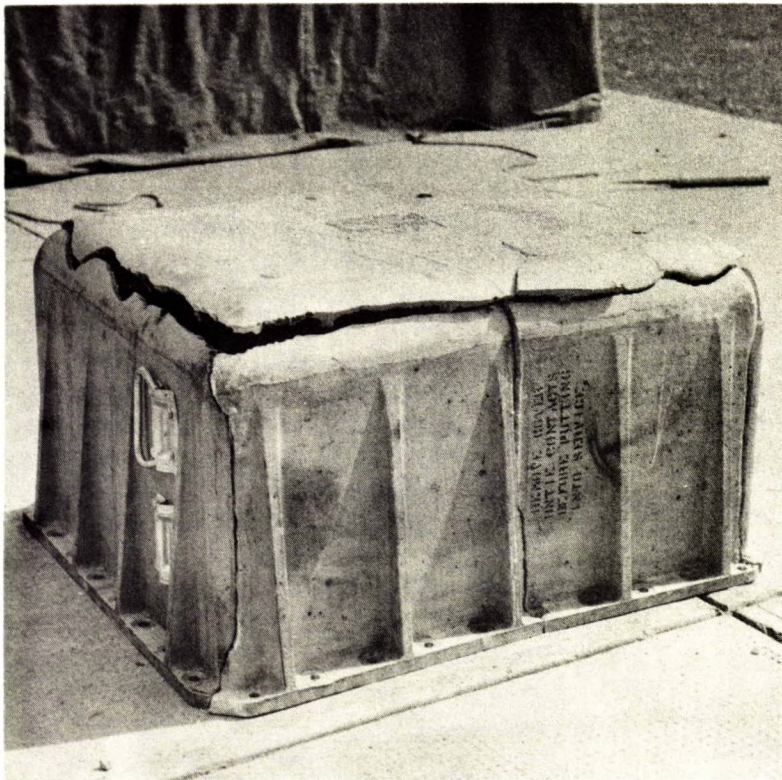
Examination of the fracture surfaces revealed many areas of gross porosity and oxide and dross inclusions. Several of these areas are shown in Figure 4. The corner shown in Figure 4 "A" was extremely unsound and from an examination of the top of the cover and the directions in which the broken parts were thrown and distorted by the explosion it seems probable that failure of the cover started at this corner, which is the one nearest the camera in Figure 2.

Fig. 2. - Another view of the broken cover shown in Figure 1. One face has broken in half. It is probable that failure started at the corner nearest the camera.

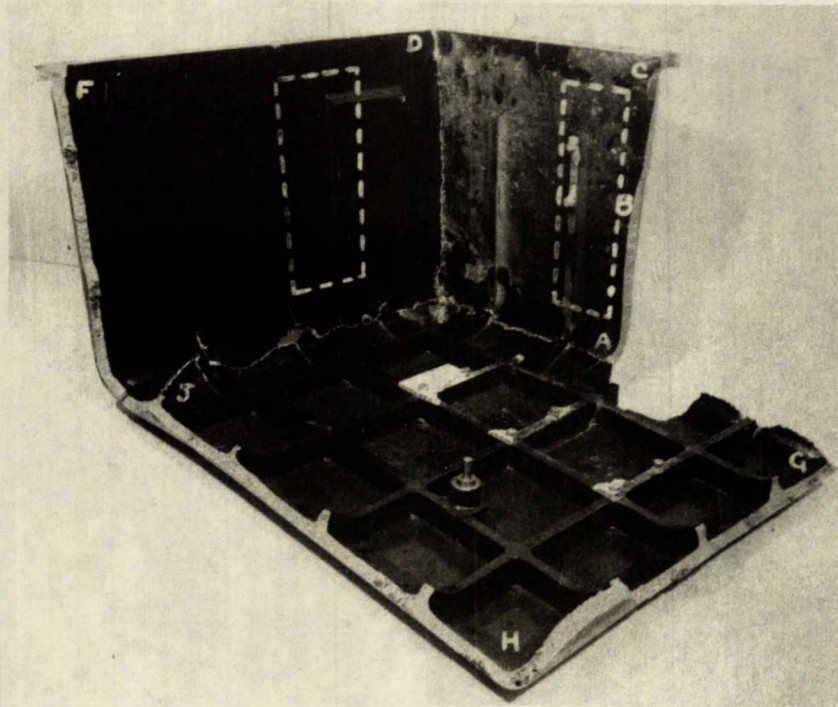
Figure 3 is a view of the inside of the broken cover taken towards the corner nearest the camera in Figure 2. The letters identify x-ray locations (see below) and the areas enclosed by broken lines indicate the sections from which test pieces were machined.

However, gross porosity and inclusions were present at a number of locations in the casting, notably at the edges and corners. In some areas, virtually the whole wall of the casting was unsound. This would be expected to have a particularly bad effect in highly stressed regions of the cover, such as corners, and from an examination of the broken parts it seems likely that failure originated at one such highly stressed, unsound region ("I" in Figure 3).

Fig. 3. - View of the inside of reassembled parts of the broken cover taken towards the corner "I" nearest the camera in Figure 2. Test pieces for tensile testing were taken from the areas enclosed by broken lines.

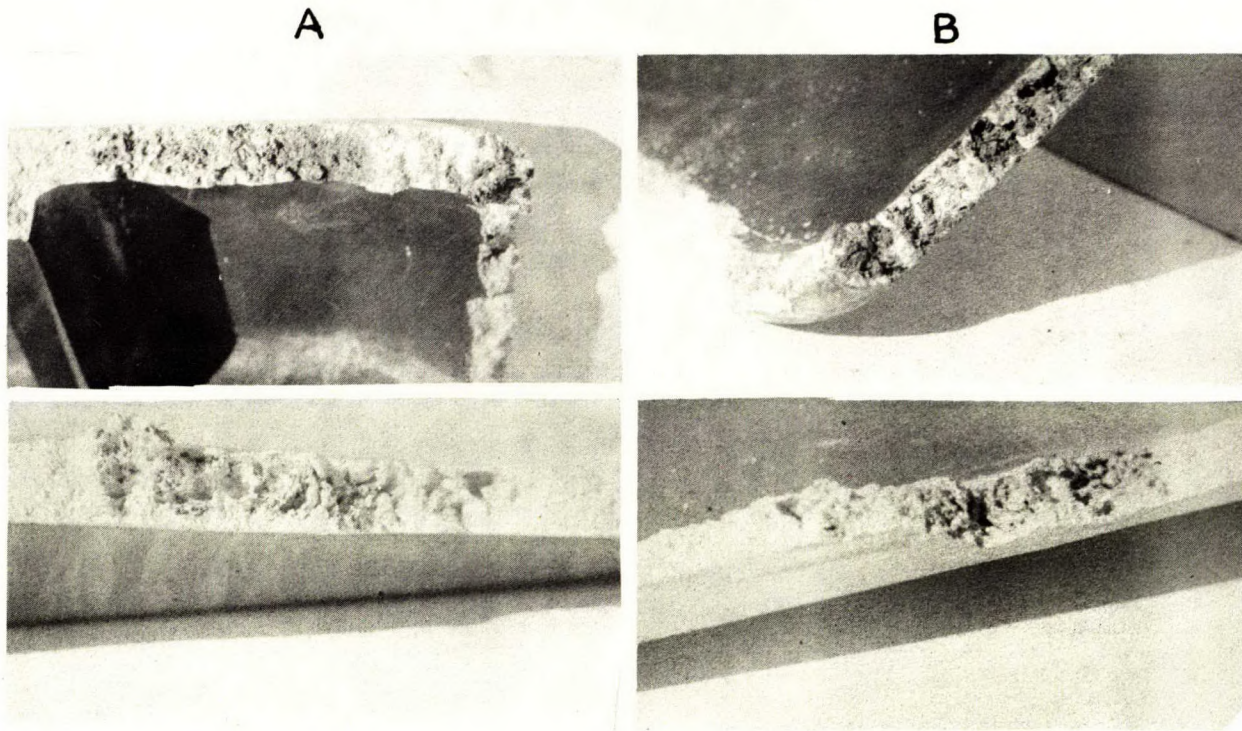
The stresses in the cover would be expected to be higher at the corners and the presence of gross unsoundness would make these regions likely places for failure to start.

Fig. 4. - Views of various parts of the fracture surfaces of the broken cover showing unsoundness and dross inclusions.

It is probable that the unsoundness in the broken casting was due to improper sand control, running, gating or risering, and it is recommended that these aspects of the foundry practice be improved in future castings.

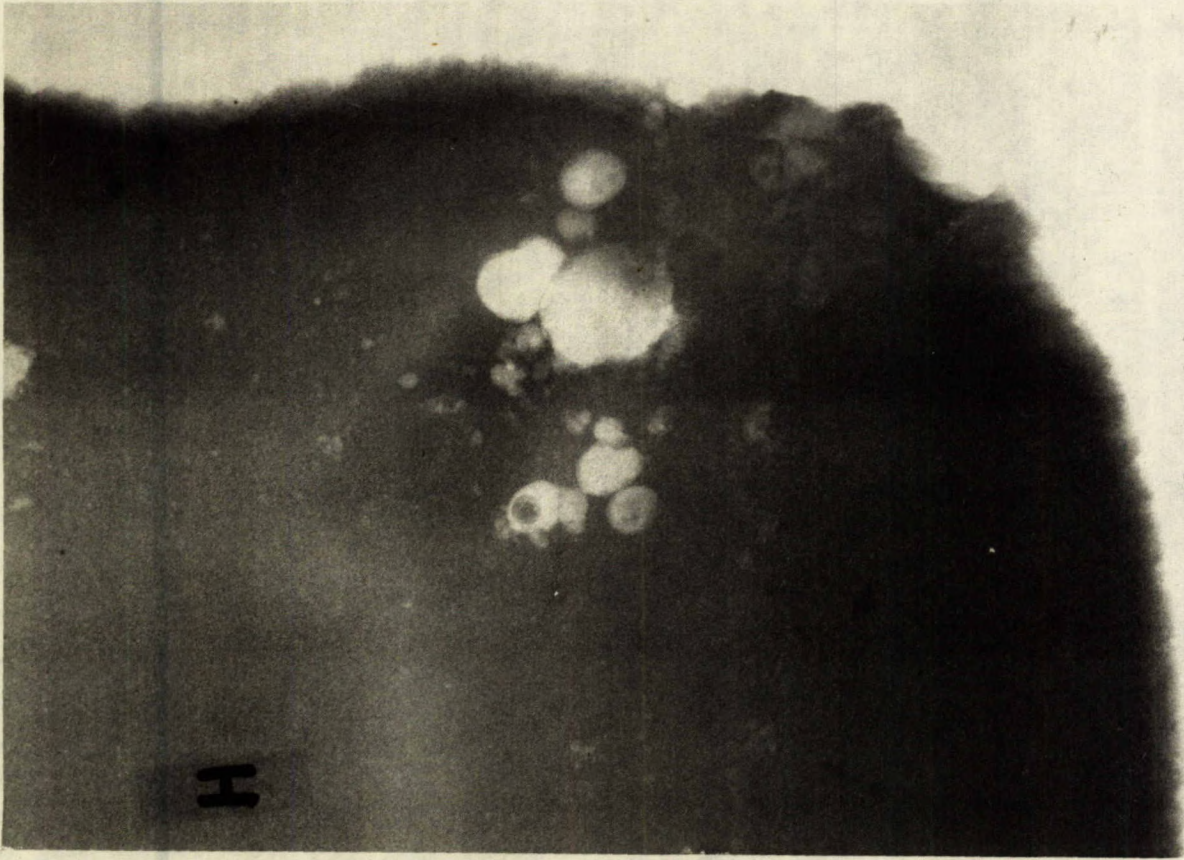
X-ray examination of the parts of the broken cover showed a number of very unsound regions. For example, Figures 5 and 6 are prints from radiographs showing porous areas near corners of the top of the cover. Another very unsound area is shown in Figure 7 which was taken near "F" (see Figure 3). It will be seen that there was very little sound metal in certain sections of the wall.

Fig. 5. - Print from a radiograph of the broken cover near "H"
(see Figure 3) showing gross unsoundness.

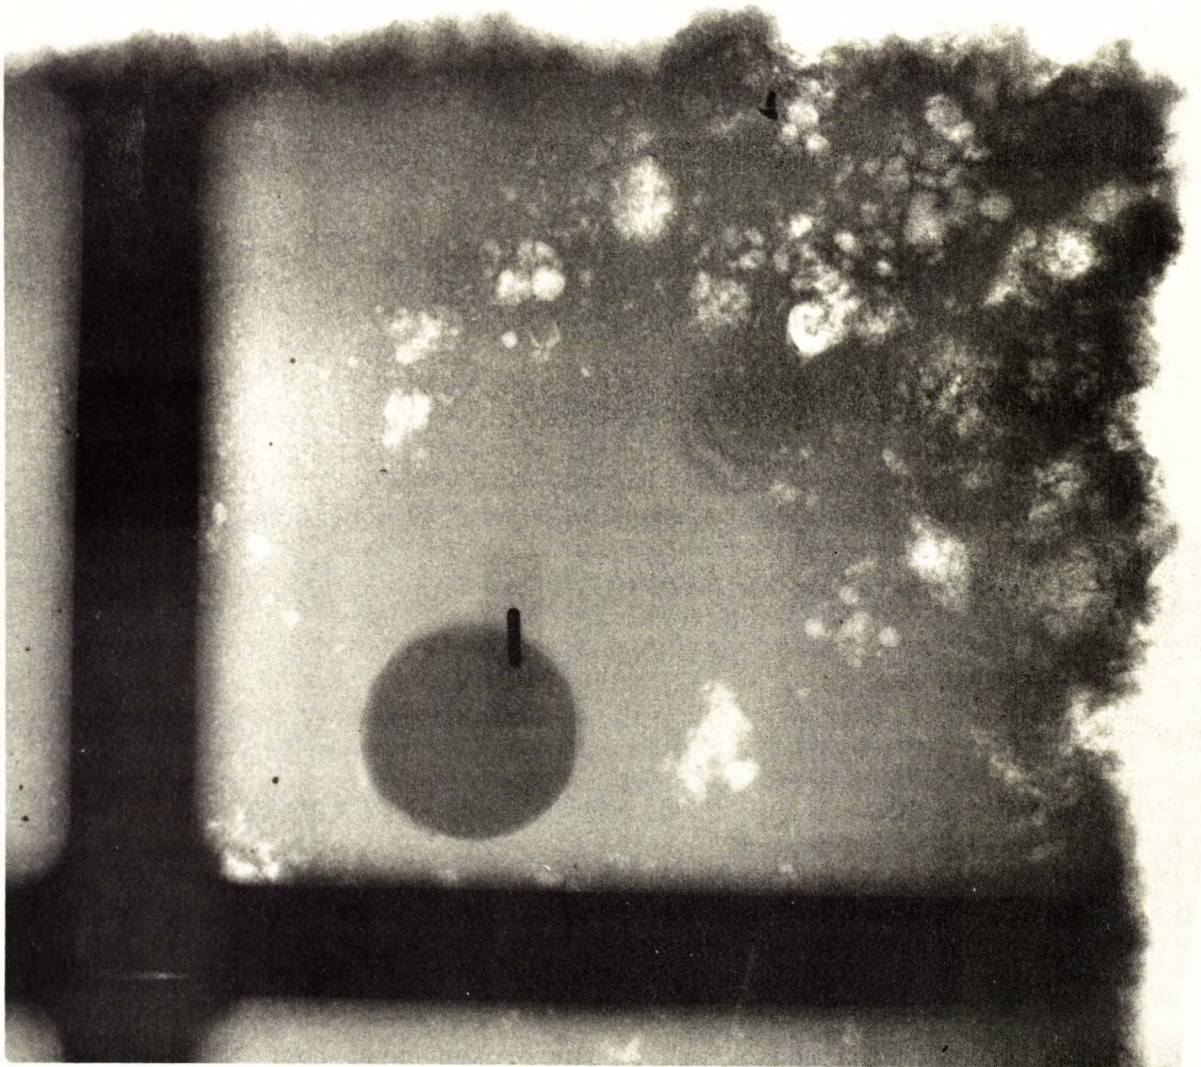
Fig. 6. - Print from a radiograph of the broken cover near "I"
(see Figure 3) showing gross unsoundness.

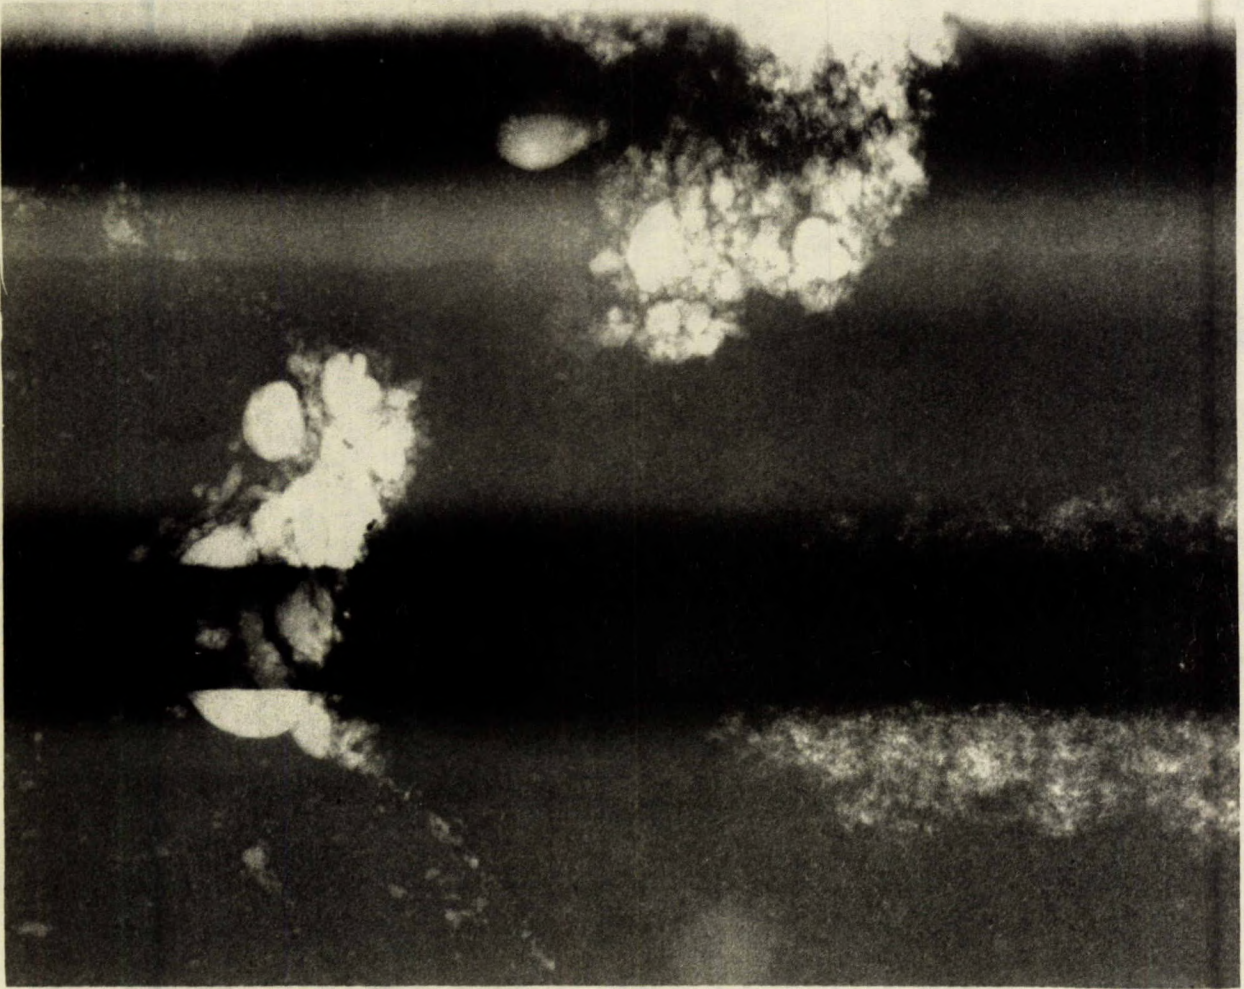
Fig. 7. - Print from a radiograph of the broken cover near "F"
(see Figure 3) showing gross unsoundness.

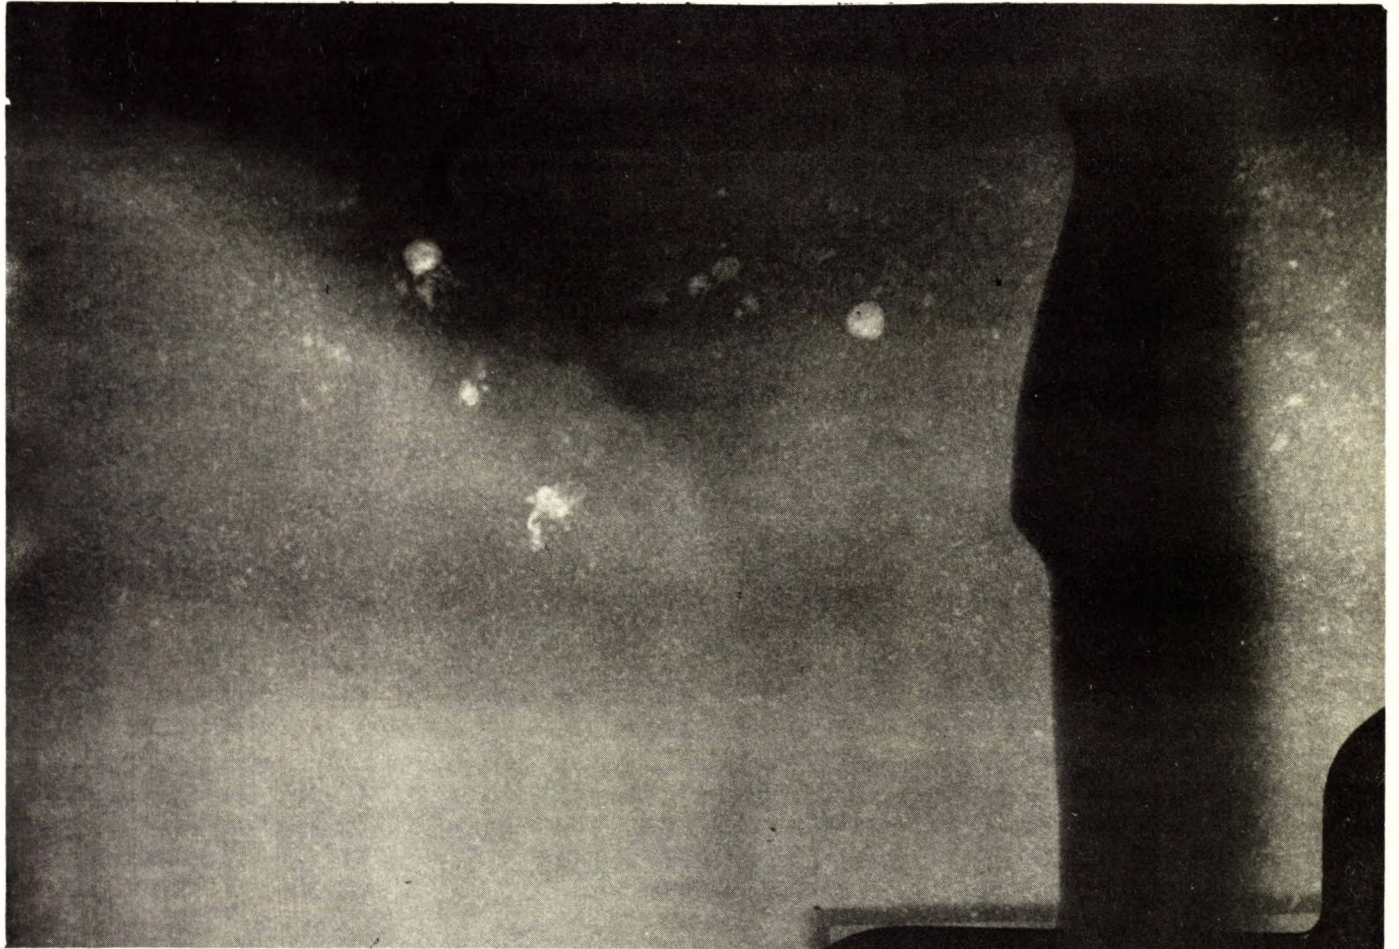
Radiographs of the three unbroken covers showed them to be generally sounder than the broken casting although there were some porous sections (see Figure 8, for example) and in one cover (approximate dimensions 26 in. x 20 in. x 9 in.) very severe microporosity was present throughout (see Figure 9).

Fig. 8. - Print from a radiograph of the smallest (approximately 20 in. x 17 in. x 7 in. deep) cover showing unsound region.

In conclusion, it is suggested that all covers should be radiographed before acceptance, and castings with gross defects (as in the broken cover whose examination is reported here) be rejected.

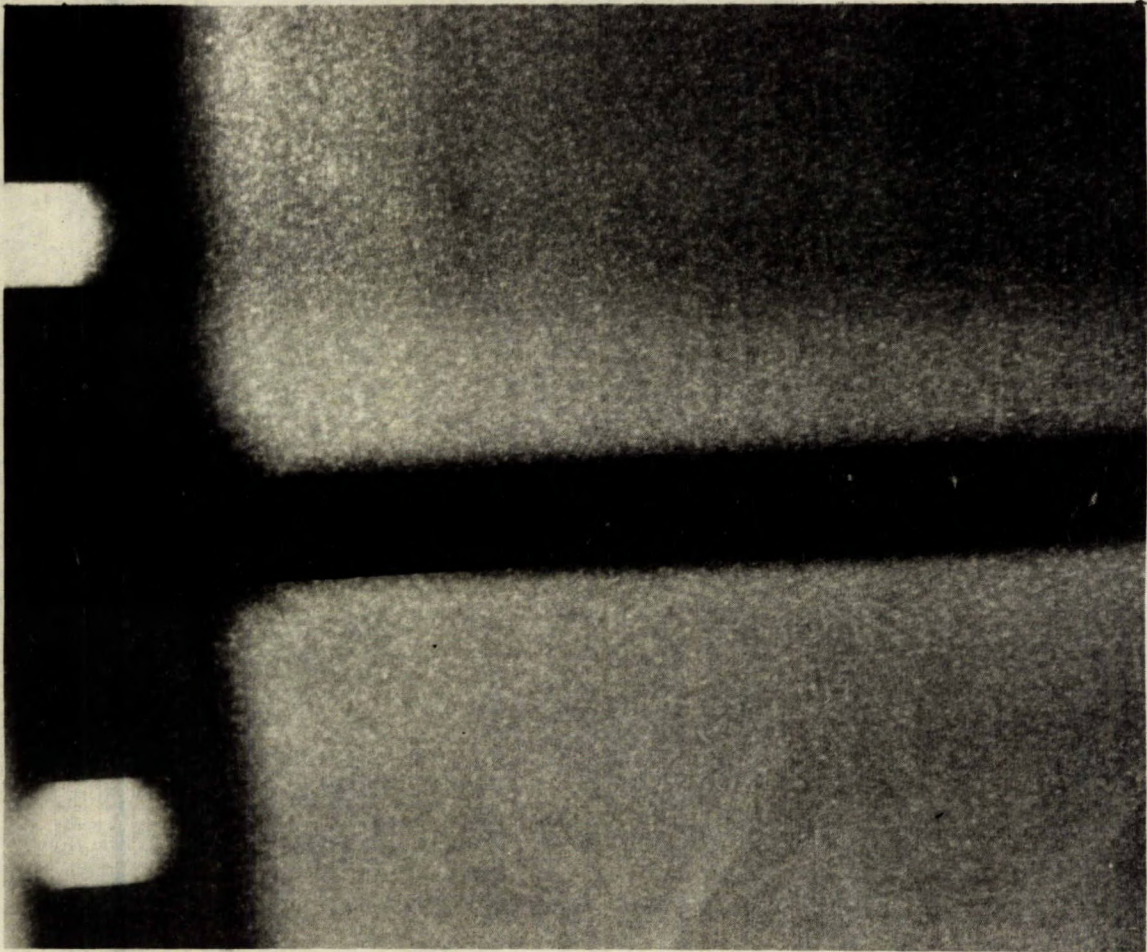
A considerable improvement in soundness was observed in the unbroken castings. In one, (approximate dimensions 26 in. x 20 in. x 9 in.) however, the general microporosity was very heavy, indicating the presence of excessive gas in the melt, which would perhaps lower the mechanical properties below the specified minima.

Fig. 9. - Print from a radiograph of an unbroken cover (approximate dimensions 26 in. x 20 in. x 9 in.) showing severe microporosity.
