MINES BRANCH INVESTIGATION REPORT IR 58-185

EXAMINATION OF FRACTURED MANGANESE STEEL,  
 ROCK CRUSHING HAMMERS

R. K. BUHR

OCTOBER 20, 1958

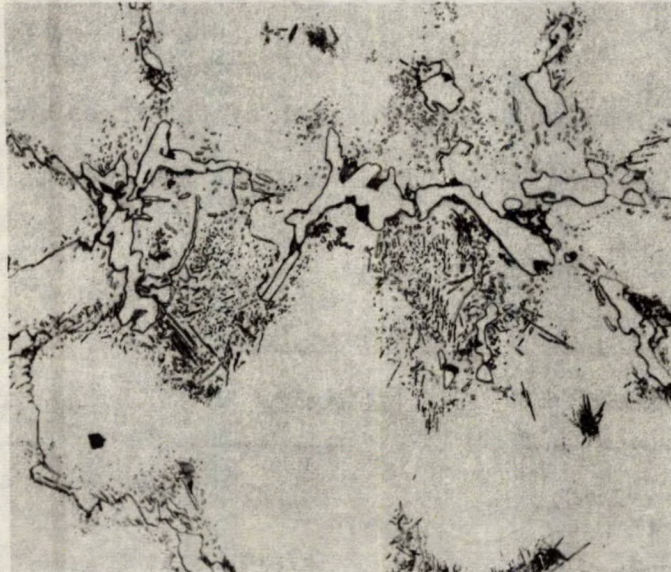
Examination of polished and etched samples showed each of the three hammers to contain large amounts of both grain boundary and massive carbides as shown in Figures 1 and 2.

Fig. 1. - Field from sample "A" showing large amounts of carbide.

The analyses of the hammers are such that it would be difficult to correctly heat treat the castings. The quantity of carbides that would originally be in the castings increases with carbon content, and the chromium content acts to make these carbides more thermally stable. Consequently, a very high heat treating temperature, coupled with an extended soaking period, would be required in order to obtain a completely austenitic structure in these hammers when water quenched.

Carbon	1.30% max.
Manganese	12.5 to 13.5%
Silicon	1.00% max.
Phosphorus	0.060 max.
Chromium	1.50 to 1.80%

A heat treating temperature of 2050°F is recommended for the above analysis, along with a sufficient time at temperature for complete solution of the carbides.

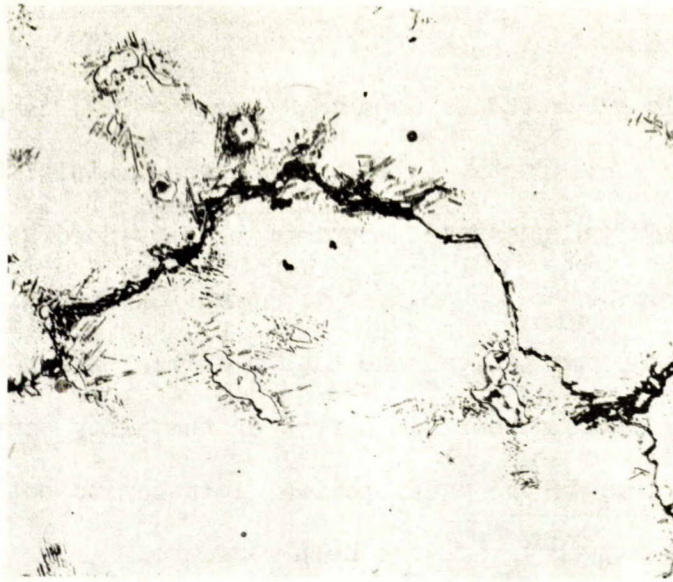
Fig. 2. - Shows intercrystalline path of crack in Sample "C".
