MINES BRANCH INVESTIGATION IR 58-192

PHYSICAL METALLURGY DIVISION

EXAMINATION OF A DEFECTIVE AUSTENITIC
MANGANESE STEEL 5½ FT BOWL LINER

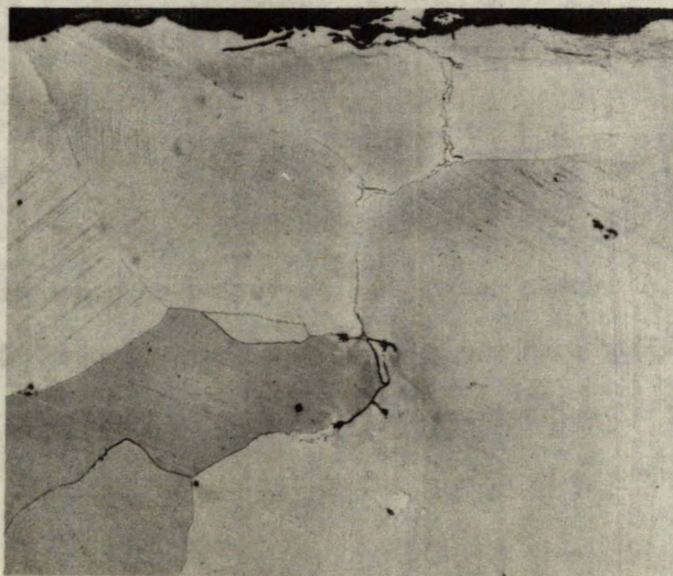
Examination of samples under a microscope showed the steel to be quite coarse-grained. Several areas were found where quite large patches of carbide at grain boundaries could be easily resolved. Figures 1 and 2 are photomicrographs taken at the surface and closer to the centre of the samples examined.

(Etched in 6% nital; X100)

Figure 1. - Area at surface showing large grain size and patches of carbide concentrated mainly at the grain boundaries.

The large grain size and presence of carbides in grain boundaries appear to be the source of the trouble encountered with this casting. It has been shown that the larger the grain size, the greater is the susceptibility to cracking. The presence of the carbides at the grain boundaries increases this tendency to cracking. Consequently, care should be taken to pour the castings with metal as cold as is practicable to ensure a small grain size and to increase either the heat treatment temperature or the soak time at the temperature in use in order to completely dissolve all carbides prior to the water quench.

1. Large grain size and grain boundary carbides were found in the steel, and are believed to be the cause of the trouble.

An investigation has been carried out on a 5½ ft austenitic manganese steel bowl liner which cracked in service. The cause of the cracking is believed to be due to a large grain size and the presence of grain boundary carbides. Lower pouring temperature and a more careful heat treatment were the remedial steps recommended.

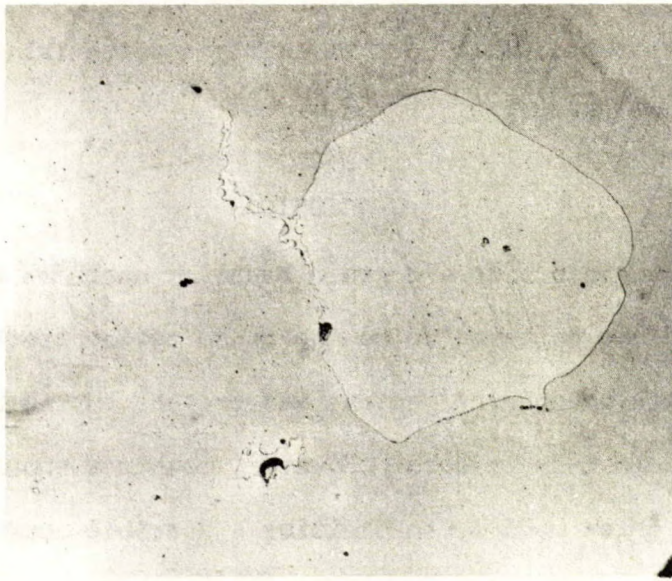
(Etched in 6% nital; X100)

Figure 2. - Same as Figure 1, except area is near centre of sample.
