MINES BRANCH INVESTIGATION REPORT IR 58-193

# METALLURGICAL INVESTIGATION INTO THE FAILURE OF METAL PLATE FROM THE SIDE WALL OF AN AUTOCLAVE

**G. P. CONTRACTOR**  
PHYSICAL METALLURGY DIVISION

OCTOBER 29, 1958

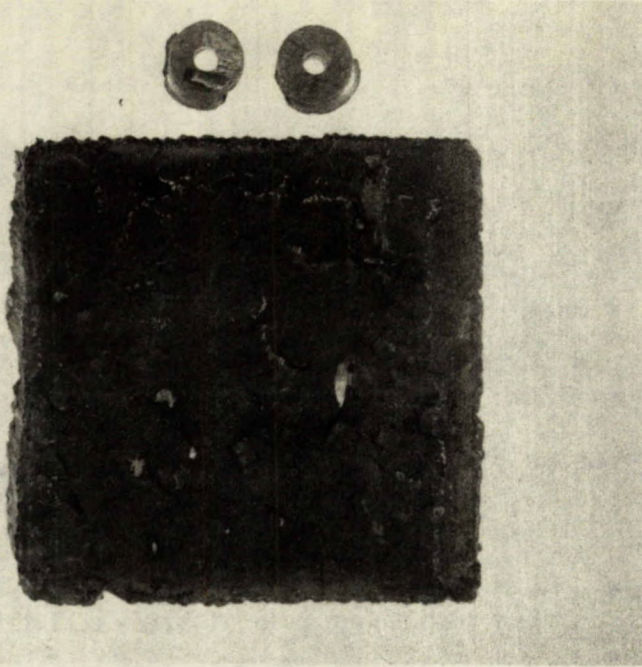
Figure 1 shows the condition of the samples as submitted by the client. The plate sample measured 5 in. square by about 7/10 in. thick. The other two samples were in the form of about 1 in. round lugs. The general surface condition of the plate was poor, being covered with tightly adhering product of corrosion and pitted areas with irregular and "curly" markings, indicating an advanced stage of corrosion. Figure 2 is a photograph of the plate after being sand-blasted and cleaned. It clearly shows the general pattern of corrosion.

Figure 1. - Photograph of the samples of plate and lugs in the as-received condition.

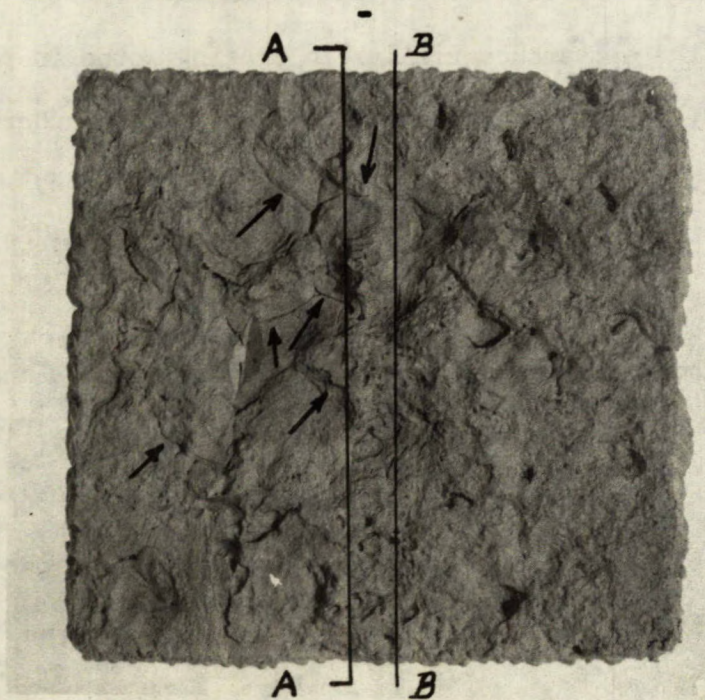
A close examination of the plate (see Figure 2) tends to indicate that the surface had undergone severe pitting erosion, a type of dynamic corrosion, in which the damage or the rate of corrosion is very rapid, resulting in unexpected deterioration of plant process equipment.

What appeared as fine cracks or crazing on the surface of the plate (see Figure 2) was in fact the surface appearance of the metal which had been slightly undercut by the turbulence of the slurry-charged liquid in the autoclave. This was confirmed subsequently by micro-examination of the metal and also by macro-etching of the section cut across the plate.

The corrosion pattern did not indicate any particular direction of the flow of liquid, but was indicative of a whirling agitation. There is little doubt that the corrosion pattern on the plate strongly suggests that abrasion conditions were present in the vessel, and that the rate and type of corrosion may have been affected by the quality of the plate material.

Figure 2. - Photograph of the plate after being sand-blasted and cleaned. Note the presence of what appeared to be cracks (arrows), and the areas of large and small corrosion pits.

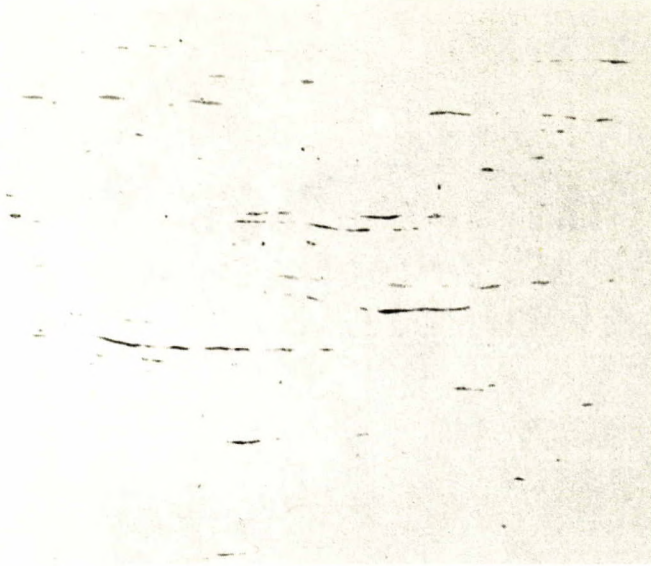
Metallographic examination of the unetched microsections cut across the plate showed the presence of a fairly large amount of non-metallic inclusions (Figure 3) in the form of stringers of sulphides and oxides. The amount present, however, is the usual distribution found in commercial semi-killed steels. Segregation impurities or their solid solutions in steel as well as stress, either applied or residual, are notable for their ability to form anodic areas. In the present case, it is likely that the presence of the inclusions may be responsible, to some extent, for accelerating the rate of corrosion, and for giving rise to crack-like formation (crazing) on the badly pitted surface of the plate.

substantial velocities, solid in suspension (i.e. slurries), marked turbulence, and impingement. Some of these conditions were certainly present in the autoclave. Furthermore, it is likely, as stated before, that the presence of non-metallic stringers (Figure 3) in the plate metal may have accelerated the rate of corrosion, and may have contributed to the crack-like (crazing) formation or pattern on the corroded surface.

Figure 3. - Photomicrograph of the plate metal showing stringers of non-metallic inclusions.

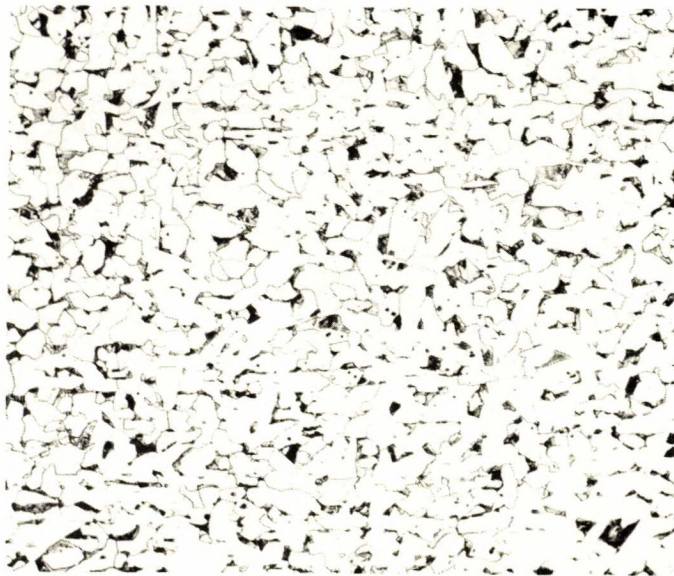
The microstructure of the plate was normal (Figure 4) and consisted of uniformly distributed grains of ferrite and areas of dark lamellar pearlite. Figures 5, 6, 7 and 8 show the cross-sectioned microstructure of the pitted surface and the metal underneath the

Figure 4. - Microstructure of the plate metal showing grains of ferrite (white) and pearlite (dark).

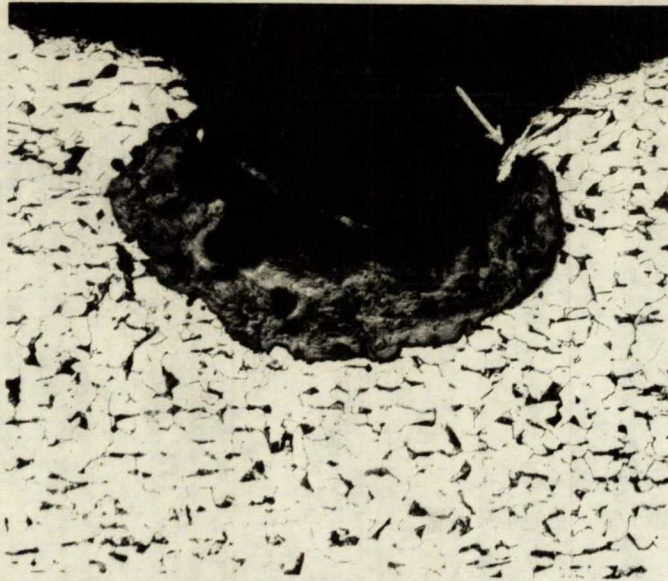
surface. It was observed that in general the pits (Figures 5 and 6) were of various sizes and shapes, and were randomly scattered.

One of the most significant aspects of microexamination was the evidence that displacement and distortion of ferrite grains (see Figures 5, 7 and 8) had taken place in the metal adjacent to the corroded surface. This is strongly suggestive of the mechanical nature of damage. In other words, it was obvious that the plate was subjected to the combined action of pitting and erosion corrosion.

Figure 5. - Photomicrograph showing a typical corrosion pit. Note the presence of distorted grains of ferrite (arrow).

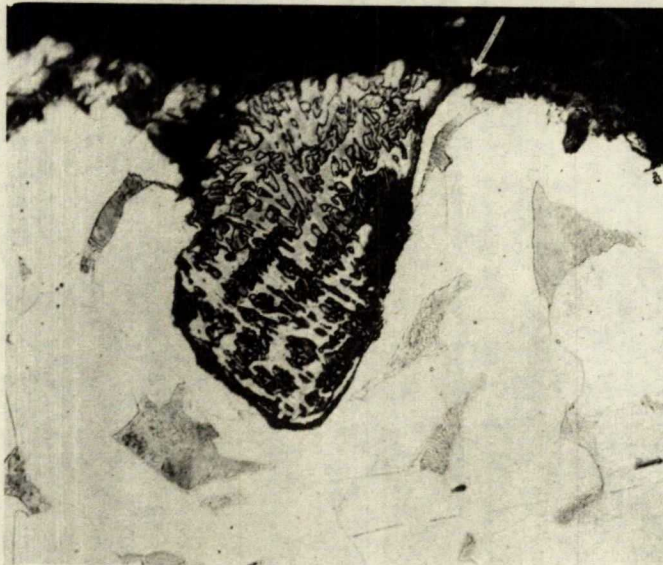
Figure 6. - Photomicrograph showing a very fine pit filled with either slurry or corrosion product. Note the distorted ferrite grain (arrow).

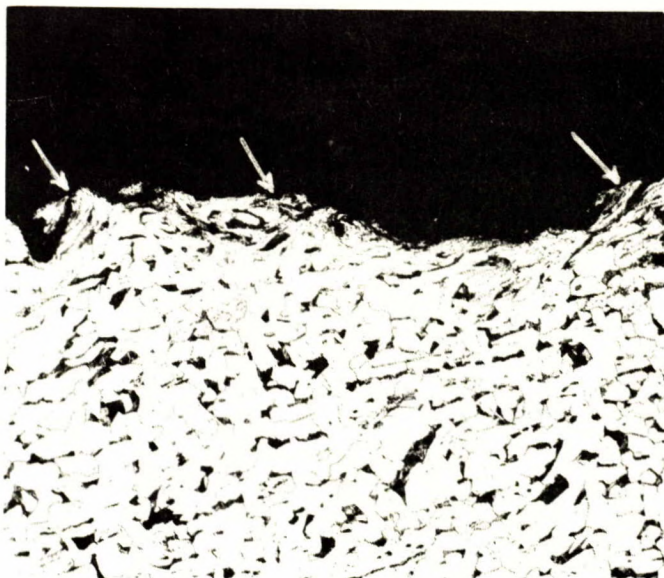
Figure 7. - Photomicrograph showing the cross-sectional appearance of the pitted surface. Note the pronounced distortion of grains (arrows) near the surface.

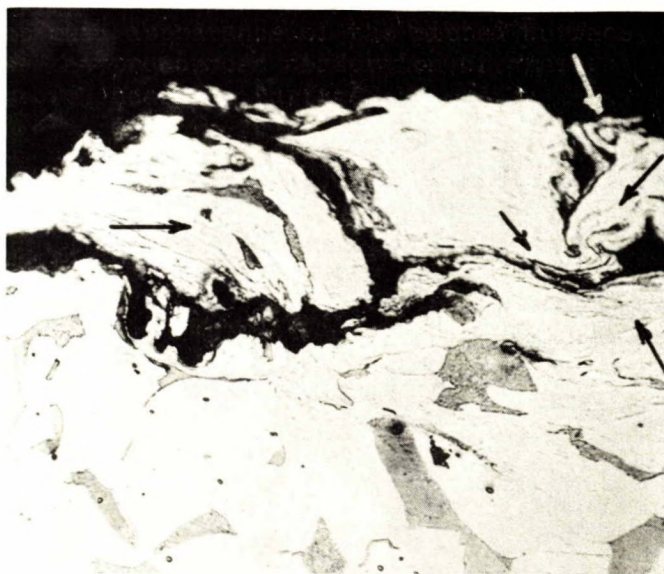
Figure 8 clearly illustrates the mechanism of corrosion in the present case. It tends to indicate that the impact of rapidly agitating slurry<sup>\*</sup> in the autoclave has torn out a part of the plate, and has caused plastic flow or deformation of the metal grains. This cycle repeats many thousands of times. In case of relatively low strength metal, like the mild steel plate under investigation, erosion would be resisted for a period of time, but breakdown of large areas that acquire the appearance of pitting takes place followed by erosion if abrasive conditions are present, such as liquids moving at

Figure 8. - Photomicrograph showing the tearing of surface metal and also how it is deformed by the impact of agitating slurry. Arrows indicate distorted metal.

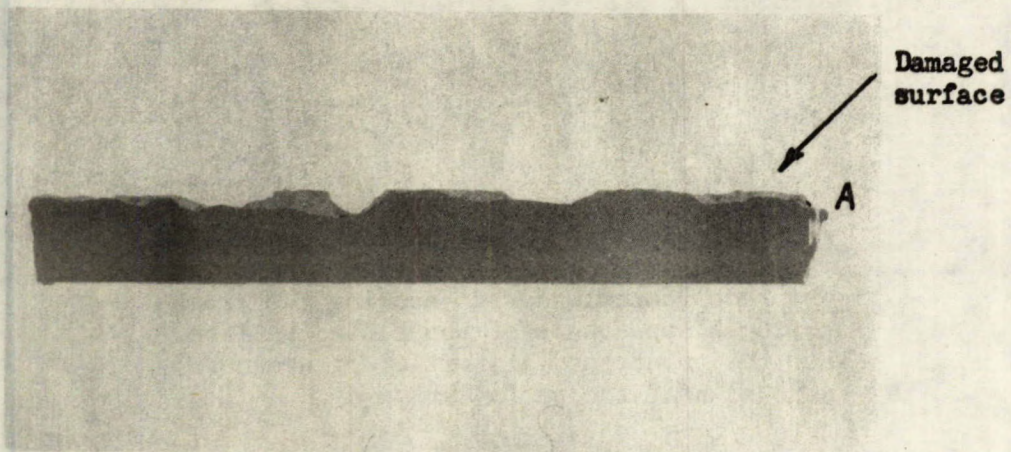
A transverse section of the plate along AA-BB, Figure 2, was etched in 1:1 HCl at 165°F for about 30 minutes. The results (Figure 9) showed a clean, uniform structure without any evidence of piping, macro-segregation or the presence of cracks extending from the damaged surface to the interior.

Figure 9. - Transverse section along AA, Figure 2, deep-etched in 1:1 HCl. Note the absence of piping, macro-segregation or crack formation from the surface to the interior.
