DEPARTMENT OF MINES AND TECHNICAL SURVEYS

MINES BRANCH INVESTIGATION REPORT IR 58-194

## EXAMINATION OF SEAM DEFECT IN COPPER TUBING

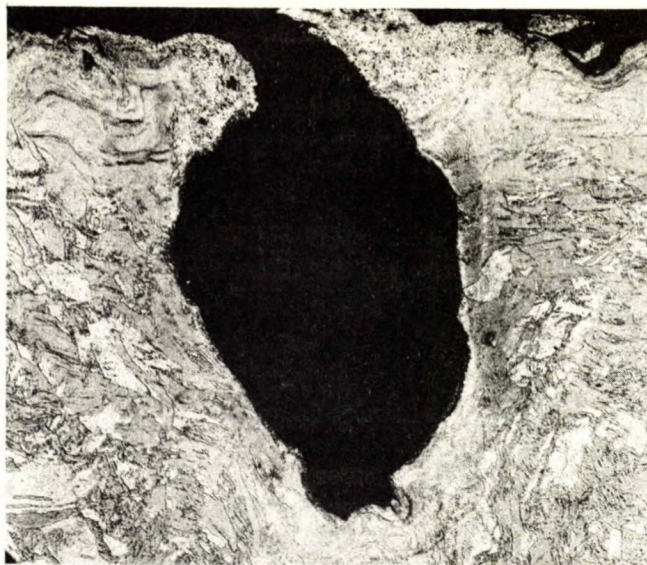
The gross nature of the seam midway in its length, where penetration up to about two-thirds of the wall thickness had occurred, is shown in Figure 1. The cross-section shape of the opening and the more severe deformation evident around the bottom, suggests that the powder material was contained in the metal and was not subsequently deposited during the fabrication process.

Origin of the seam defect appears to have been related to entrapment of a piece of refractory, presumably from the furnace lining during billet manufacture; during tube drawing operations, the inclusion was distributed as a continuous stringer. The otherwise sound quality of metal in the tubing suggests that the defect in the sample submitted was an isolated occurrence and that other material from the same batch was probably not affected. Similarly, the absence of all but traces of the original inclusion suggests that it was not wetted appreciably by the metal; being brittle it would become powdered and would eventually fall free of the crack during drawing.

(Etched 2 sec in alcoholic  $\text{FeCl}_3$ ; X100)

Fig. 1. - Section through seam midway in its length showing gross separation and severely deformed structure around seam walls. Penetration on this plane was almost two-thirds of wall thickness.

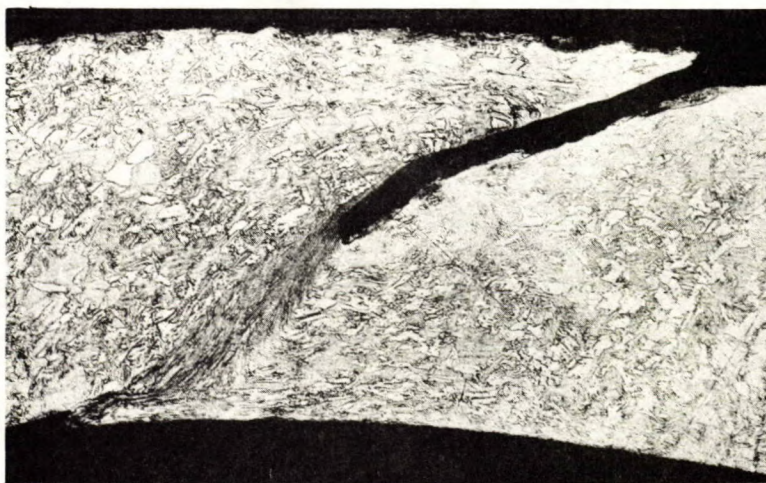
A section near one end of the seam is shown in Figure 2. In this area, pronounced shearing deformation occurred beyond the end of the seam and this resulted in formation of a crack on the inside wall. The relative movement of metal in this area during fabrication thus accounts for the ridge defect which was found extending for some distance along the inside of the tubing. Microexamination of this and

other samples taken at and near both ends of the seam failed to reveal any evidence of other inclusions. This suggests that the defect was caused by one discrete piece of material rather than generally poor metal quality.

(Etched 2 sec in alcoholic  $\text{FeCl}_3$ ; X50)

Fig. 2. - Section near one end of seam showing shear deformation band beyond seam front terminating in a crack and a ridge on the internal surface. This photomicrograph was taken looking towards opposite end of tubing to that for Figures 1 and 3.

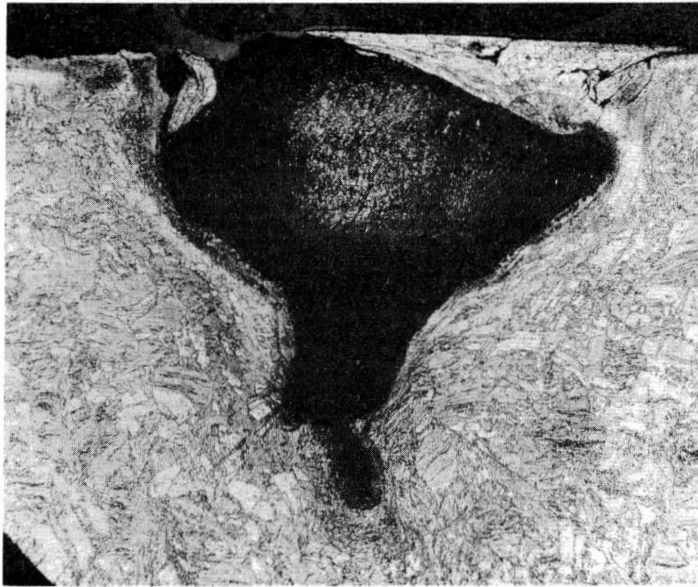
A section through one of the iron particles found on the surface is shown in Figure 3. As illustrated on this typical plane the particle was essentially contained near the surface. This, and also the fact that it did not appear to be associated with the deformed metal around the base of the seam, suggests that the particle was forced into the seam at some stage when the latter was well developed.

While no explanation can be offered for presence of the tramp particles of iron right at the seam on the surface of the tubing, it is not considered that these were directly involved in formation of the seam. This is supported by the fact that the seam extended for some distance to either side of the particles. In

addition, these were located at some distance above the base of the seam, where metal deformation had been considerably affected by the unyielding material contained therein. The iron particles may have been associated with the original refractory inclusion, but a more likely explanation is that they were picked up during the final drawing operations.

(Etched 2 sec in alcoholic  $\text{FeCl}_3$ ; X100)

Fig. 3. - Section through iron particle showing its location near surface. Most severely deformed metal around bottom of seam is some distance from base of particle.
