MINES BRANCH INVESTIGATION REPORT IR 58-196

METALLURGICAL EXAMINATION OF CORRODED BRASS BELLOWS

G. W. TOOP

PHYSICAL METALLURGY DIVISION

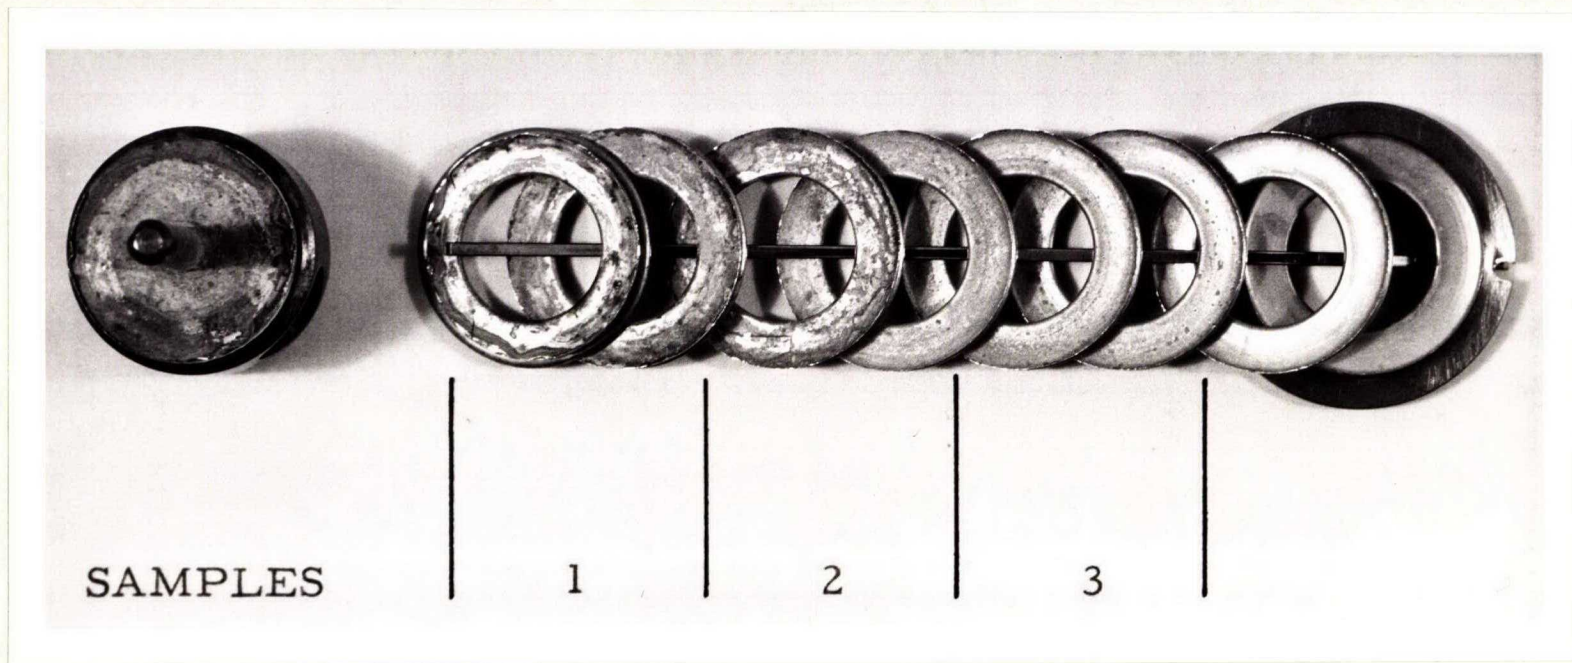
The U.S. bellows exhibited extensive internal corrosion which increased toward the bottom of the bellows (see Figure 1). The corrosion products were green and blue in color, and metallic copper stains on the underlying brass indicated dezincification.

A qualitative test for chloride ion, and sulphate radical was performed on the corrosion products of selected Canadian and U.S. bellows. Three samples, as shown in Figure 1, were immersed in acidified solution to dissolve the corrosion salts.

The addition of silver nitrate to a nitric acid solution of the corrosion salts, indicated positively the presence of chloride ion in both the Canadian and U.S. bellows. However, chloride ion in the Canadian samples was barely detectable, whereas the U.S. samples gave a heavy positive indication of chlorine which increased toward the soldered bottom bellows.

Figure 1. - Dismantled U.S. bellows showing increased corrosion toward the soldered bottom bellows. The corrosion products of three samples, as shown, were tested qualitatively for chloride ion and sulphate radical, for both U.S. and Canadian bellows.

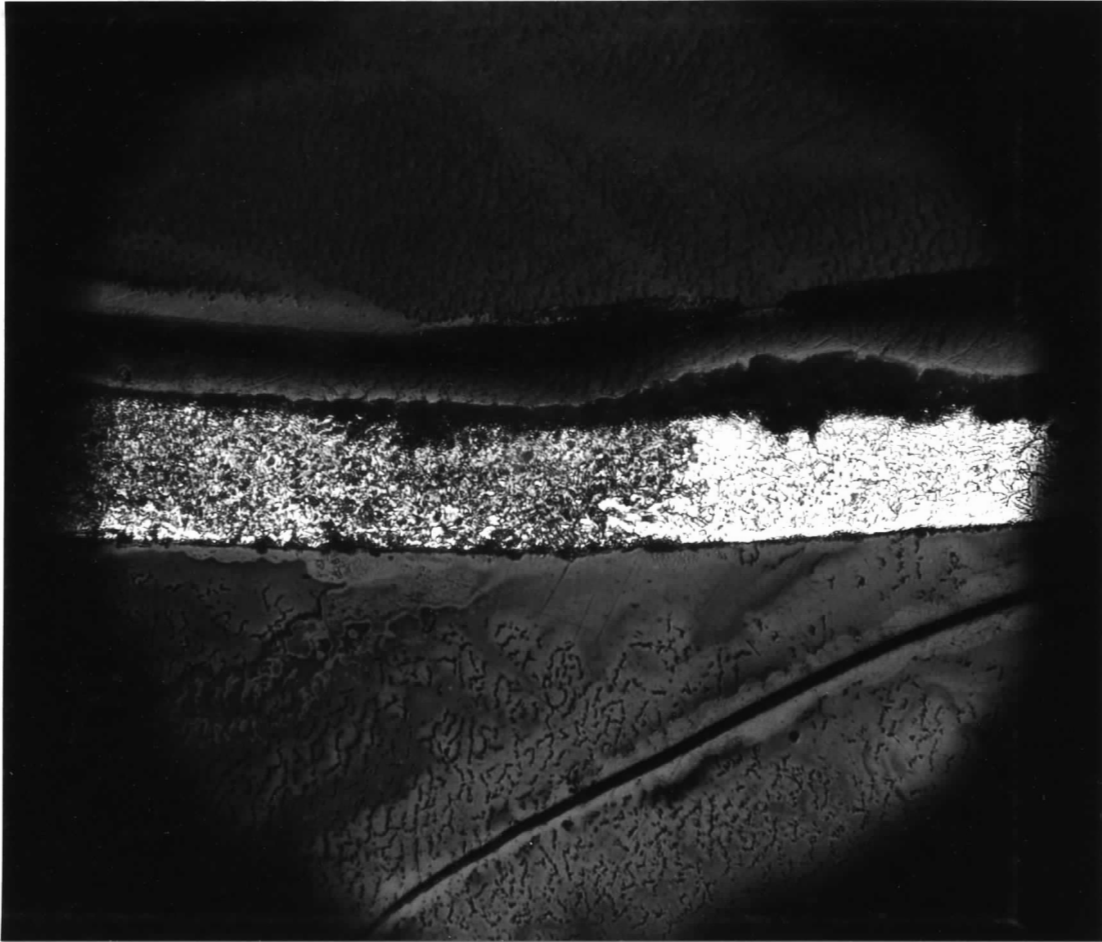
Cross-sections of some of the corroded bellows were examined under a microscope. The U.S. samples showed advanced dezincification (see Figure 2). The Canadian samples showed considerably less attack (see Figure 3).

The presence of appreciable chlorine in the U.S. bellows indicated not only that washing of the soldered parts had been inadequate, but that the washing medium had distributed some of the soldering-flux chlorides to the upper part of the bellows.

The microsection of the U.S. bellows, Figure 2, shows advanced dezincification of the walls of the bellows and it is

evident that other U.S. bellows in a similar condition are not reclaimable.

Figure 2. - Cross-section of U.S. bellows. Note dark-coloured spongy mass of copper, indicative of advanced dezincification, extending completely through the bellows wall.

For subsequent production, it is apparent that a very vigorous washing of the bellows, such as might be obtained with a jet of water, is necessary, or a soldering procedure utilizing a less active flux could be adopted.

Fused zinc chloride residues are best removed⁽¹⁾ by washing with boiling water containing a few drops per gallon of muriatic acid. The acidified water removes the crust of zinc oxychloride which retards the removal of the residue beneath. A subsequent water wash should remove all corrosive materials.
