MINES BRANCH INVESTIGATION REPORT IR 58-206

EXAMINATION OF INDUCTION WELDED STEEL PIPE

W. P. CAMPBELL

PHYSICAL METALLURGY DIVISION

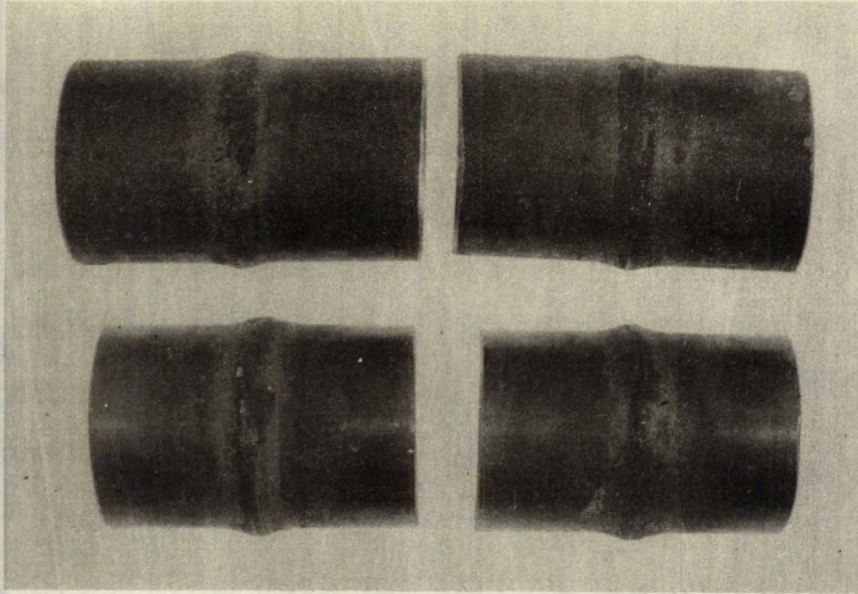
Figure 1 - Outer Surface

Figures 1 and 3, typical of the appearance of the external surfaces of the samples, show that the joint surface is clearly outlined by a sharp line, usually at the centre of the upset portion. At some locations, closer examination particularly with a magnifying lens, suggests that some lack of adhesion may be present. However, no definite conclusions as to the overall joint quality were possible on the basis of visual examination.

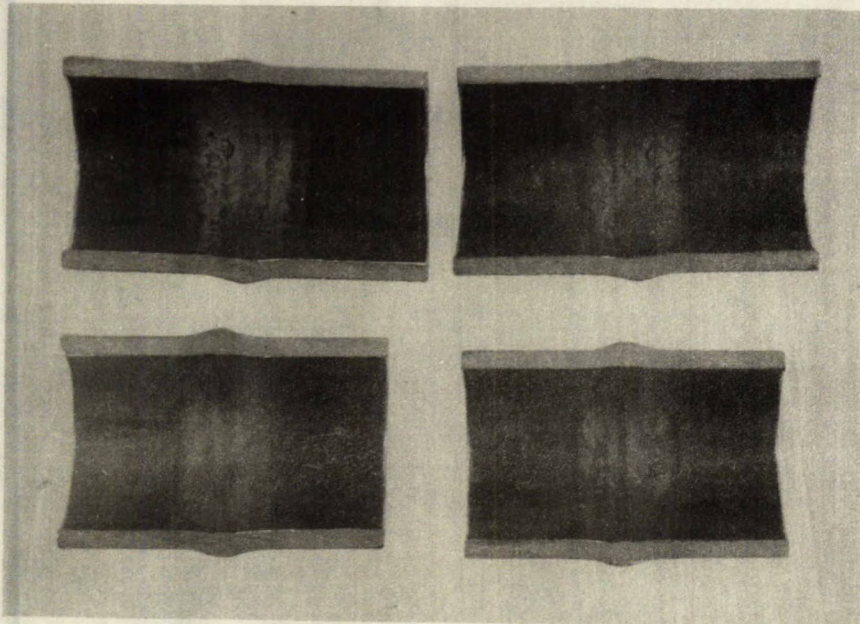
Figure 2 - Inner surface of samples
shown in Figure 1

Some outward flaring of the pipe occurred during the upsetting as illustrated by Figures 2 and 4. Good flow conditions should result from this type of internal configuration. No evidence of joint deficiency was noted on examination of the "as welded" surface at the interior of

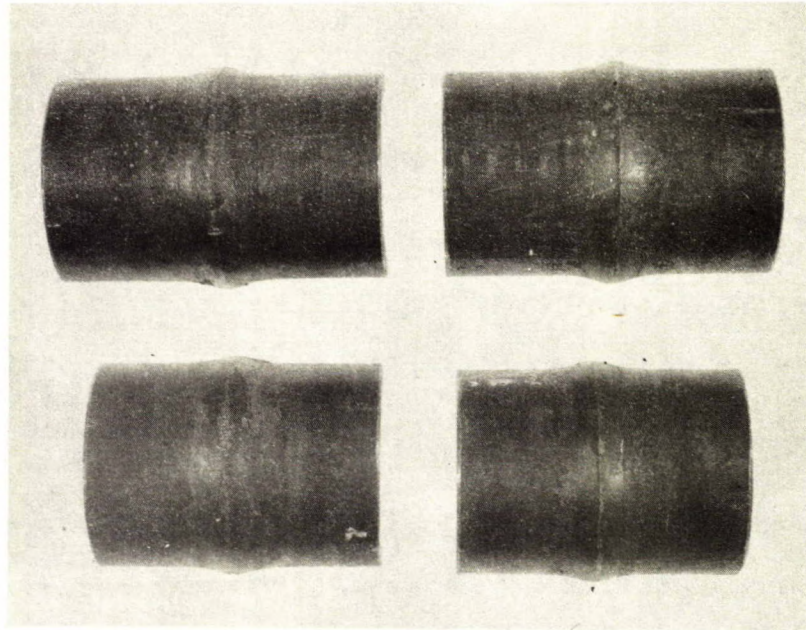
Figure 3 - Outer Surface

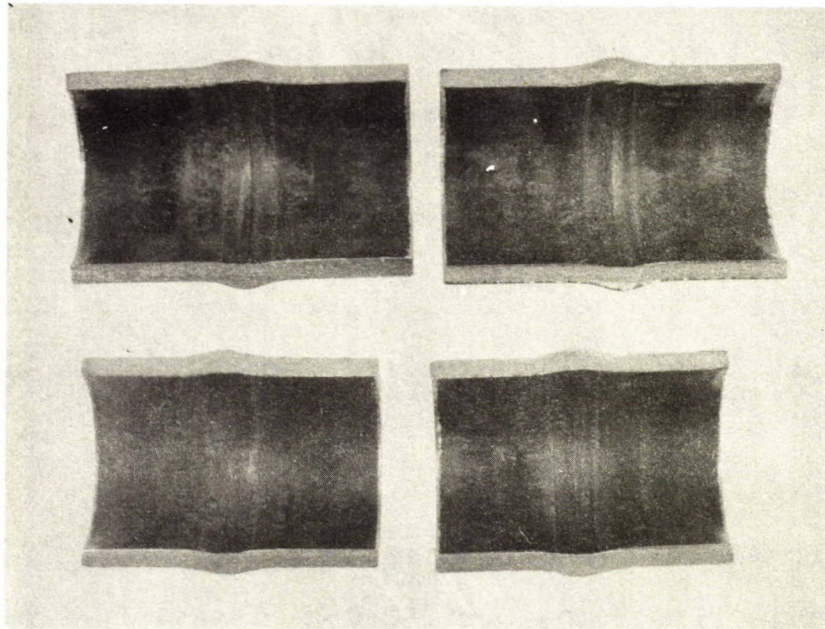
Figure 4 - Inner surface of samples
shown in Figure 3

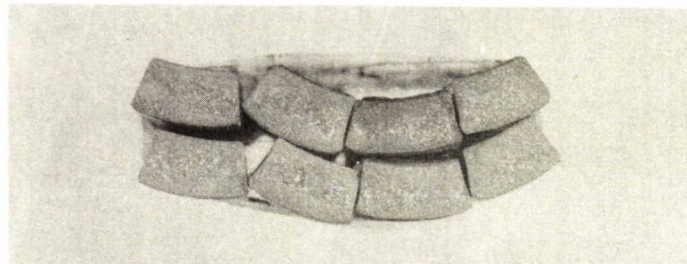
All eight bend specimens from pipe number (A...) failed in a brittle fashion after bending usually only a few degrees and at the most 45 degrees. The fractured surfaces had areas of distinctly different appearance as shown in Figure 5.

Figure 5 - Typical fractured bend test specimens from sample (A...)

Bending of strips from three samples was found to be a revealing test of weld quality. In two of the samples thus tested, a tendency for separation at the joint interface on the external surface was noted. This was associated with oxidation at the interface such as shown in Figures 6 and 7. As judged by the requirements of ASME Section IX, Para. Q 8(e), one of the samples would be considered to have failed the bend test. Heavier and more continuous oxidation across the interface such as illustrated by Figures 8 and 9 is considered to be the chief reason for the extremely poor performance in root and face bend tests on the third sample. The small crystalline appearing areas noted on the fractured surface of bend test specimens (see Figure 5) are considered to be the only areas where any appreciable degree of bonding was obtained. Removal by

grinding of the more severely oxidized portion of the joint near the external surface appears to lessen the tendency for brittle behaviour. This grinding may reduce the cross section of the joint to less than that of the pipe wall. Also, if heavy intermittent oxidation is present across the remainder of the joint, it is very likely that inadequate ductility will still result. It should be noted that there was more continuous oxidation across the joint interface in one of the three sections (See Figure 8) compared with the other two sections from sample (A..), thus indicating variation around the weld periphery. Thus grinding away of the heavily oxidized outer portion of the joint should not be considered as a suitable substitute to reducing the oxidation at the interface during welding.

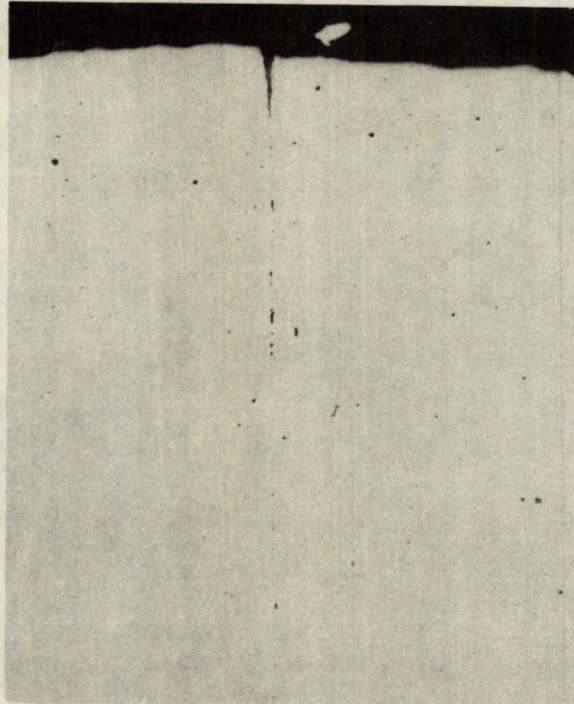
Figure 6 - Oxide at joint interface extending inward from outer surface

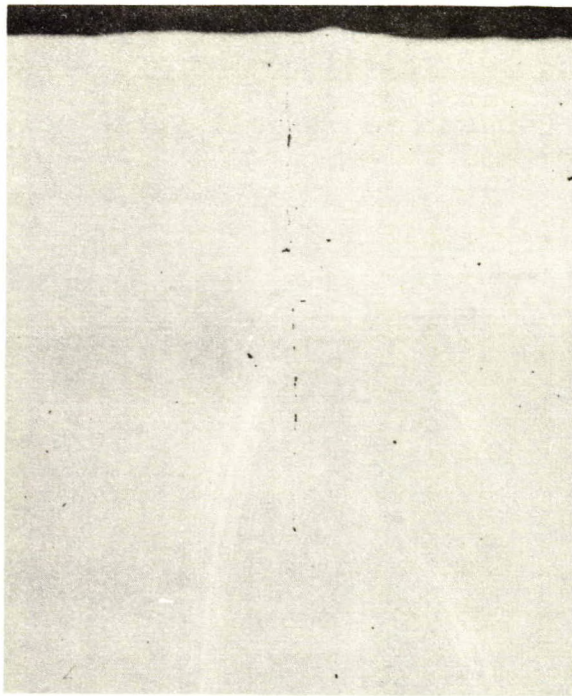
Figure 7 - As Fig. 6, but of a different section

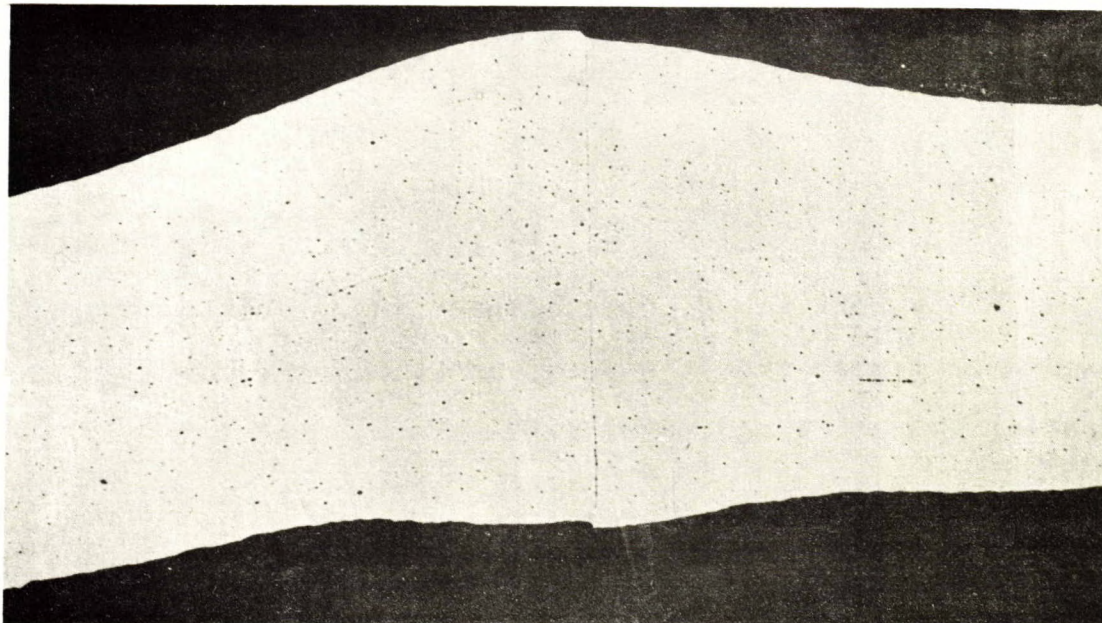
Figure 8 - Oxide outlining joint interface

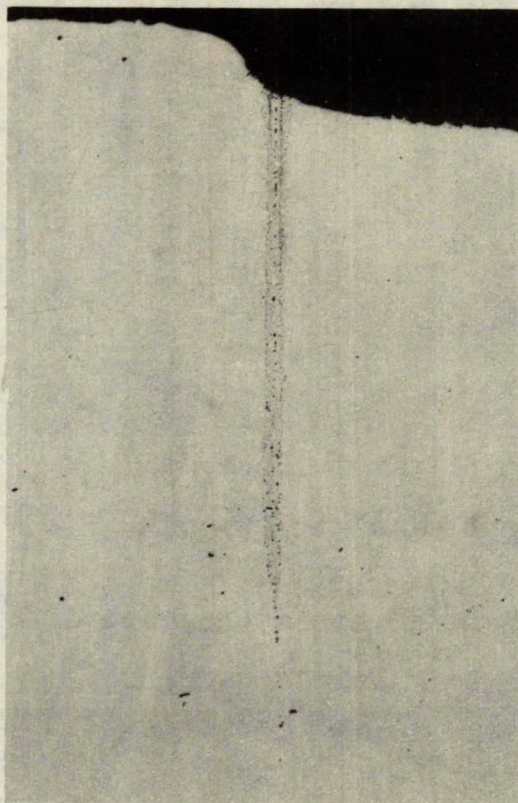
Figure 9 is typical of the appearance at the joint adjacent to the OD surface of all three sections from sample (A...).

Figure 9 - Oxide at joint interface

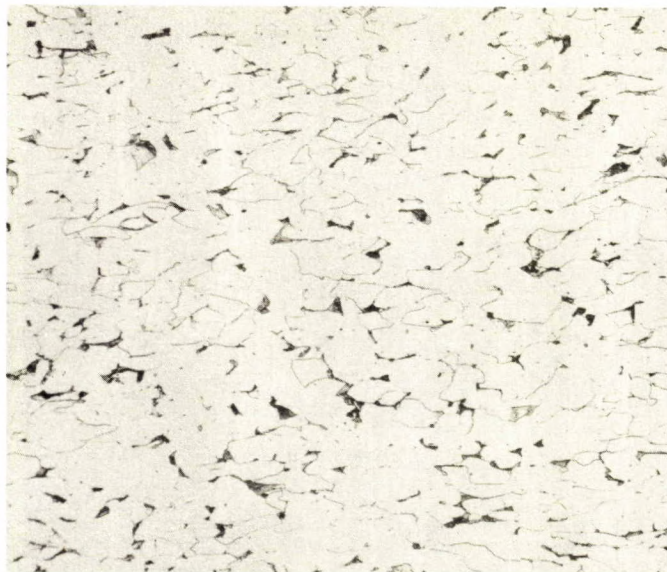
Figure 10 - Microstructure remote from joint
typical of samples 21 and 22

The microstructure remote from the joint in two of the three samples examined metallographically, is shown in Figure 10 to consist of ferrite and pearlite. This is a typical low carbon steel microstructure. In the third sample, the comparison specimen has a microstructure as shown in Figure 11, consisting of much finer grain ferrite with spheroidal carbides. This difference in microstructure is not believed to have influenced the weld quality, but it is pointed out to illustrate that the steels used in preparing the welded samples were not identical. The original microstructure of the pipe influences the microstructure in the joint area. For example, the microstructure in the joint area in samples 21 and 22 consists of ferrite and

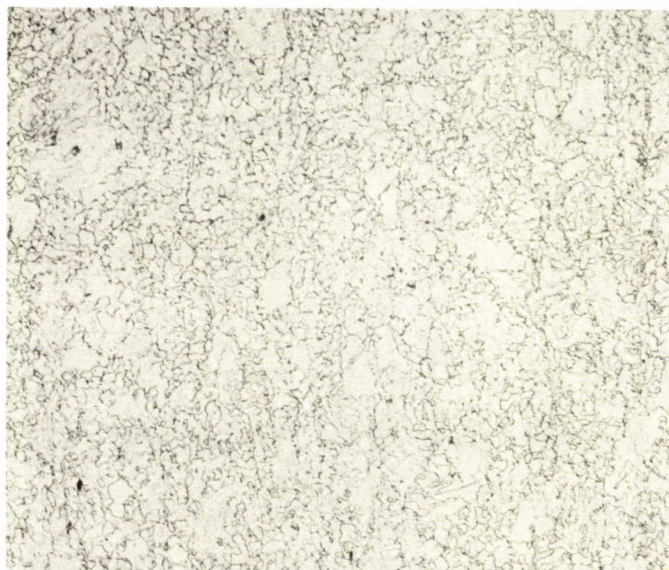
Figure 11 - Microstructure remote from joint
of sample (A...)

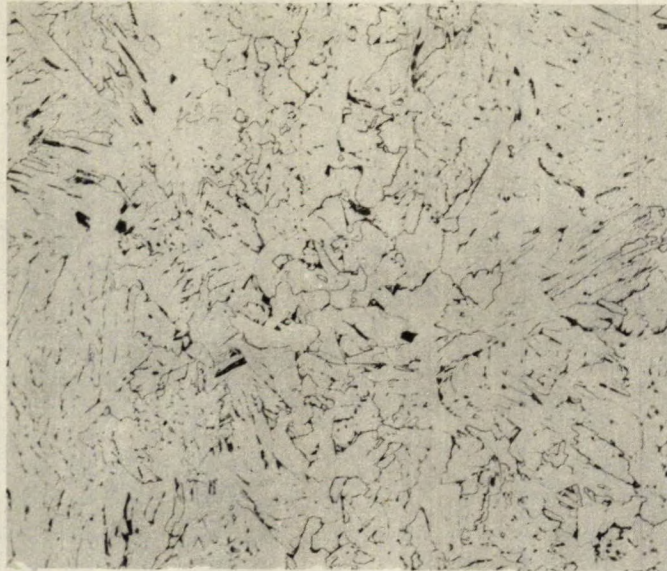
Figure 12 - Microstructure at weld interface
typical of samples 21 and 22

pearlite (Figure 12), while the microstructure (not shown) at a corresponding location in sample (A..) consists of much finer grain ferrite and spheroidal carbides.
