MINES BRANCH INVESTIGATION REPORT IR 58-210

EXAMINATION OF FRACTURE OF SAE 4140 TEST BAR

Mines Branch Investigation Report IR 58-210

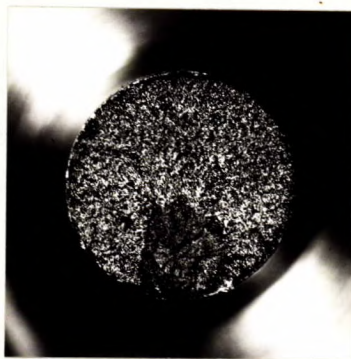
Fig. 1. - Area at the bottom of the picture appeared dark and rough, and the remainder showed many shiny facets.

Macroscopic examination of the fracture revealed traces of material which had the appearance of entrapped slag or deoxidation product. Most of this material was found at the edge of the bar, and considerably more was present at the edge of the dark fracture than adjacent to the bright fracture. Material, with a similar appearance was observed in surface ruptures near the fracture which were formed when the bar was broken. Most of the fracture surface did not show any of this non-metallic component.

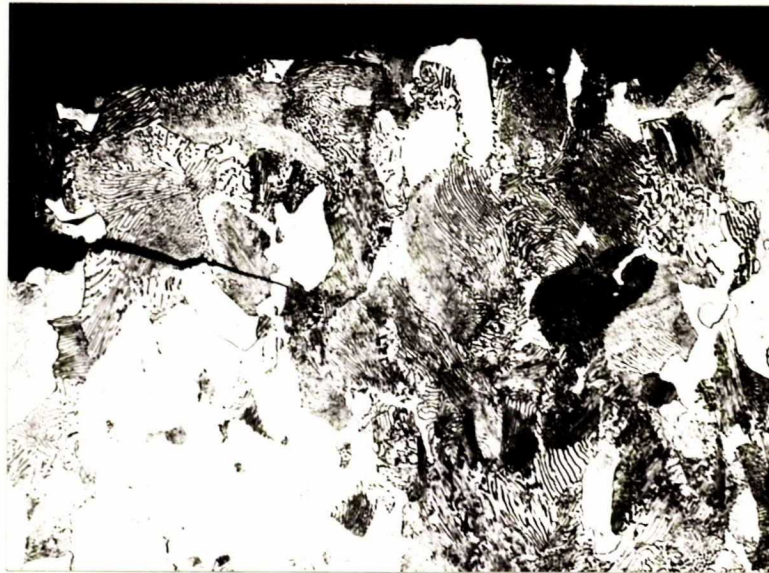
Fig. 2. - Cross-section through bright fracture showing transcrystalline cleavage.

of the fracture showed bright facets due to transcrystalline cleavage failure.

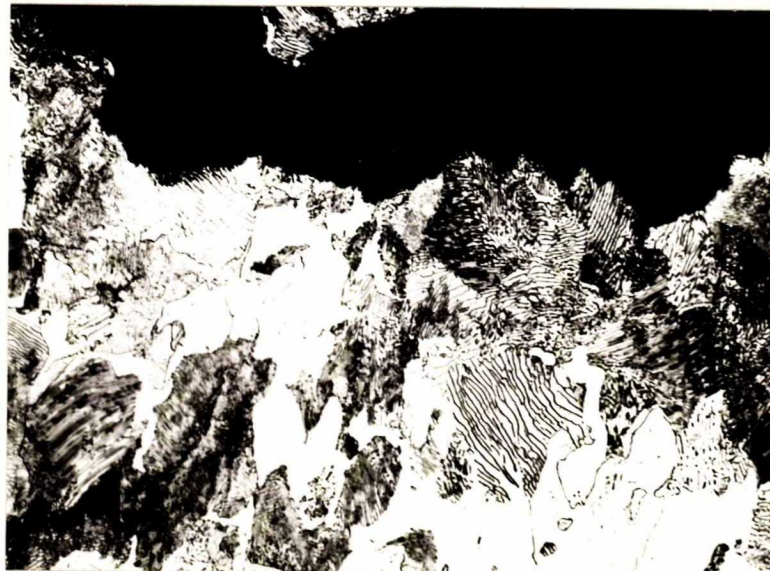
Fig. 3. - Cross-section through dark fracture showing evidence of intergranular failure and no transcrystalline cleavage.

The two distinct fracture appearances were due to differences in the mode of failure. The dark, rough appearance of one section of the fracture was due to the intercrystalline failure promoted by the presence of large silicate inclusions. The remainder

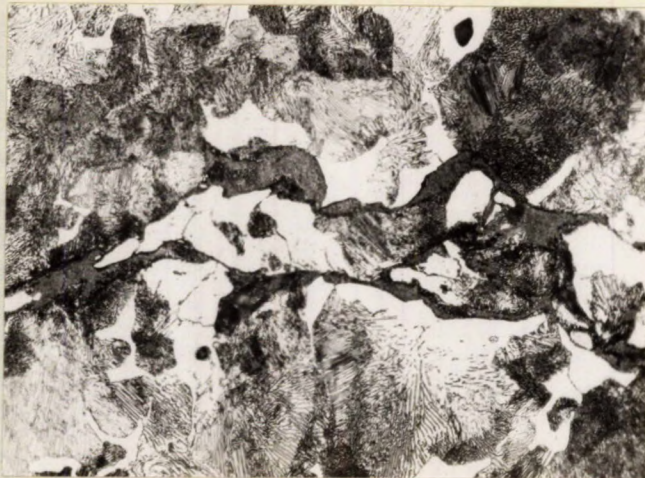
Fig. 7. - Sulphide removed.

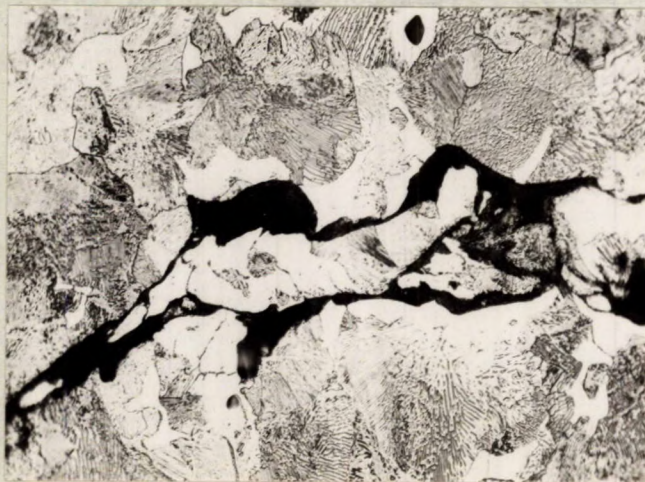
Fig. 8. - Inclusion darkened.

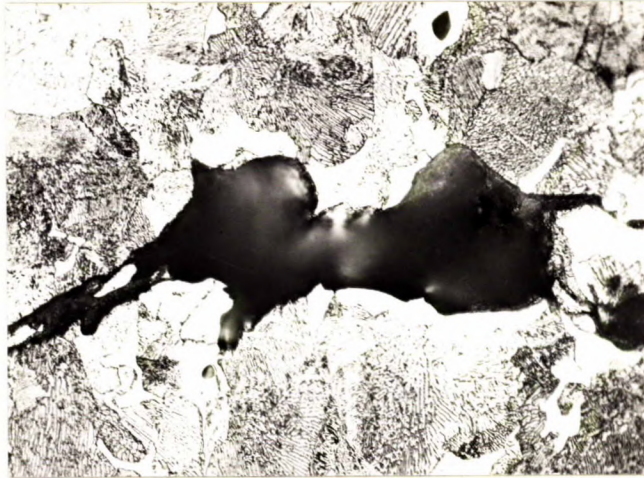
Fig. 9. - Inclusion removed
