DEPARTMENT OF MINES AND TECHNICAL SURVEYS

MINES BRANCH INVESTIGATION REPORT IR 58-216

INVESTIGATION OF BRITTLE FRACTURES OF CHROMIUM PLATED TENSILE TEST BARS OF SAE 4340

DECEMBER 12, 1958

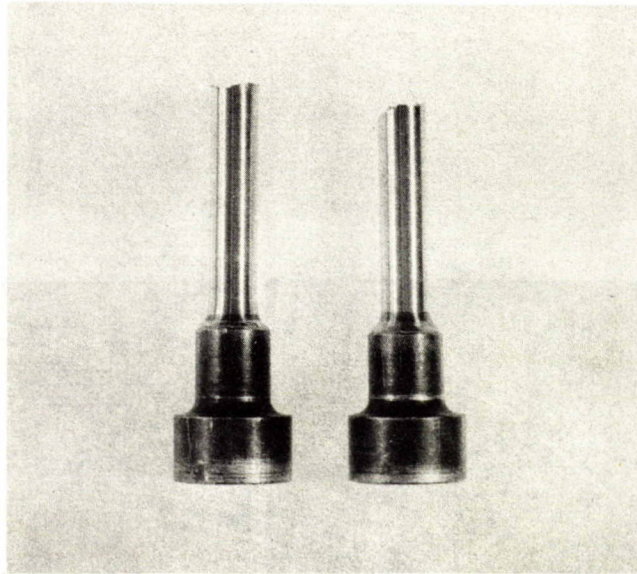
On 19 June, 1958, Mr. A. Sankoff of Canadian Vickers Limited, Montreal, Que., submitted halves of two chromium plated tensile test bars (Figure 1) which had fractured with little or no reduction of area with a request for an opinion as to the reason for the lack of ductility. A copy of their test report was appended. The relevant data from this report are shown in Table 1.

Fig. 1. - Brittle fractures, No. 1 I.D. on the left, and No. 1 O.D. on the right.

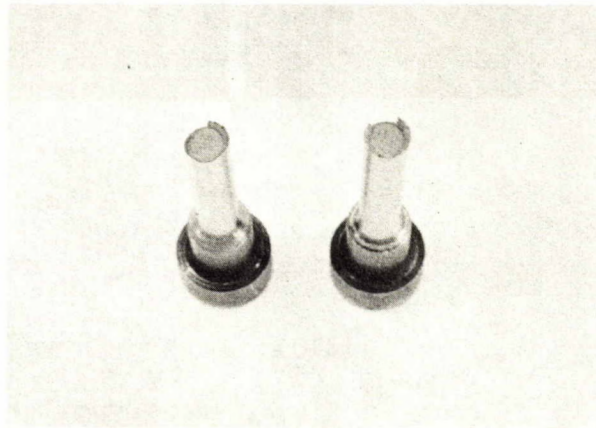
Visual examination of the "brittle" bars showed the fracture to be symmetrical about a longitudinal plane in both cases. Figure 2 shows how the flat central portion of the fracture extends to the surface in one area only and is surrounded by a shear lip around the remainder of the circumference. Striations on the flat portion of the fracture indicate the fracture origin to be at the surface (Figure 3a). No such striations were observed on the flat portions of the ductile fractures (Figure 3b). This, of course, is consistent with the normal case where the tensile fracture originates at the centre of the section. The extensive "craze" cracks observed on the surface of the bars are normal for hard chromium plate. There was no evidence of oxidation in any portion of the fracture surfaces.

Fig. 2. - Brittle tensile bars as above. Note the symmetry about a longitudinal plane with the central plane extending to the circumference in one area, and a shear lip around the remainder of the circumference.

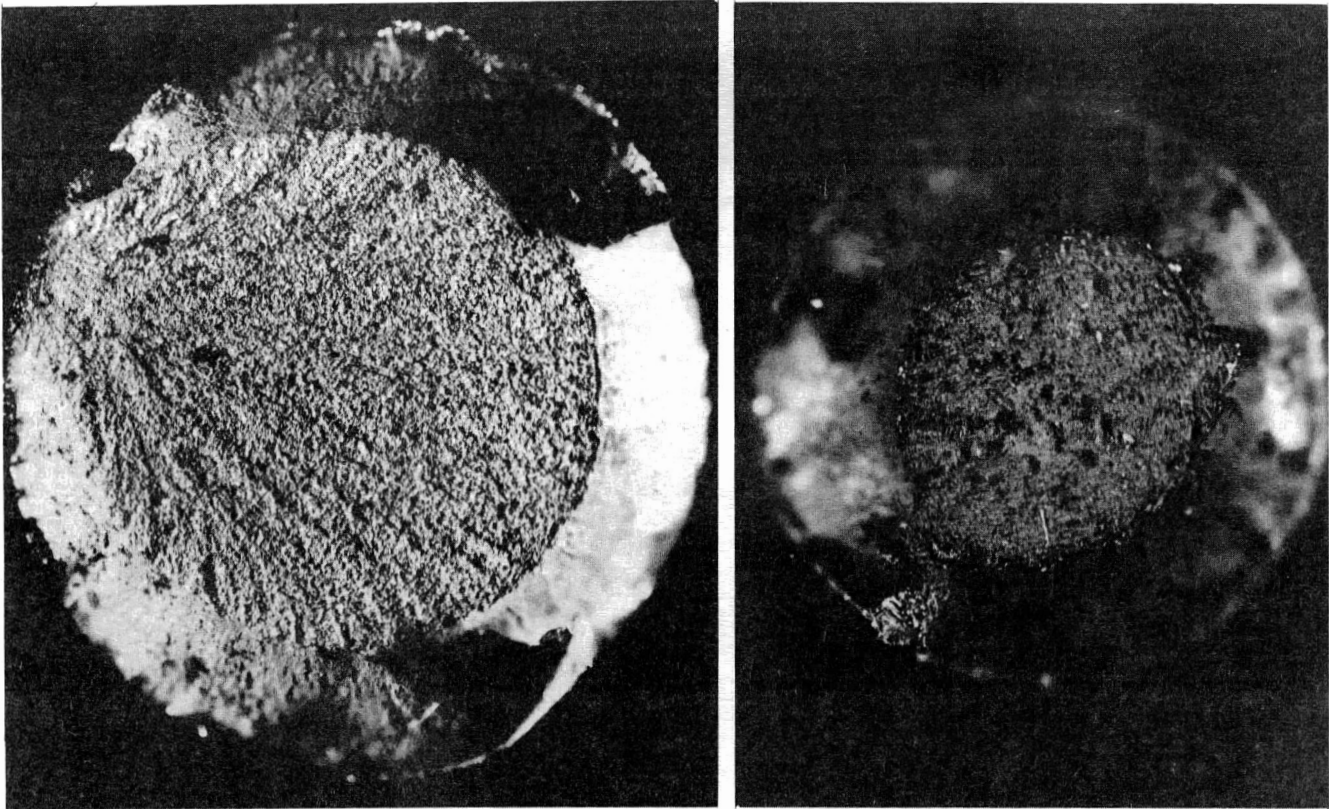
Fig. 3 (a). - Brittle fracture of 1 O.D. Note striations indicating the fracture origin to be at the surface at the left.

(b). - Ductile fracture of 2 O.D. Note lack of striations.

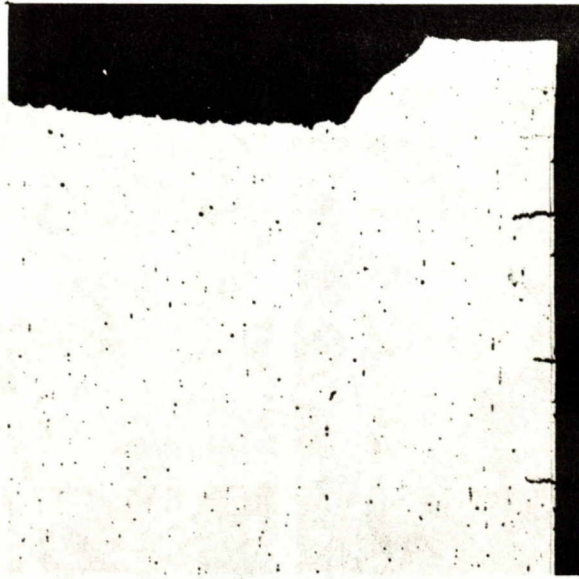
Longitudinal sections through the fractures and through the bases were prepared from samples 1 I.D., 1 O.D., 2 I.D. and 2 O.D. A considerable number of cracks normal to the surface were noted in the area of the fracture on 1 I.D. (Fig. 4). Two similar cracks were noted on 1 O.D. and none on 2 I.D. or 2 O.D. There was no evidence of oxidation nor of chromium plate in the cracks in the steel. From this, it is inferred that the cracks were formed during tensile testing. There did not appear to be any significant difference between the four samples in the roughness of the steel surface. Some slight ductility was noted immediately adjacent to the fracture of 1 O.D. There was no perceptible evidence of ductility in the fracture

Fig. 4. - Longitudinal section through the fracture of 1 I.D. Note the cracks normal to the surface at the right.

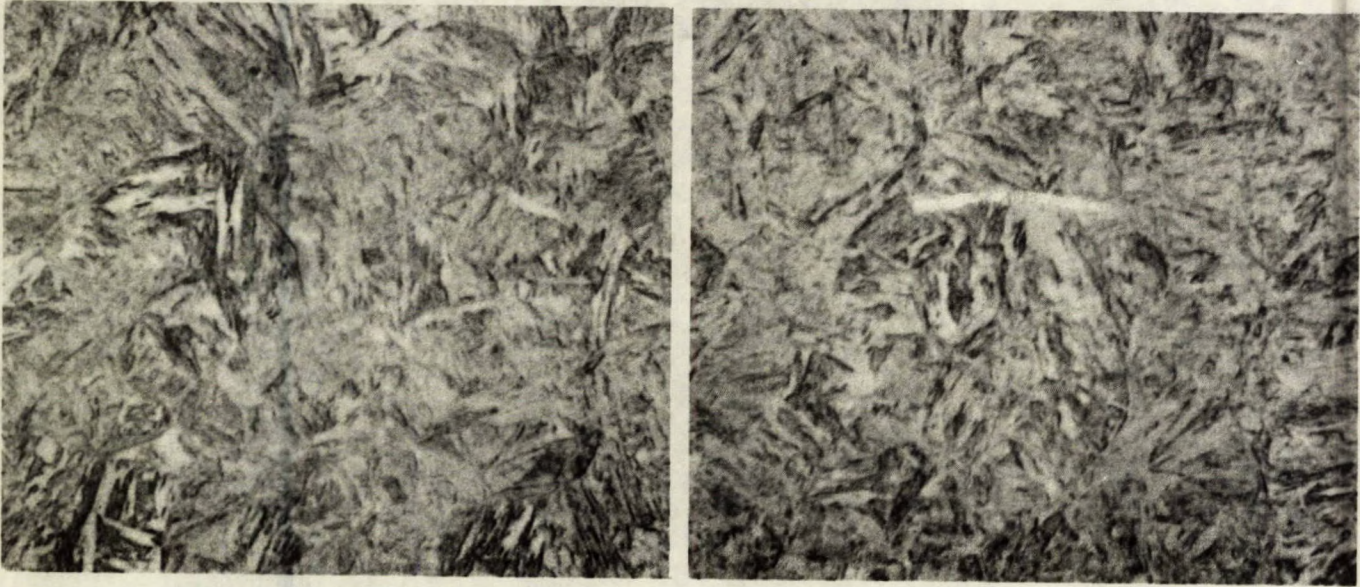
Fig. 6. - Microstructures typical of quenched and tempered material, consisting principally of tempered martensite with some bainite. Note there is no apparent difference between the brittle and the ductile material.

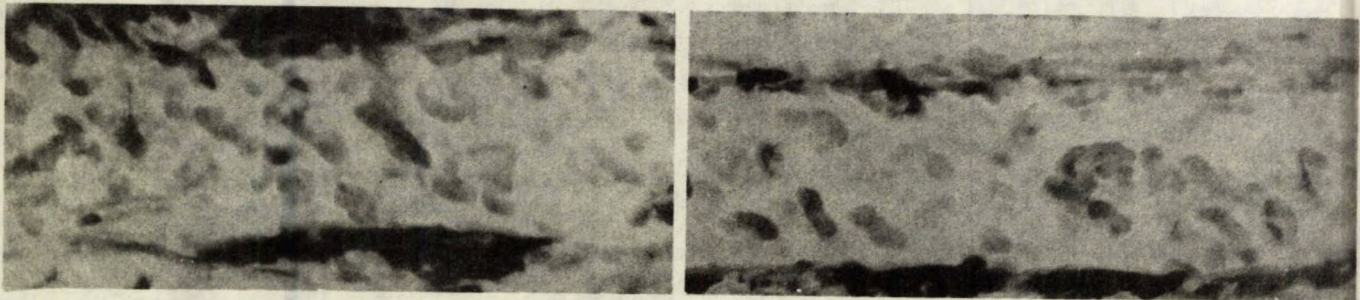
Fig. 7. - Note similarity of configuration of the carbides in the martensite plates.
