MINES BRANCH INVESTIGATION REPORT IR 58-23

**METALLURGICAL EXAMINATION OF A CRACKED FRONT PLATE  
FROM A HIGH PRESSURE STEAM BOILER (#5SD, MONCTON, N. B. ).**

FEBRUARY 14, 1958

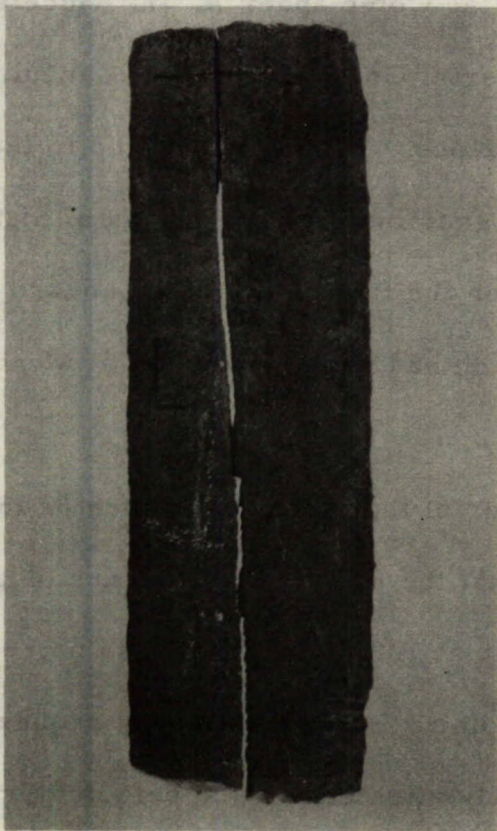
Fig. 1. - Crack in front plate on bend surface (near front circumferential seam).

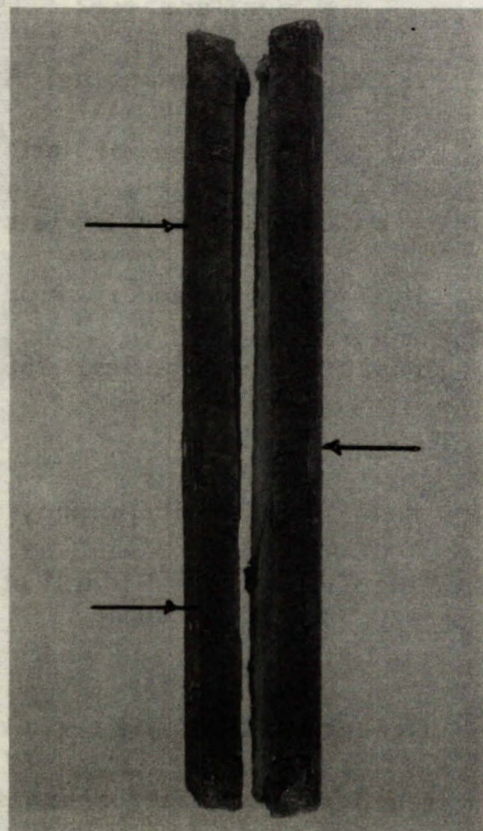
Fig. 2. - Crack surfaces. The steam surfaces are illustrated at the centre; the outer surfaces are shown (arrows).

The fracture surface consisted of two parts. About four-fifths of the fracture adjacent to the steam side of the plate had a ragged appearance and showed evidence of laminations in its deepest part. The remaining one-fifth of the fracture next to the outside surface appeared to be of the 45° shear type and showed evidence of deformation.

The appearance of the fracture suggested that the crack developed from the steam side and progressed slowly through four-fifths of the metal section, where it was interrupted by an inclusion stringer. Corrosion occurred at this lamination for a time. Then the reduced section bulged and failed in shear, leaving a deformed 45° lip for one-fifth of the section adjacent to the outer surface.

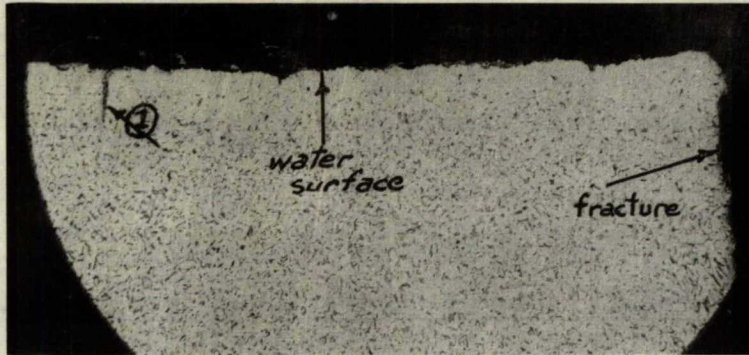
Transcrystalline, corroded microcracks were observed at the steam surface which were parallel to the main fracture. Possibly a similar crack acted as an origin for the main fracture.

Fig. 3. - Water side of plate (top). Fracture at extreme right. A corroded microcrack, 0.012 in. in depth, parallel to the fracture, is illustrated at the water surface (arrow ①).  
X33.

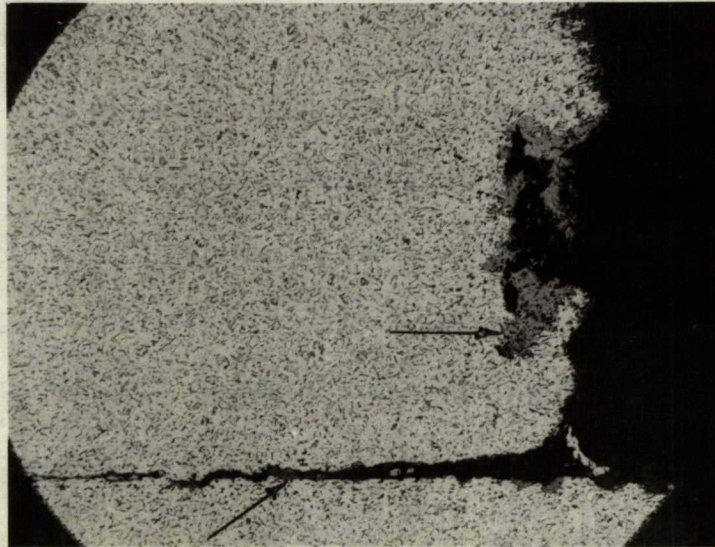
Metallographic examination of microsections cut transversely through the fracture showed the presence of corrosion pits and microcracks at the steam surface. The main fracture was transgranular but showed evidence of pitting corrosion, especially in the vicinity of the inclusion stringer which interrupted the fracture about 1/8 inch from the outside surface.

Fig. 4. - Appearance of fracture at 4/5 section distance. The fracture has been interrupted by a sulphide stringer and corrosion (arrows) has occurred on the fracture surface and along the stringer.  
X33.

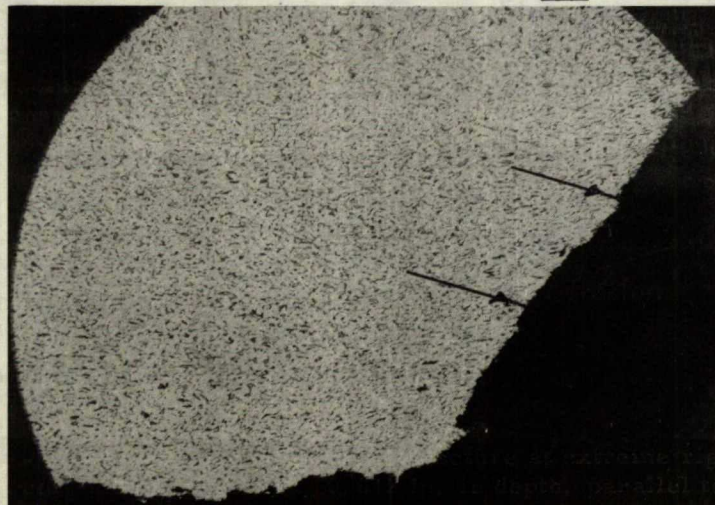
Fig. 5. - Appearance of shear fracture (arrows) present for 1/5 of the section at the outside plate surface. In this shear zone, plastic deformation of metal was observed (arrows).  
X33.

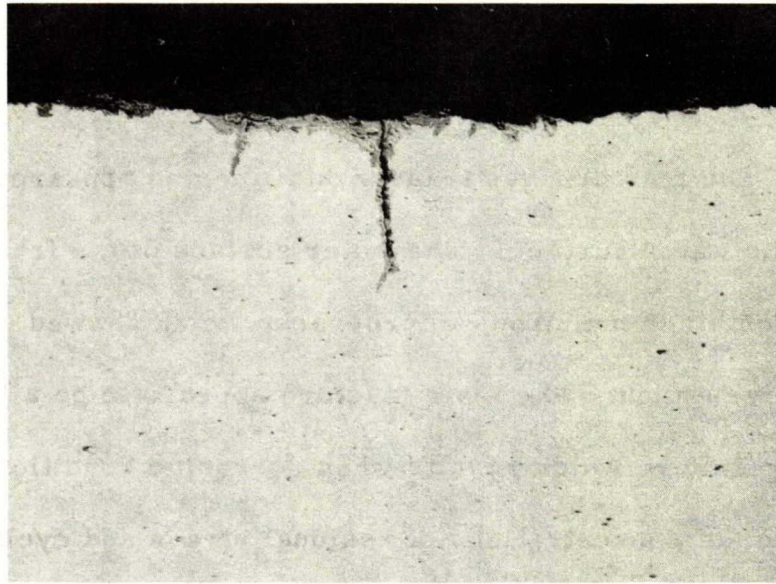
Fig. 6. - Water side of boiler, front plate.

Figures 6 and 7 illustrate the appearance of a typical microcrack on the water side of the plate. (If the plate had not fractured at the bend, microcracks similar to those shown in Figure 6 could have propagated under the influence of residual stress and applied cyclic stress.)

This section, transverse to the main fracture, illustrates the corroded surface and shows a typical microcrack parallel to the main fracture. Several similar microcracks were detected in the small sample of front plate submitted for examination.

1. If the boiler is repaired, consideration should be given to inspection for cracks by the magnetic particle method.
2. If the boiler is repaired, consideration should be given to

a hydrostatic test and to a stress relief treatment prior to service.  
(Stress-relief of the boiler plate bend regions and control of the feed  
water to avoid corrosive conditions would be expected to minimize  
the possibility of failure.)

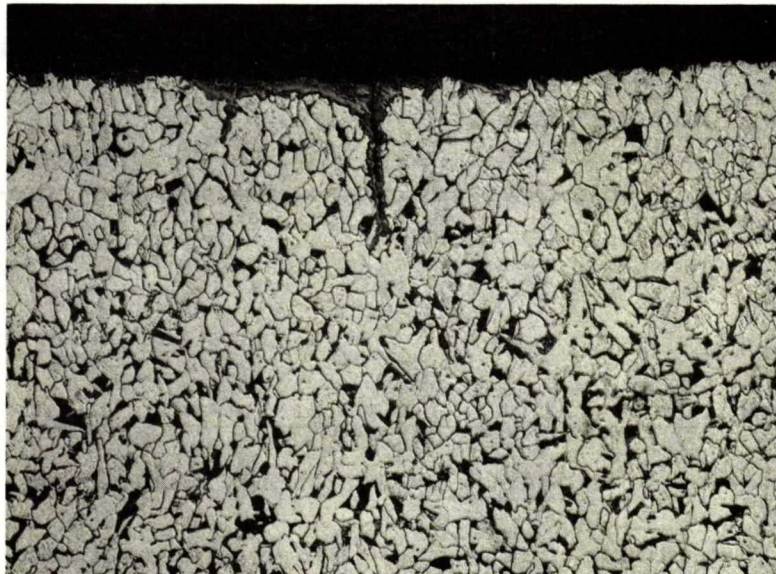
Fig. 7. - Water side of boiler, front plate.

The same field as shown in Figure 6 is shown in the etched condition. The microcrack is transcrystalline and shows evidence of corrosive attack.
