MINES BRANCH INVESTIGATION REPORT IR 59-24

# FAILURE OF ROAD GRADER CHANNEL MEMBER

**R. F. KNIGHT**

FEBRUARY 27, 1959

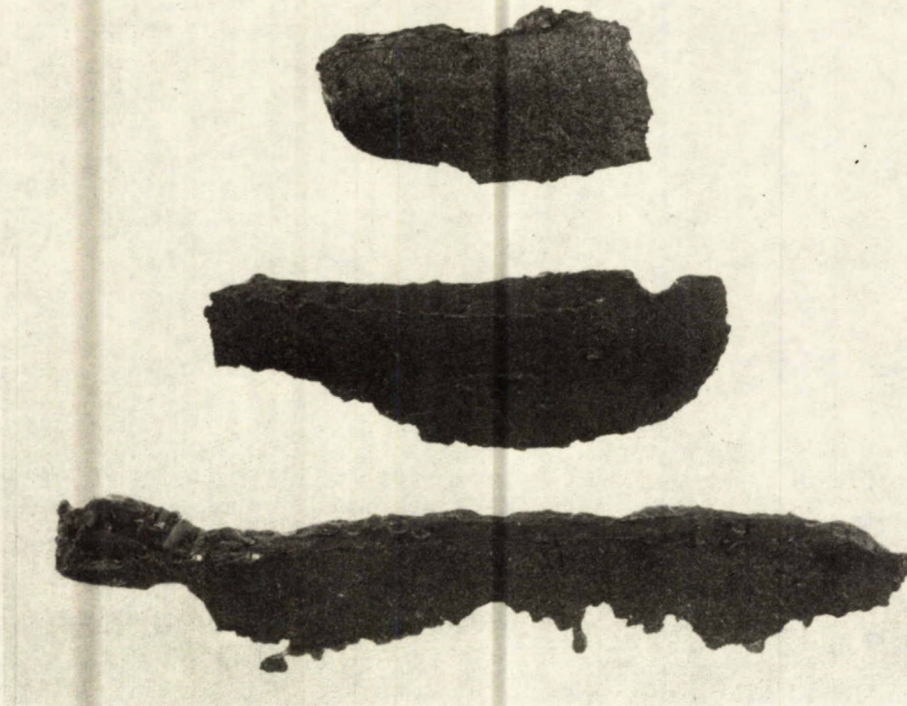
Figure 1. - Samples of the fracture

Careful visual examination of the middle sample shown above revealed traces of a chevron pattern typical of brittle fracture. A faint indication of this pattern is seen at the right of the picture.

Visual observation of the fracture surfaces revealed the chevron pattern and apparent lack of deformation typical of a brittle fracture. The weld sample appeared to be of good quality, but no sample of welding from the failed frame was available. Microscopic examination of the fracture samples revealed little, since the structure had been affected by the flame cutting. The microstructure of one of the channel sections is shown in Figure 3.

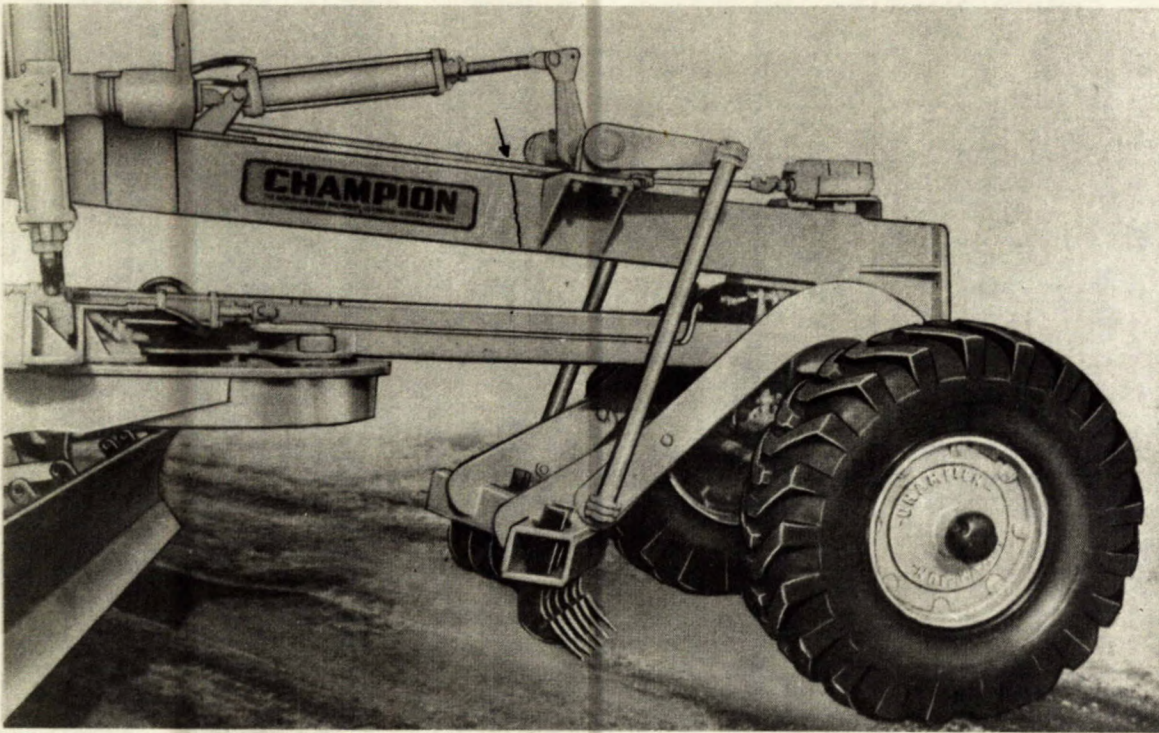
At the time of the failure, the Grader was being used to scarify ice and frozen snow at a temperature of about  $-5^{\circ}\text{F}$ . It was reported that the scarifier teeth hit some solid object, causing the Grader, which weighs about 14 tons, to come to a dead stop.

The fracture occurred at right angles to the longitudinal weld and close to the scarifier-mounting welds. It was 3 in. from, and parallel to, the scarifier mounting plate weld on the top flange, and approached to within 2-1/2 in. of the side welds (along the webs) (see Figure 2). The bottom flange (loaded in compression) did not break, but bent so as to leave a displacement of about 3/4 in. at the top flange. When the frame was bent back into shape no deformation was apparent at the crack. Three fracture samples (Figure 1) were cut, the frame was repaired, and the grader was put back into service.

**Figure 2.** - The position of the crack along one web was as indicated above (at arrow). The crack on the other web was parallel to this, and the crack in the top flange was parallel to, and 3 in. away from, the scarifier mounting plate.

In general, killed steels (fine-grained) have better mechanical properties at low temperatures than the semi-killed steels presently used, but the former are considerably more expensive. If such failures are frequent, it would be desirable to incorporate into the design a less critical and easily changed component which will fail due to such accidental overload in preference to the main frame member.

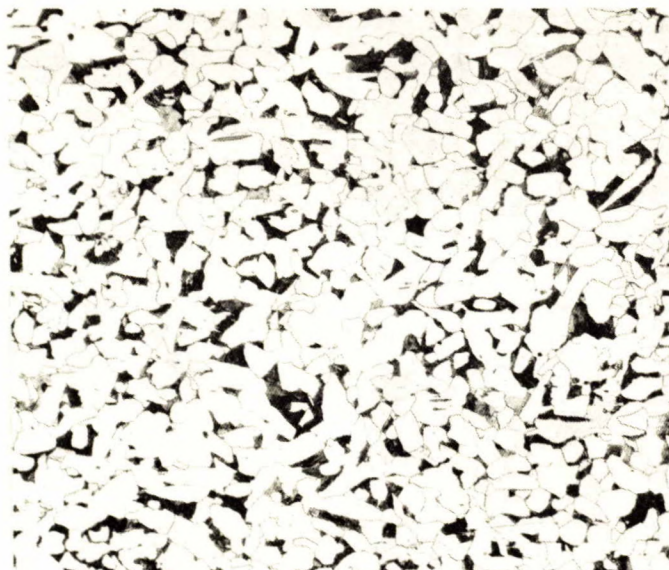
Figure 3. - Microstructure of channel material

This figure shows the fine pearlite-ferrite structure normal for material of this type.
