MINES BRANCH INVESTIGATION IR 59-32

EXAMINATION OF A CRACKED MANGANESE STEEL JAW CRUSHER

R. K. BUHR

MARCH 13, 1959

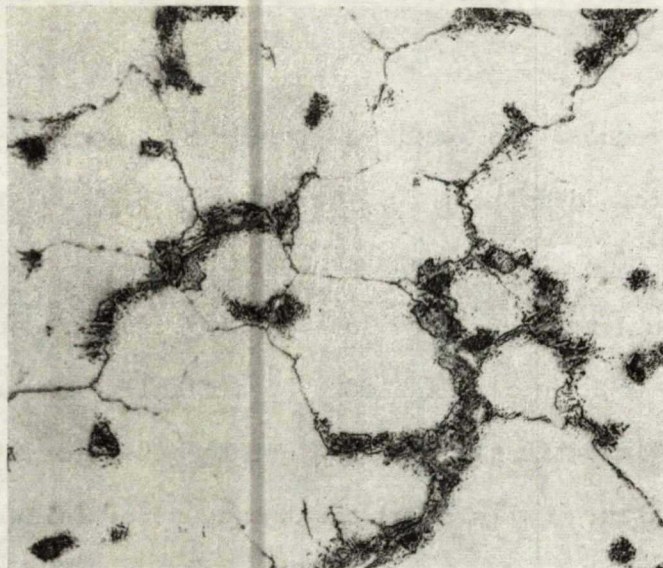
Sections were carefully cut from the samples and suitably prepared for examination under a microscope. The etched specimen showed the presence of large amounts of massive and film type grain boundary carbides. Some of the carbide was needle-shaped, which is typical of that found in the as cast steel. Figures 1 and 2 illustrate the above remarks.

Figure 1 - Typical microstructure of the section showing large amounts of carbides present in the steel.

The cause of failure of the casting is undoubtedly due to the large amount of carbide in the steel, especially the grain boundary carbide. The presence of the needle-shaped carbide indicates that this carbide is the original constituent, i.e. the heat treatment given the casting was not sufficient to bring about complete solution of the carbide. The needle-shaped carbide is also found in manganese steel after reheating the fully heat treated steel, but this is not suspected in the present case.

The solution to the problems is twofold. First, it is suggested that a lower carbon content be aimed for. A carbon content of 1.10% would be easier to heat treat correctly. The presence of chromium is, however, the primary cause of heat treatment difficulties. This element produces a complex carbide which is quite stable. The second change is a higher austenitizing temperature and a longer soak time in order to obtain a completely austenitic structure. This time and temperature may be best determined by tests under plant conditions. A temperature of 2050°F and a soak time of 1 hour per inch has been found satisfactory in some instances and may be a good starting point.

1. The cause of failure is due to the presence of large amounts of massive and grain boundary type carbides.
2. An increase in the austenitizing temperature is necessary in order to dissolve all the carbides. A revision in the composition of the steel may also prove helpful.

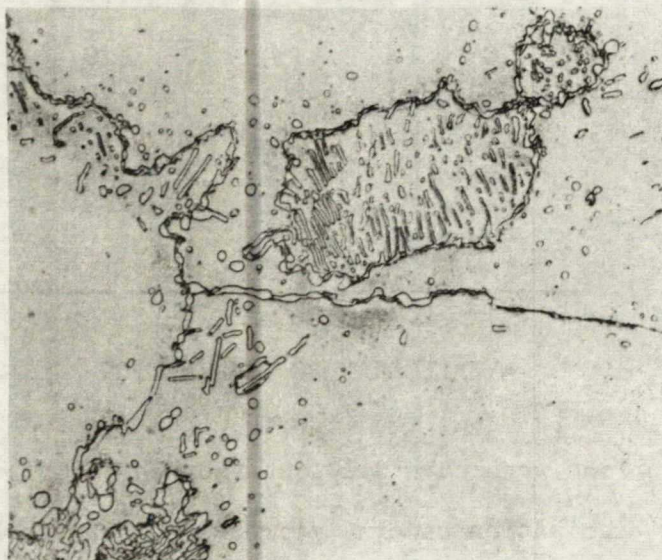
Figure 2 - Shows carbide at grain boundaries as well as the needle-shaped carbide typical of as-cast manganese steel.
