MINES BRANCH INVESTIGATION REPORT IR 59-35

EXAMINATION OF BUTT-WELDED PIPE SAMPLES
JOINED BY INDUCTION HEATING

DR. S. G. HARRIS

PHYSICAL METALLURGY DIVISION

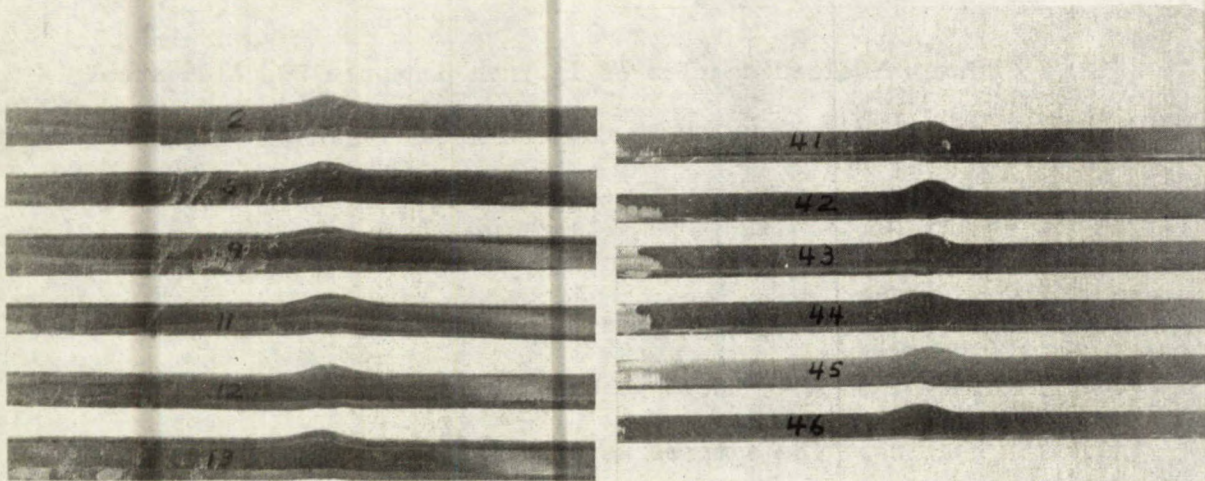
Figure 1 shows the contours of the welded joint. It is apparent that acceptable interior weld contours have been obtained in all samples.

Figure 1 - Sections of the welded joints (interior surface downward)

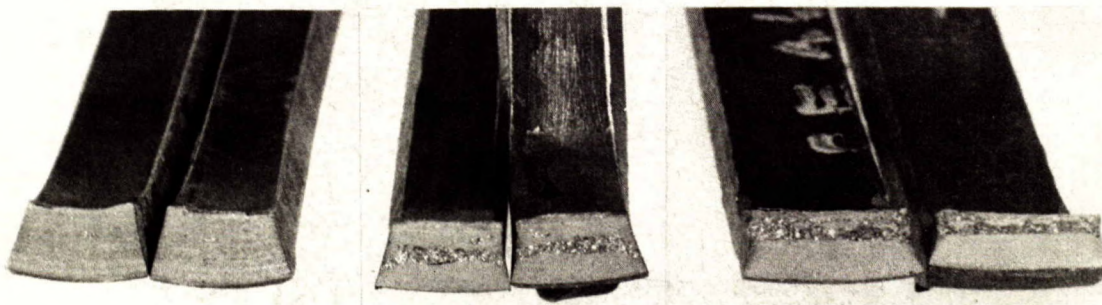
The bend test results are presented as angles of bend at point of failure, or in coupons where failure did not occur, 180 represents a successful test. Since the weld reinforcement on all samples was very slight, it was not removed before bend testing. The surface of the fractured bend test coupons appeared dull grey with occasional brilliant crystalline facets as shown in Figure 2.

Figure 2 - Typical fracture surfaces.

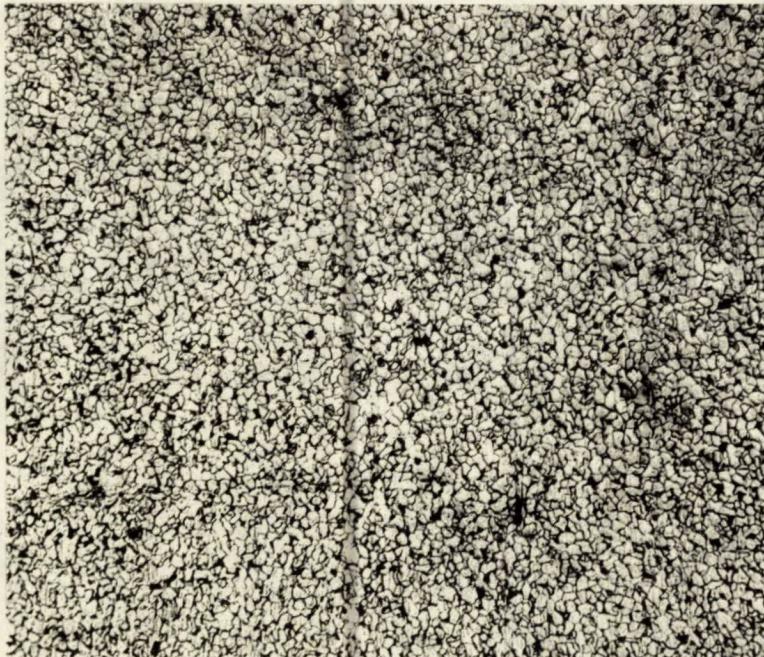
Sections were taken from each pipe weld and examined metallographically. Figure 3 is typical of the original normalized pipe structure away from the heat-affected weld zone.

Figure 3 - Normalized pipe structure.

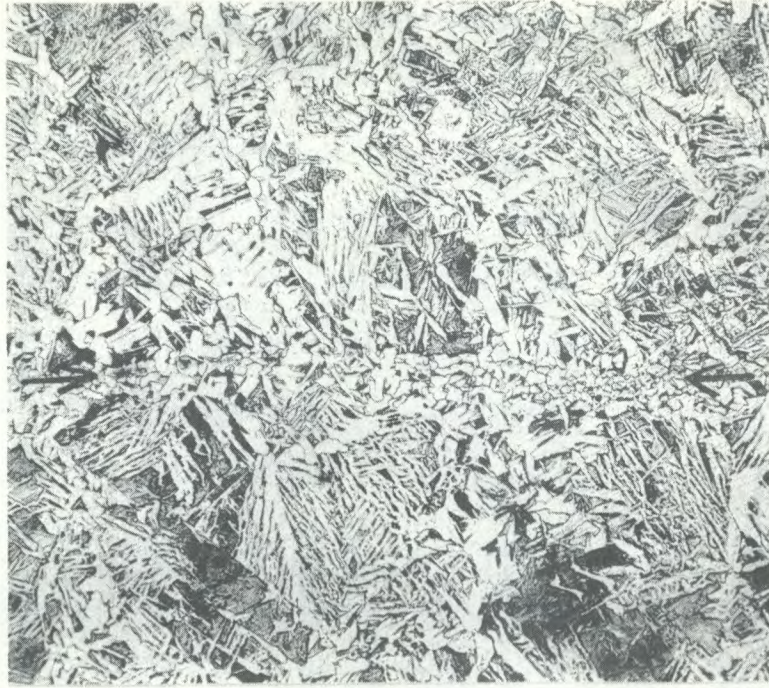
Figure 4 - Photomicrograph of weld interface from Sample No. 6

Figures 4 and 5 are micrographs of the weld interface from samples No. 6 and 12, respectively. Sample No. 6 (which failed to pass the bend tests) exhibits a band of fine ferrite grains and a few black specks (presumably oxide inclusions) along the weld plane. In Figure 5, the weld plane is hardly discernible except for the fact that the carbon content is slightly different in the two pieces joined which results in more pearlite on one side of the weld plane. Weld interfaces such as this, which were free of oxide and fine ferrite grains, were typical of the welds which successfully passed the bend tests. It should also be noted that considerable grain growth has occurred in the heat-affected zone (compare Figure 5 and 6 with Figure 4).

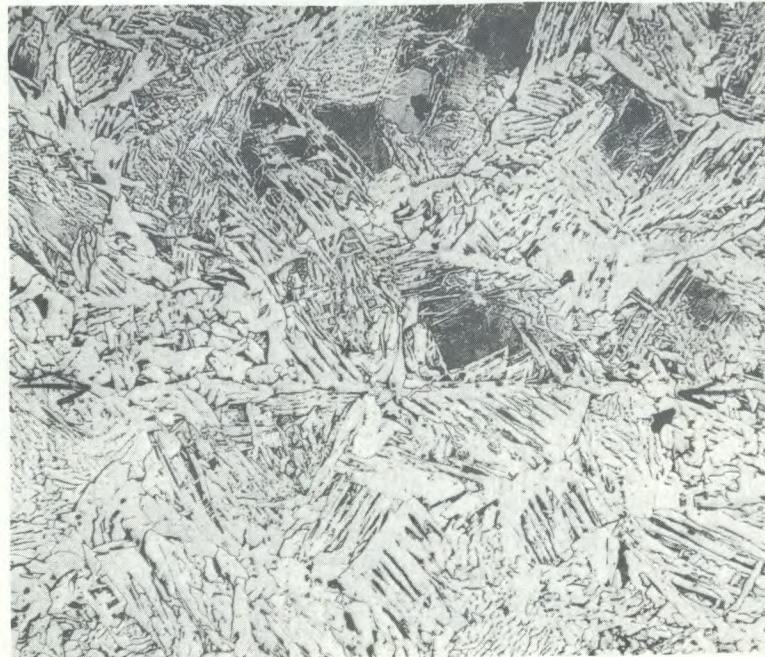
Figure 5 - Photomicrograph of weld interface from Sample No. 12
