MINES BRANCH INVESTIGATION IR 59-51

INVESTIGATION OF THE CAUSE OF FAILURE OF  
THREE AXLES FOR MINE HEAD SHEAVES

Mines Branch Investigation Report No. I R 59-51

INVESTIGATION OF THE CAUSE OF FAILURE OF THREE  
AXLES FOR MINE HEAD SHEAVES

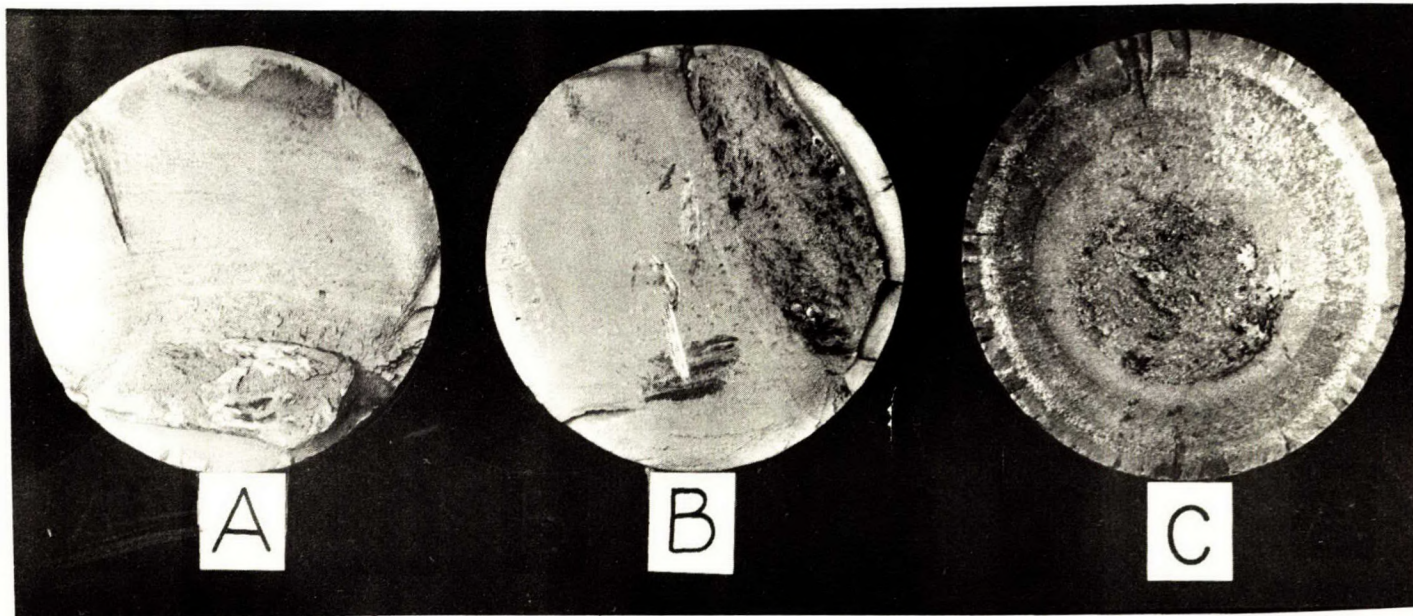
In all three axles, the fracture consisted of two distinct areas. The larger area exhibited a smooth surface due to the propagation of a fatigue crack which initiated at the periphery. The smaller and rougher part of the fracture, largely enclosed by the smoother part, showed where the final break occurred. The appearance of these fractures is typical of fatigue failures in rotating bending.

The outside surfaces of axles A and B adjacent to the fractured surfaces showed indications of a small fillet. The outside surface of axle C adjacent to the fracture showed a marked degree of corrosion pitting.

The fractured surfaces on all three axles are typical of fatigue failures. The axles A and B show indications of a fillet on the surface adjacent to the fracture face; the small radius (1/4 in.) used for this fillet would give a stress concentration factor of about 1.75 and would account for the failures originating in this region.

Figure 1. - Fracture surfaces of the three axles, as received.

- 1) Increase the fillet radius on axles A and B; a 1 in. fillet, for example, would reduce the stress concentration to 1.28.
- 2) Protect shaft C from corrosion, particularly in the region of the sheave hub.
- 3) Check the alignment of the shaft, and lubrication of the bearings, and avoid excessive loads.
- 4) Use a material of higher strength, e.g., heat-treated SPS 245 steel.

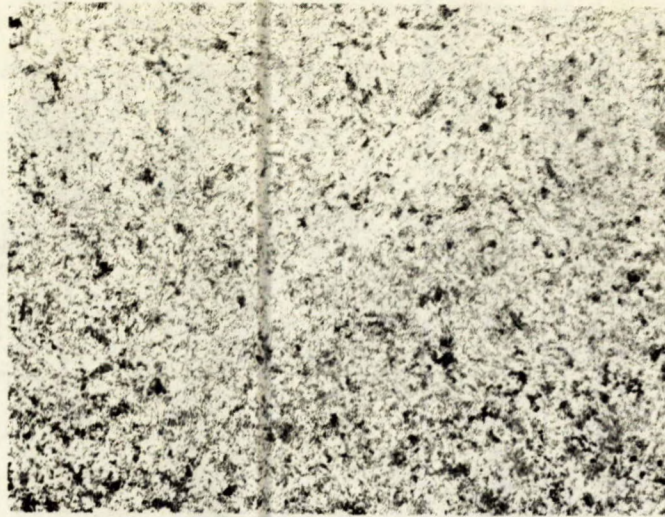
Photomicrographs of the etched structures of the three axles are shown in Figures 2, 3 and 4. All samples for metallographic examination were cut from the fractured ends of the axles and at right angles to the fracture surface. There is a marked similarity between the microstructures of axles A and B, both showing the type of ferrite-pearlite structure which would be expected from the chemical analysis and the mechanical properties. The microstructure of axle C also appears to be consistent with the chemical analysis and mechanical properties.

Figure 2. - Axle A - taken at right angles to fracture face .  
(X100; Etched in 2% Nital)

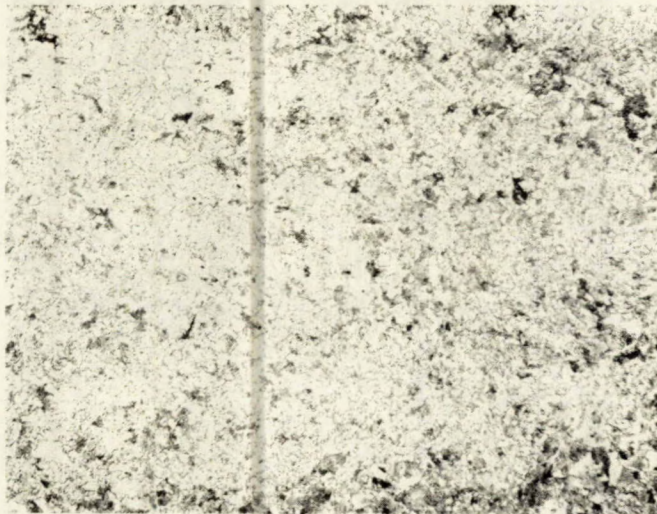
Figure 3. - Axle B - taken at right angles to fracture face .  
(X100; Etched in 2% Nital)

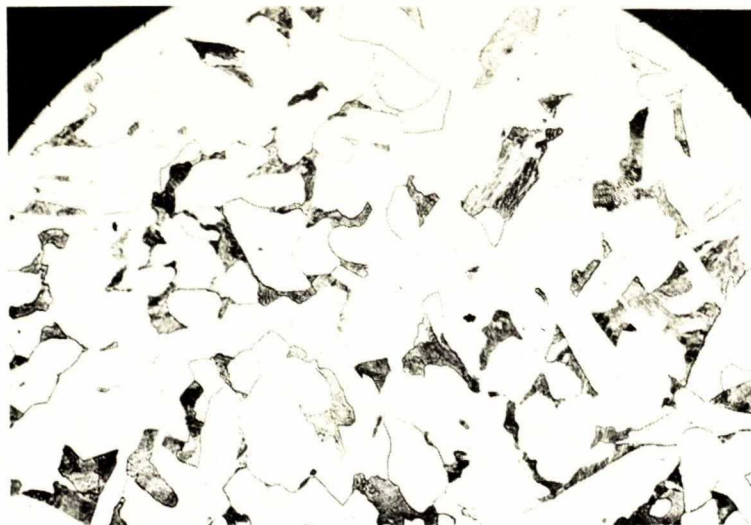
Figure 4. - Axle C - taken at right angles to fracture face.  
(X100; Etched in 2% Nital)

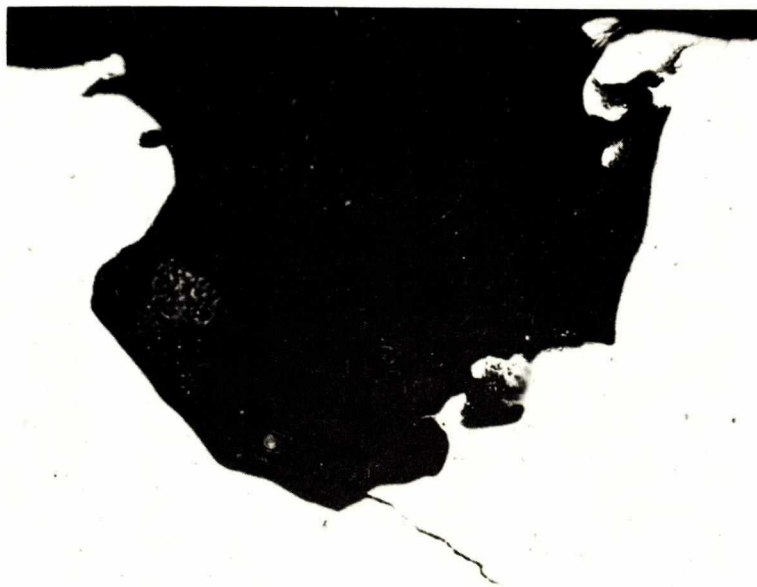
Axle C showed no indication of a fillet on the shaft, but adjacent to the fracture surface was a band of heavy corrosion pitting. Examination showed that small hairline cracks had developed at the base of some of the pits. This is illustrated in

Figure 5. It is considered that the method of failure has been one of corrosion fatigue, whereby the most severe cracks developed on approximately the same plane at the edge of the hub, and joined up to form a continuous crack around the periphery of the shaft. The central location of the fibrous portion of the fracture indicates a high stress condition, due to stress concentrations at the roots of the corrosion pits. This condition need not necessarily be associated with higher applied load.

from the appearance of the surface of the shaft, it is probable that the corrosion pitting was due to attack by the atmosphere.

The pits caused by corrosion acted as stress raisers.

Figure 5. - Axle C - taken at right angles to fracture face,  
showing a corrosion pit with crack at the root.  
(X400; Unetched)
