MINES BRANCH INVESTIGATION REPORT IR 59-62

EXAMINATION OF BROKEN ELEVATOR PART

R. F. KNIGHT

PHYSICAL METALLURGY DIVISION

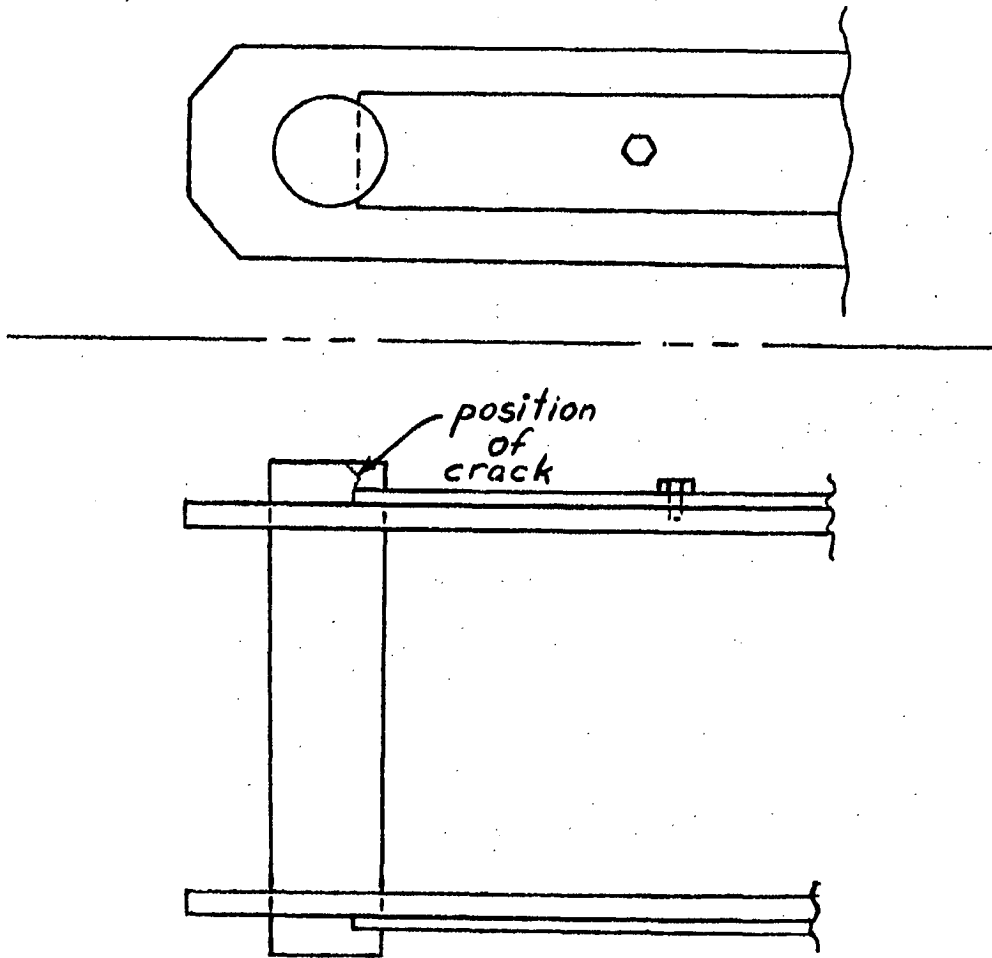
A broken assembly from a construction elevator was submitted for examination by Mr. J. R. Waterman of Sarnia Scaffolds, Limited, P. O. Box 67, St. Catharines, Ontario. A sketch of one-half the assembly is given in Figure 1, showing how it was held rigid by means of plates fitted into notches in the pins. The ends of the pins, which in normal service would carry very little load, broke at the notches.

Figure 1. - Sketch of one-half the elevator assembly. The path of the fracture is indicated.

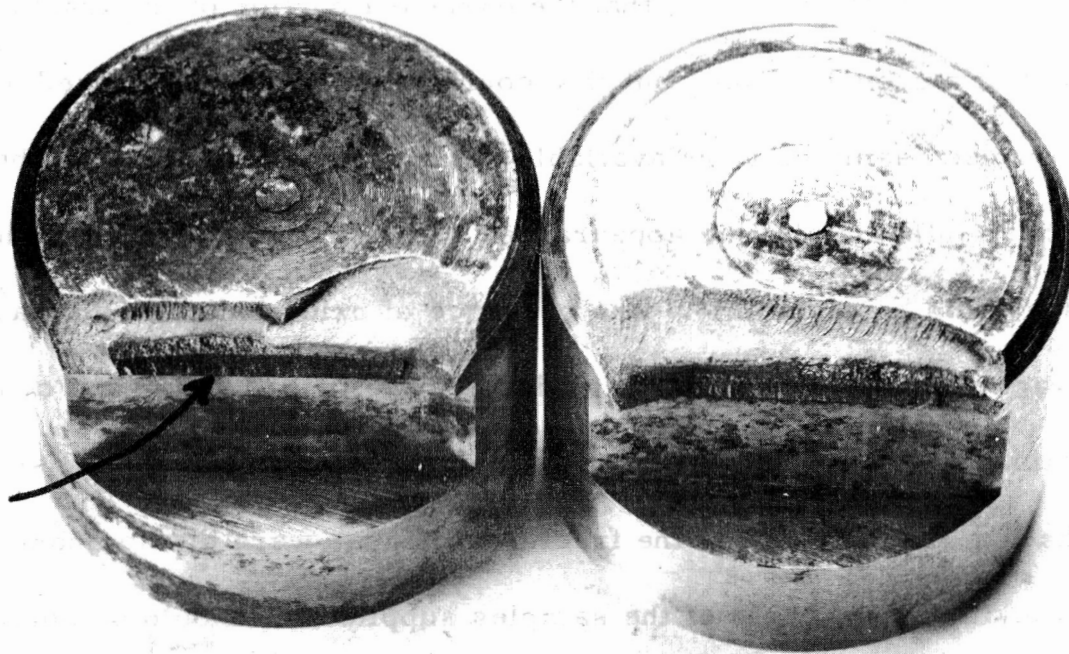
Inspection of the fractured surface of one of the broken pins showed a brownish-red oxide discolouration on a portion of the fracture (at the end of the arrow in Figure 2).

It is suspected that the darkened portion of the fracture is part of a quench-crack, but this could not be definitely proved since no unused samples were available. A part of the fracture on the other pin had a similar appearance, but little or no oxide discolouration could be seen on it. The presence of oxide indicates that a crack was present for some period of time prior to the final complete failure of the section. While it could not be definitely established that the initial areas of the fracture surfaces were due to quench-cracking on the basis of the samples supplied, it should be noted that the design used, featuring a sharp notch, would be very susceptible to quench-cracking.

Figure 2. - Shows view of fractured end of pins. Arrow indicates pre-existing crack darkened by oxide. A similar crack can be seen on the other pin, but little or no oxide is evident.

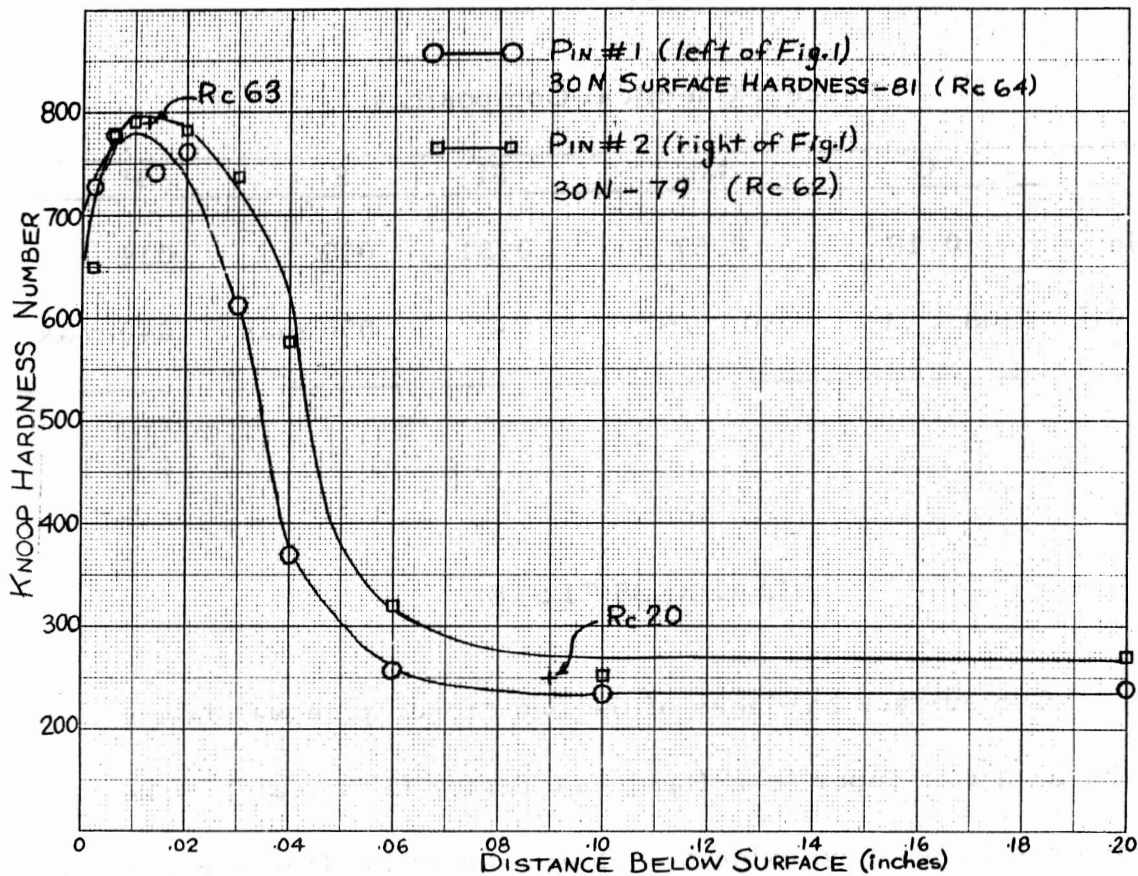
Pieces were cut from the pins, mounted in bakelite and polished. Hardness surveys were carried out on these samples from the surface inwards using the Tukon Hardness Tester with a 1000 gm load. The results of these surveys are indicated in Figure 3.

Figure 3. - Results of Tukon Hardness Surveys.

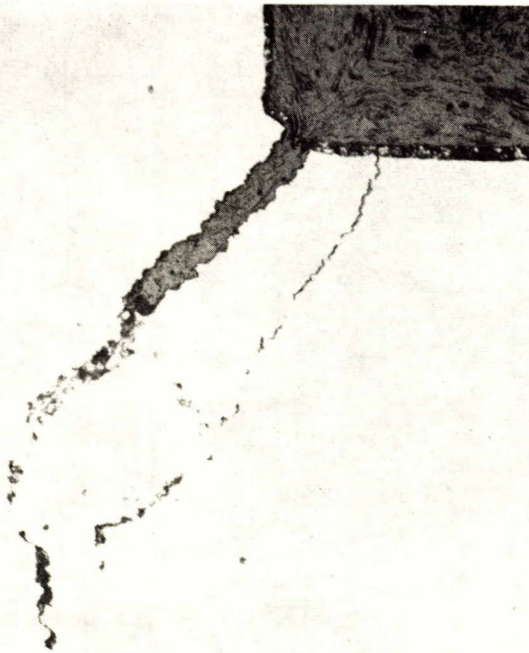
Microspecimens were cut at the fractured and unfractured ends of the pins, and these were examined microscopically. An open crack could be seen with the unaided eye at the unfractured end of Sample 1 (the pin having no oxide on the fracture surface). No crack could be seen macroscopically on the unfractured end of Sample 2, but microscopic examination did reveal a fine crack. Views of these cracks are shown and explained in Figures 4, 5, 6 and 7.

Figure 4. - Shows open crack at the unfractured end of Sample 1 and also a fine, parallel crack which was not visible to the naked eye.

Figures 4, 5, 6 and 7 show cracks which appear to have been present for a considerable period of time before the failure occurred. The presence of oxide in the cracks supports this supposition. It is possible that these are quench-cracks, but no unused samples of similar parts were available for inspection to confirm this opinion. A thin layer of grain boundary non-metallics, presumably oxides, could be seen at most of the carburized surfaces, and their presence might have aided in the formation of cracks in the hard, martensitic case.

1. Any similar parts should be checked for quench-cracks by means of magnetic particle inspection, or some other suitable means.
2. If possible, the design should be altered to eliminate the notch.
3. Quenched pins should be given a stress-relieving tempering treatment, at not lower than 400°F.
4. It is believed that the end of the pins which broke had no bearing contact in this application which implies that wear resistance is not important. If this is the case, these ends could be masked before carburization to prevent the formation of the brittle high-carbon martensite in these areas on quenching.

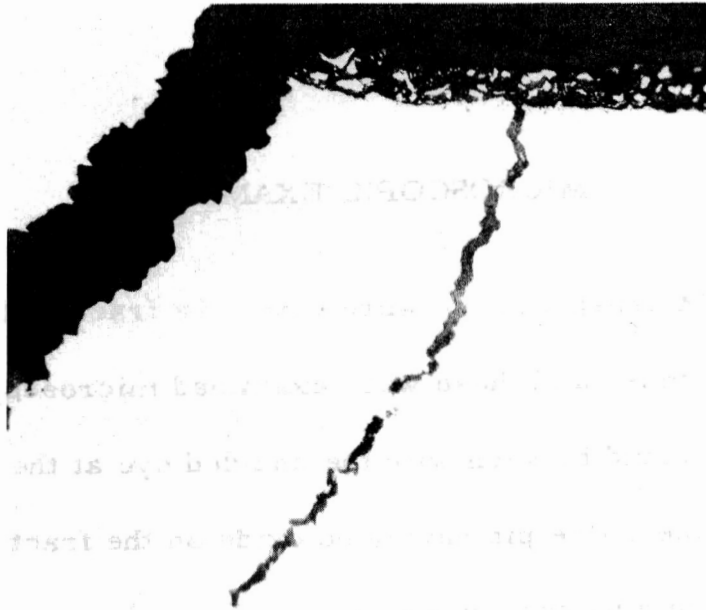
Figure 5. - Shows same field as in Figure 3 at a higher magnification. The oxide seen in the fine crack is indicative that the crack had been present for some time, and it is suspected that it was a quench-crack.

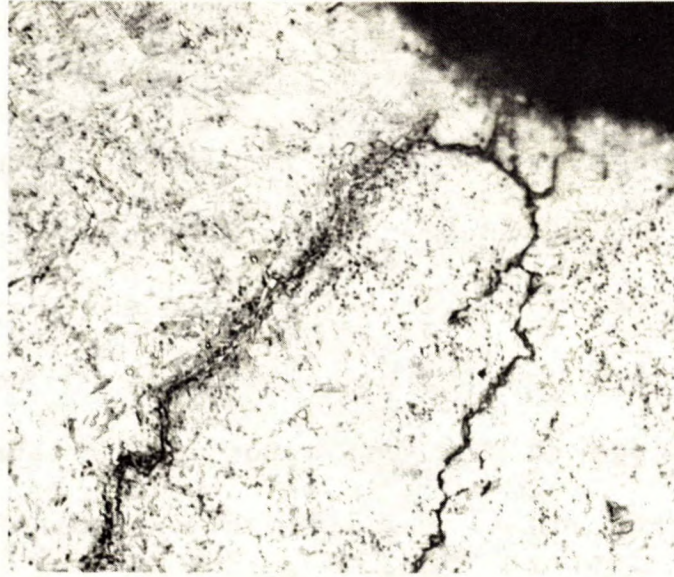
Figure 7. - Same field as in Figure 5, but etched, and at double the magnification. Matrix is very hard, brittle martensite.

The microstructure of the case of the pins is shown in Figures 7 and 8. The matrix is a high-carbon martensite. The high hardness (around Rc 63) is indicative that no tempering operation had been carried out. (While untempered martensite should not etch, it should be noted that the samples shown were mounted in bakelite, which in effect gave them a short temper at about 300°F). In most areas, a large number of grain boundary carbides were present. None was seen in the areas of crack initiation because the degree of carburization at these areas was less than average (since cracking started at internal angles).

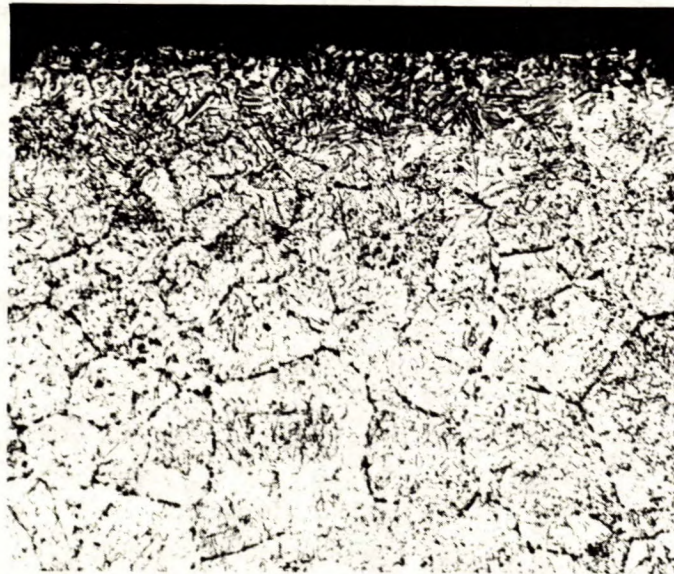
Figure 8. - Photograph taken at the surface of Sample 2. Shows the surface carbide network that could be seen at most of the surfaces of the samples. Note that such carbides were not found at the points of origin of the cracks, since these points were internal angles which had been carburized to a lesser degree than the more accessible surfaces.
