MINES BRANCH INVESTIGATION REPORT IR 59-66

EXAMINATION OF CURB STOP VALVE

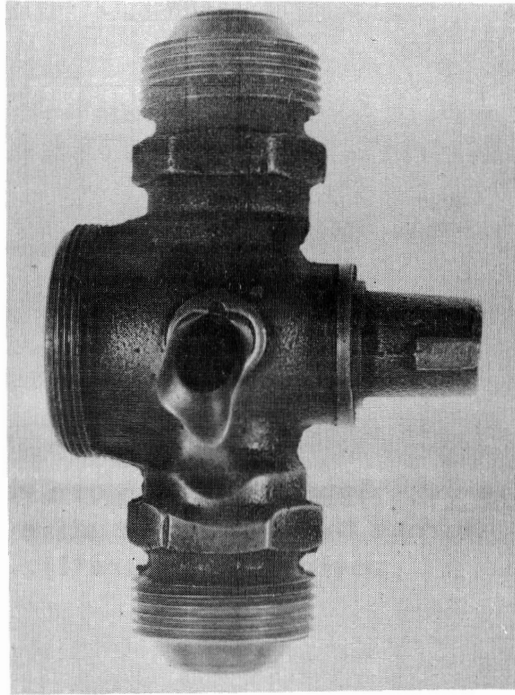
The large hole which had been worn through one side of the valve body and the pronounced directional wear of the outer surface is shown in Figure 1. The wear pattern points towards the outlet end of the valve. A characteristic feature of this and other severely worn internal areas was the polished surface which had been produced.

Figure 1. - External appearance of failed valve. Inlet end is uppermost.

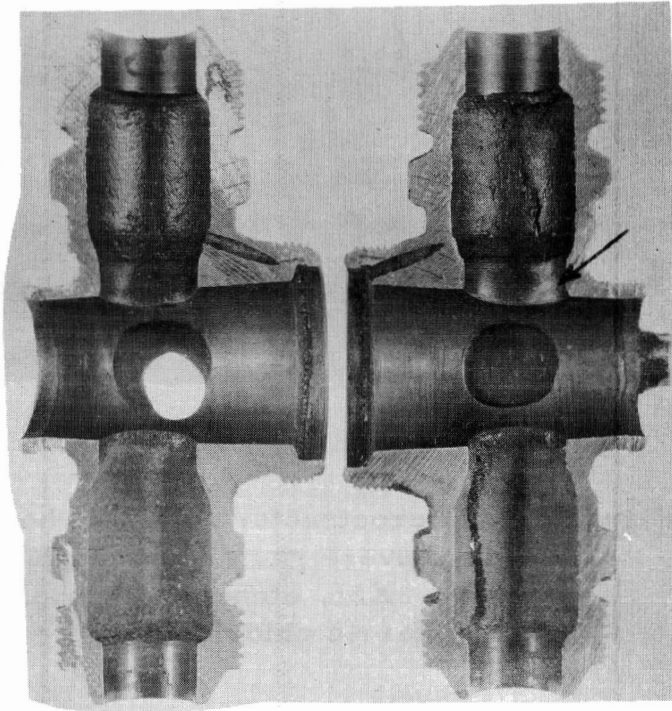
The sectioned valve body, with the inlet end uppermost, is shown in Figure 2. In addition to penetration of the wall, principal internal wear was confined to the highlighted area indicated by the arrow and to the oval-shaped markings on the side walls. The latter mated with the main passage of the valve plug when this was in the fully closed position. While the wear at different points in these oval areas was non-uniform the maximum depth of penetration was relatively small. This suggests that penetration of the valve body wall must have occurred at a fairly early stage in the process.

Figure 2. - Sectioned valve body showing internal wear.

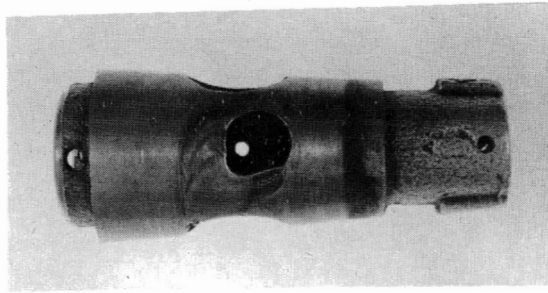
A photograph of the valve plug showing the large hole worn on the inlet-port side is shown in Figure 3. The degree of enlargement of the small pressure relief hole, which was presumably present originally, is clearly evident by comparison with the unaffected hole in the opposite side of the valve stem. Pronounced but variable wear was apparent on the internal walls of the plug orifice, and as mentioned above, all areas so affected showed a relatively smooth polish.

Figure 3. - Appearance of worn valve plug
(turned through 90° relative to
position in Figure 1).

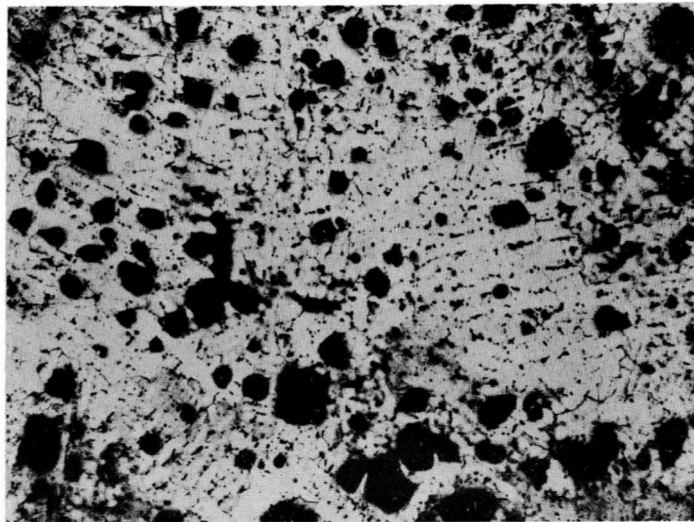
The only defect of note was an aggregation of fine to coarse pinhole porosity as illustrated in Figure 4. While the metal at and near the surface was sound, the otherwise general distribution of porosity suggested that this condition was principally related to excessive gas content of the alloy while molten. Shrinkage contraction was probably a contributing factor as indicated by the increased porosity in the thicker walls at the

Figure 4. - Microstructure of valve body
showing severe gas or shrinkage
porosity. X36, etched in alcoholic
ferric chloride.
