MINES BRANCH INVESTIGATION REPORT IR 59-77

EXAMINATION OF CRACKED STEEL CASTINGS

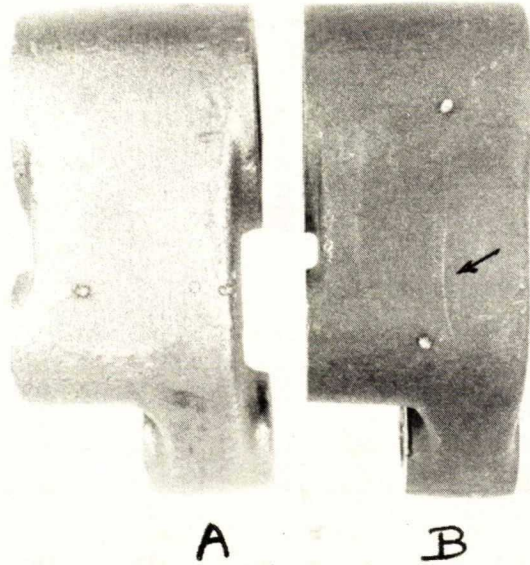
Figure 1 shows the castings under investigation. Both the visual and magnaflux examination revealed the presence of a crack on the machined castings (Figure 1), whereas those heat treated by the foundry and supplied to the customer showed no evidence of surface flaw or cracking. As a further check the castings were also examined radiographically. It confirmed the presence of a crack in the machined castings as detected by magnaflux, and showed that there was no other major defect in the body of the castings. It also indicated that there was no shrinkage around the area of the crack.

(Approx. 2-1/4 actual size)
Figure 1. - Photograph of unmachined (A) and machined (B) castings. Note the presence of crack (arrow) on machined casting.

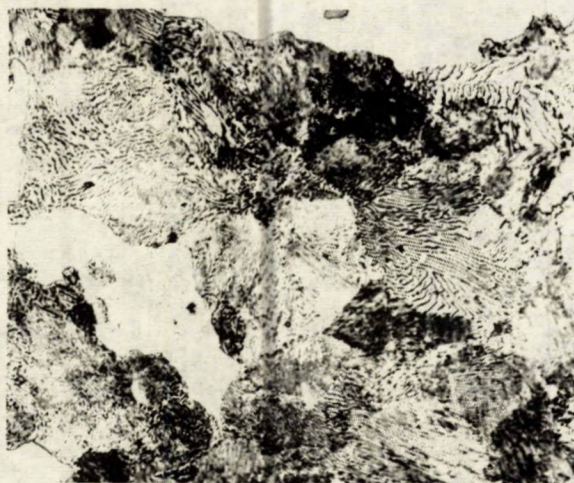
(Etched 2% nital; magnification X500)
Figure 4. - Microstructure of the casting as heat
treated by the foundry. Hardness: Rockwell
C 23 (240 Bhn).

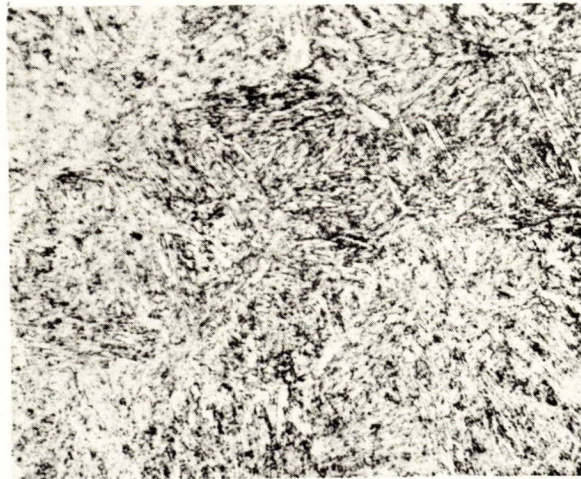
The microstructure of the castings as heat treated by the customer showed coarse tempered martensite (Figure 5) with the hardness of Rockwell C 38 (352 Bhn) against the desired level of Rockwell C 25-30 (255-283 Bhn). Presence of coarse tempered martensite is indicative of a high quenching temperature.

(Etched 2% nital; magnification X500)
Figure 5. - Microstructure after the customers'
heat treatment. Hardness: Rockwell C 38
(352 Bhn).

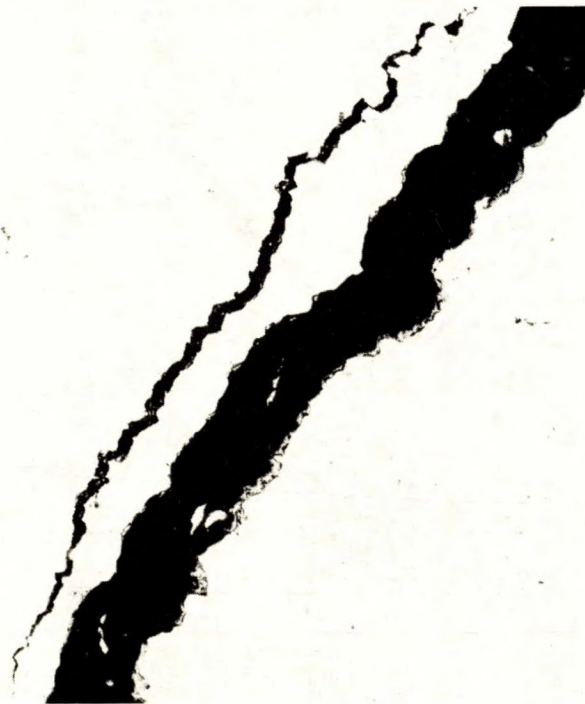
Metallographic examination of a section including the cracks (Figures 6A and 6B) showed that there was no decarburization along the crack area and that the cracks were of duplex nature following both inter- and trans-granular paths. The cracks did not

(Unetched; magnification X100)
Figure 6A. - Photomicrograph showing crack
area. Fine particles are sulphide.

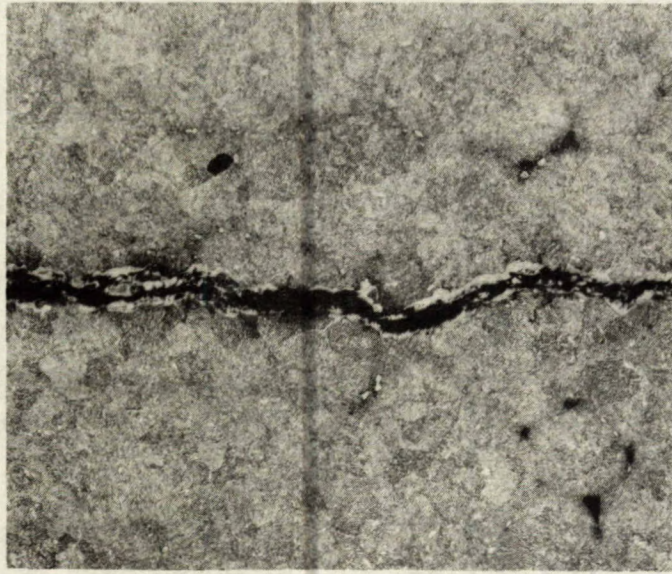
(Etched 2% nital; magnification X100)
Figure 6B. - Photomicrograph showing absence
of decarburization along the crack area.

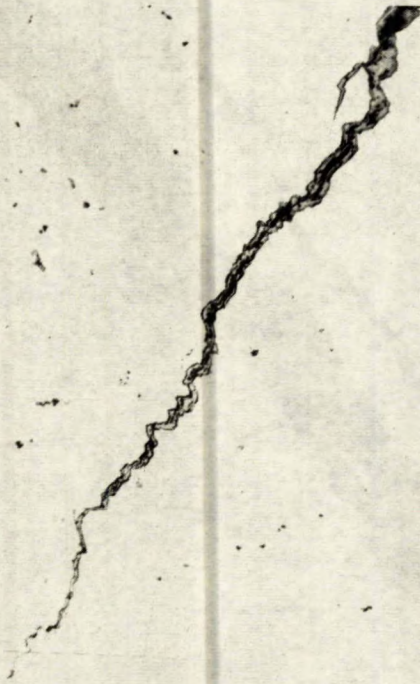
extend for the full thickness of the casting, but tapered out from the surface inwards (Figure 7). Furthermore, they were sharp-ended type, typical of those formed by sudden cooling or quenching of steel.

(Unetched; magnification X100)
Figure 7. - Photomicrograph of the bottom
position of the major crack shown in
Figure 6A.

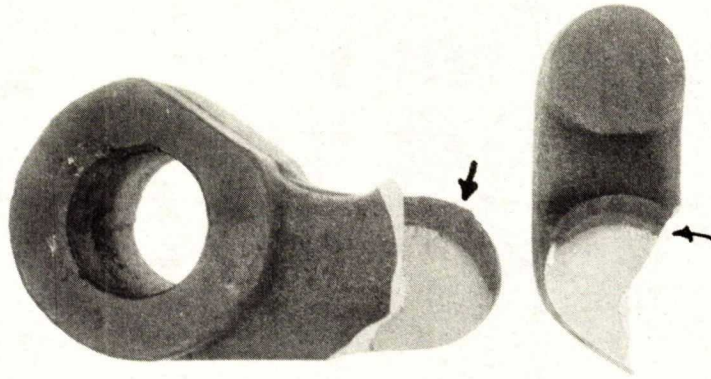
The same casting was later on oil-quenched at 1675°F. This treatment gave a hardness of Rockwell C 58 (587 Bhn). As anticipated the casting formed a typical quenching crack which, when opened with a hammer blow, showed characteristic brittle fracture as shown in Figure 8.

The crack formation may therefore be attributed to an unduly high quenching temperature which produces not only a grain coarsening effect, but also lowers the critical rate of cooling or the Ms* point of steel. A lowering of the critical cooling rate increases the hardenability of steel which in turn produces sharp volume changes in carbon and low-alloy steels from the surface to the interior. It may be added that an increase in carbon content would have the added effect of lowering the critical cooling rate of the casting.

(Approx. 2-1/4 actual size)
Figure 8. - Cracked casting after being quenched in oil from 1675 °F. Note the black rim (arrow) showing the area penetrated by oil after the crack formation.

(c) quenching temperature be maintained in the range of 1550 °F - 1600 °F as higher temperatures lower the adverse effect of depressing the Ms point, or increasing the critical rate of cooling resulting in crack formation.

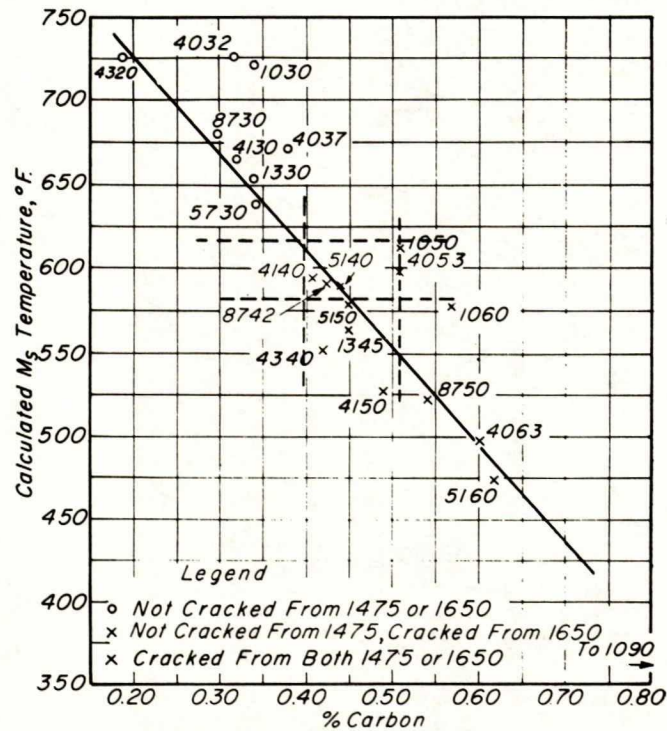
increased. Figure 9 summarizes their results. It will be seen that SAE 4140 steel with the M_s point at 594°F is appreciably less prone to cracking than SAE 4150 steel. One of the important deductions from Figure 9 is that the lower the temperature of martensite formation in the steel, the more likely it is to crack, because at lower temperatures there is less possibility of plastic flow to relieve stresses resulting from the expansion occurring during the martensite formation.

Figure 9. - Cracking tendency as related to Ms temperature and carbon content when quenched from 1475 °F to 1650 °F.

(a) the chemical composition of the castings be maintained within the SAE Specification 4140 which has an appreciably lower crack susceptibility than SAE 4150,
