MINES BRANCH INVESTIGATION REPORT IR 59-79

# METALLURGICAL EXAMINATION OF DEFECTIVE EXTRUDED SOLDER

G. W. TOOP AND J. O. EDWARDS

AUGUST 24, 1959

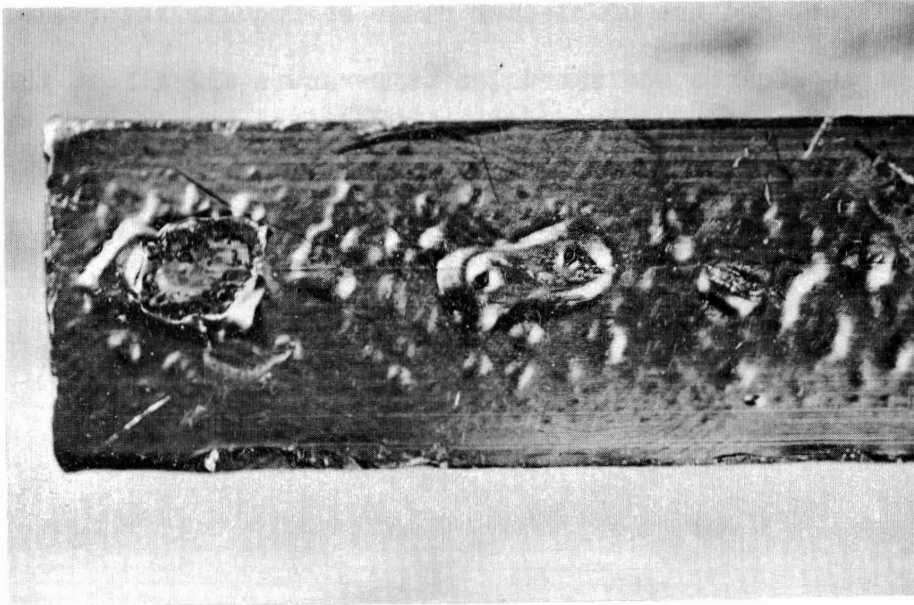
The samples of extruded solder exhibited prominent blisters and in some areas the defect was so deep seated that no blister formed but there was definite separation, causing the defect known to the manufacturer as "double skins", (see Figures 1 and 2). In some instances dark grease-like stains were seen between the two layers of metal and the interface was definitely oxidized. The dark stains

There is very strong evidence that the blisters and double skins are a result of butting a new ingot up to the end of the previous one which may have become concave in the final stages of extrusion, if too high an extrusion yield has been sought. When the new ingot is pushed into the hollow, air is trapped between the two layers of metal, which may only partially weld, and the result is a double skinned and blistered bar.

Figure 1. - View of exhibit No. 1, 70-30 extrusion, showing large blisters.

If successive ingots are extruded, care should be taken not to over-extrude any ingot, and excessive use of organic dressings should be avoided. Depending on the type of die used, extrusion ratio, etc., it should be possible to establish tables for good extrusion practice which the operator can follow. It is also advisable to clean out containers regularly to ensure that there is no excessive build-up of surface oxides on the container. This can readily be accomplished by the periodic use of a cleaning ring on the end of the ram.

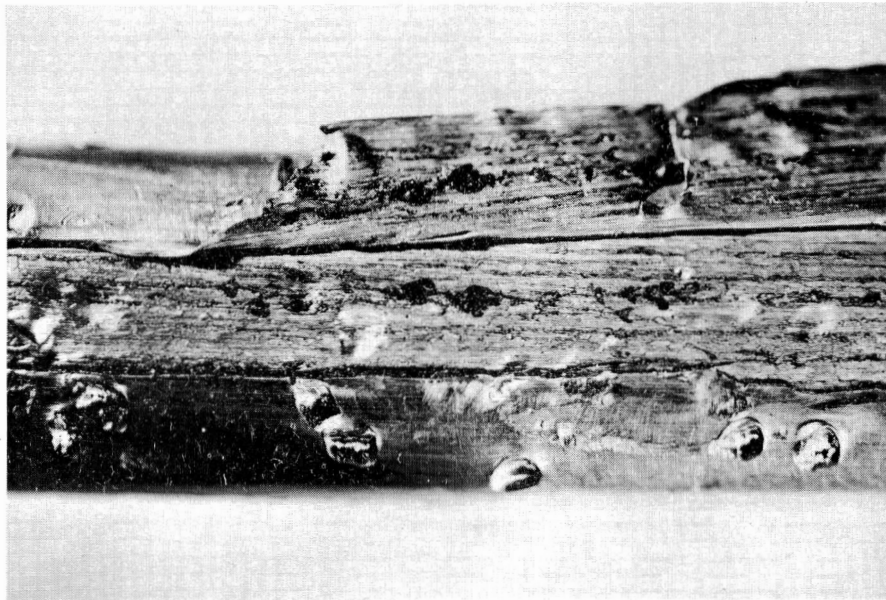
The dark grease-like stains between the metal layers may be

mould dressing, dressing from the die, container, dummy block, etc., or grease accidentally dropped on the billet. Using semi-continuous extrusion without butt end discard, this defect would probably occur at the beginning of a new ingot and, hence, at the end of the previous ingot. The central core of solder, shown in Figure 3, was impregnated with the grease-like material. These, and similar inclusions would account for the poor workability of some of the solder.

Figure 2. - View of exhibit No. 9, 60-40 extrusion. The outer skin has been bent away from the central core and dark stains are shown at the interface.

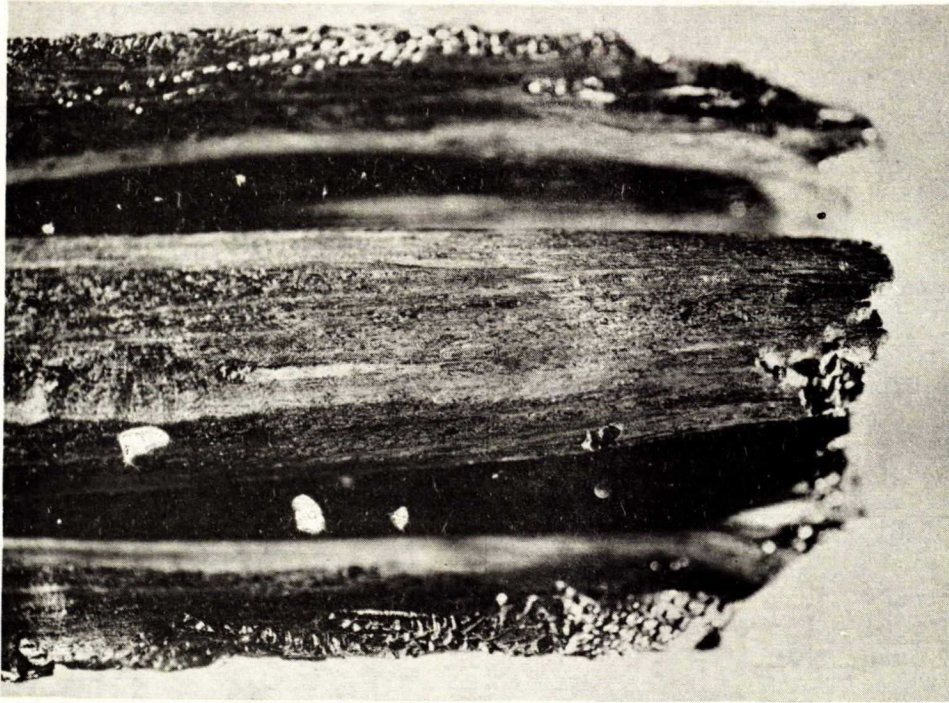
The outside skins on the extruded solder varied in thickness from a very thin layer to a very heavy layer which constituted almost half of the extruded cross-section of the solder (see Figure 3).

Figure 3. - View of exhibit No. 9, 60-40 extrusion. Note heavy outer skin. The inner core of this sample was impregnated with a black grease-like material.

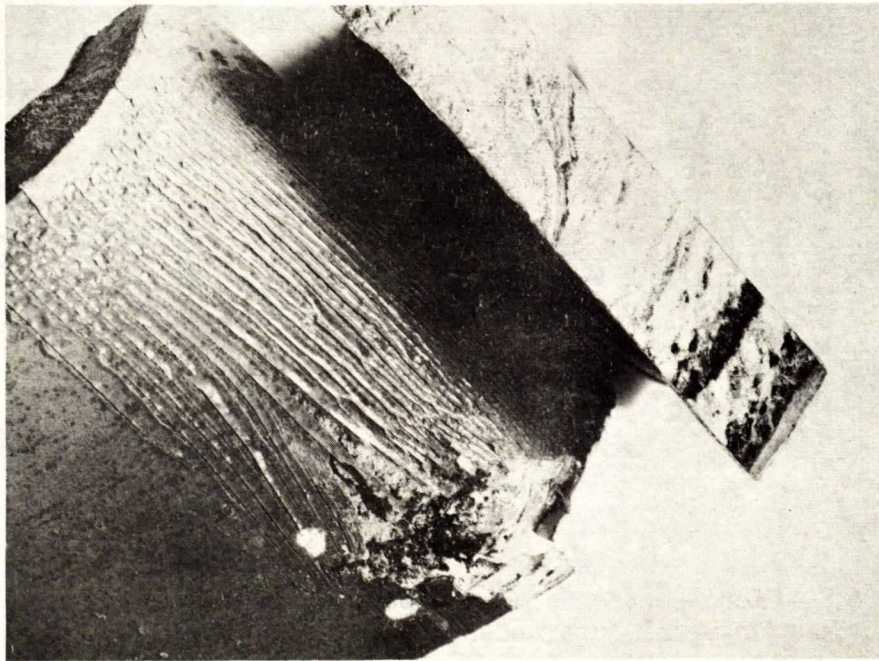
On the samples from the billets, folds and voids in the metal were visible on sections from both the inside and the outside. In addition, large dross inclusions were often associated with these laps. It was apparent that the laps were generated by pouring the metal in successive batches rather than continuously, and that there was at least partial freezing of the surface of one batch before the next batch was poured. The dross inclusions appeared to be concentrated at the surface of the billet, and may be due to insufficient skimming of the metal surface in the mould, or may be generated by turbulent pouring of the next batch of metal, the dross thus generated being trapped at the interface. These defects were particularly evident at the top of the billet where apparently feed metal had formed a number of well defined layers, each with an interface. These defects were not apparent on the samples as supplied but could be clearly seen on bending the samples (see Figure 4). Some shrinkage porosity and dross was also found on the interior of the billet by this method.

Considering the ingot samples first, bonding of the successive metal pours was not complete and voids and oxide inclusions in the ingot were associated with folds on the ingot surface. These defects could be minimized by reducing the number of successive pours per ingot, by careful skimming, and by taking particular care to avoid turbulence when pouring. Shrinkage cavities, open to the atmosphere in the top of the ingot, could account for some of the bubbles in the extruded solder. With a low melting point material, such as solder, these could easily be eliminated by some form of "hot top" or heater to ensure directional solidification. In addition, it is apparent that the heavily lapped top of the billets should be cut off before extrusion, if hand feeding is continued.

Figure 4. - Billet sample bent at surface lap showing depth of unbonded area and presence of inclusions. Note clean unbonded surface, from between successive pours, shown on upper billet sample.

It is recommended that billet quality be improved by the adaptation of melting or holding equipment so that a complete billet can be poured in one operation. Also, care should be taken that the metal is cleaned and skimmed before pouring and that pouring should be without turbulence. Some form of hot top to ensure the absence of shrinkage porosity is also recommended, and it may be necessary to cut off and discard the feed head of each billet.

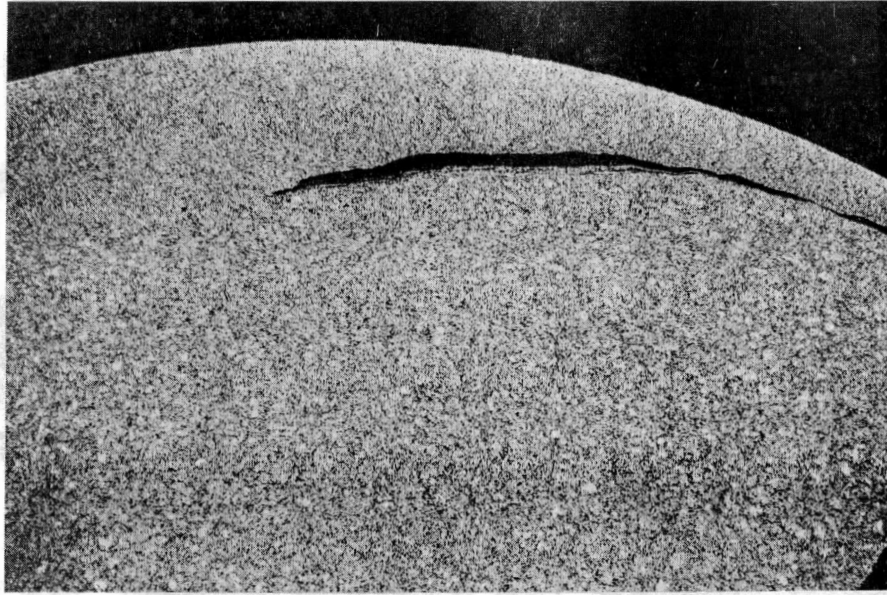
Specimens of the extruded and ingot solder were mounted and polished. Examination of the polished sections indicated that the outer skins adhered to the underlying metal in some areas and in other areas was quite non-adherent (see Figure 5).

Figure 5. - Micro-section of exhibit No. 9. Note only partial welding of outer skin.

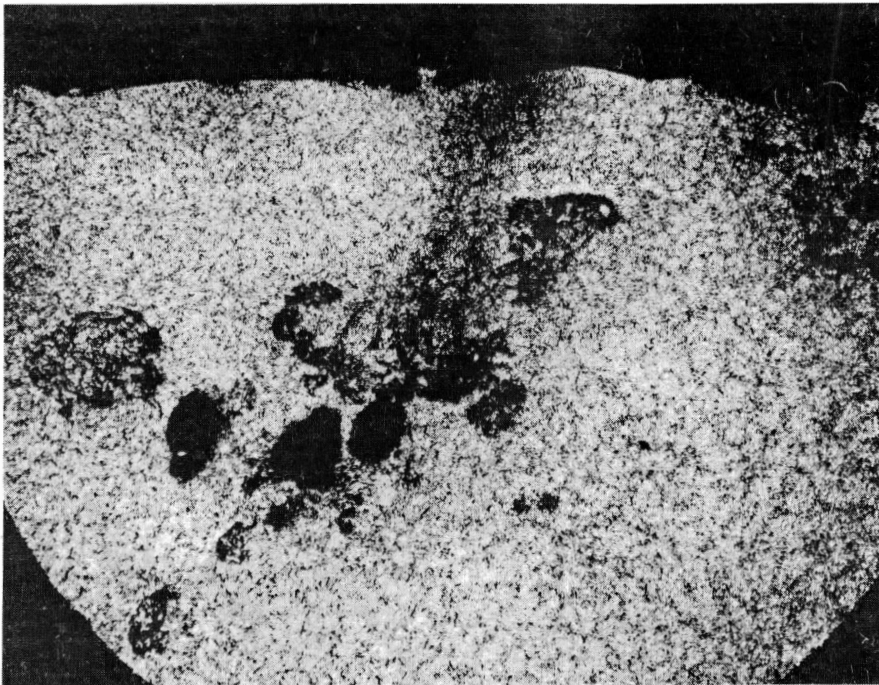
A micro section of the metal just under the ingot surface showed that rough surface defects, indicative of turbulent pouring, and oxide skins extended into the ingot (see Figure 6). Similar defects were found in the extruded sections (see Figure 7).

Figure 6. - Micro-section of ingot sample A5, showing voids and inclusions in metal just under the folded billet surface.

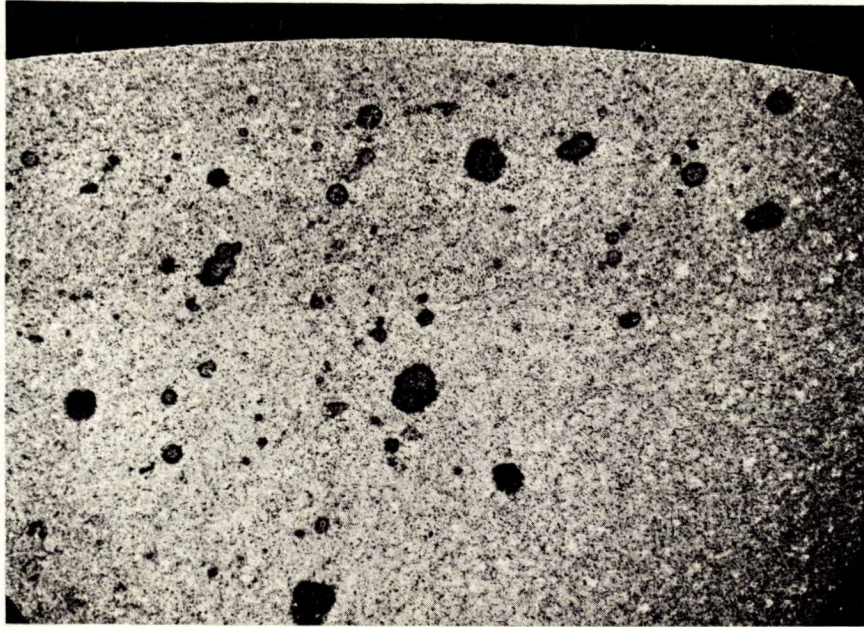
Figure 7. - Micro-section of exhibit No. 2, showing voids and inclusions in the extruded section.
