MINES BRANCH INVESTIGATION REPORT IR 60-60

**EXAMINATION OF TWO RAILWAY
ROLLER BEARING RACES**

D. E. PARSONS

JUNE 15, 1960

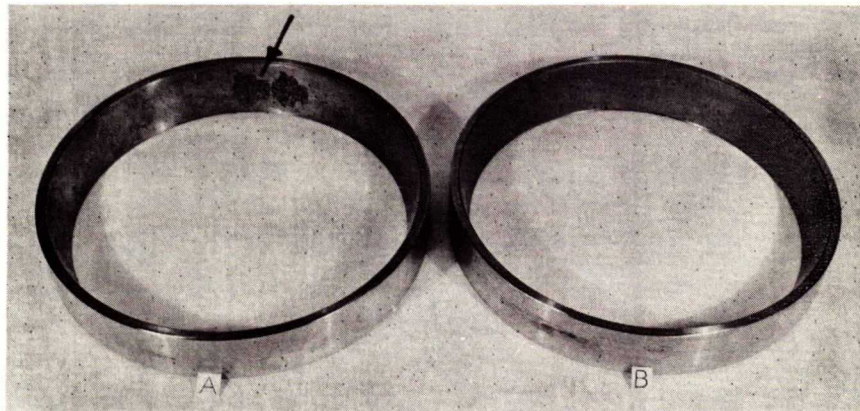
Figure 1. Timken bearing races X 1/5 approx. from the Quebec North Shore and Labrador Railway Company.

The inside, working-surface of sample A was shiny and polished but exhibited two "galled" areas (arrow). The same surface of sample B had a dull grey, matte or "etched" appearance but showed little evidence of wear.

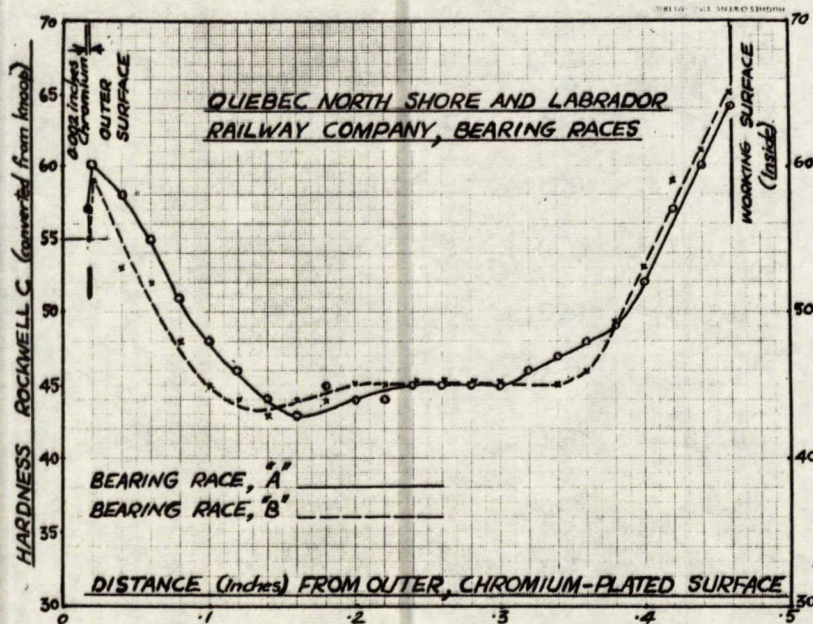
Figure 2

Transverse sections were cut through the bearing rings and Knoop hardness surveys were run from the outer, chromium-plated and carburized surface, through the core to the inner carburized working surface. The results of these surveys are shown in Fig. 2

The chromium plating on the outside surface of both races had a uniform thickness of 0.0025 in. and a hardness of Rockwell C 55 to 57 except for local areas on each race where the thickness of chromium plating had been reduced to 0.0004 in. This reduction in thickness of the plating was probably caused by wear or fretting corrosion between the plated surface and the bearing housing. The only other areas where the plating was non-uniform were the corners where thicker than average (up to 0.009 in.) deposits were observed.

The total depth of carburization, for both rings at the outer surface, beneath the chromium plating, was about 0.1 in. The surface hardness of the case beneath the chromium was Rockwell C 59 to 60.

The core hardness for both rings was of the order of Rockwell C 45.

The total case depths at the inside surfaces (working surfaces) of the races was approximately 0.15 in. The hardness of the working surfaces of both races was of the order of Rockwell C 64-65.

The hardness gradient at the interface between the case and the core was gradual, providing no abrupt hardness transition.

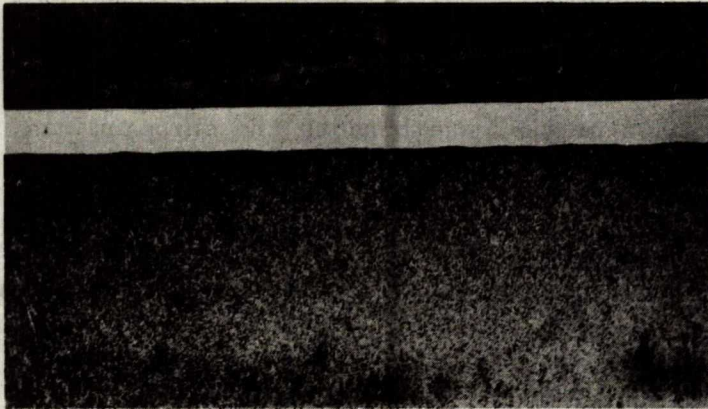
Figure 3. Typical Area of Unworn Chromium Plating.

The plating was generally similar to this material in both samples except for local areas of wear.

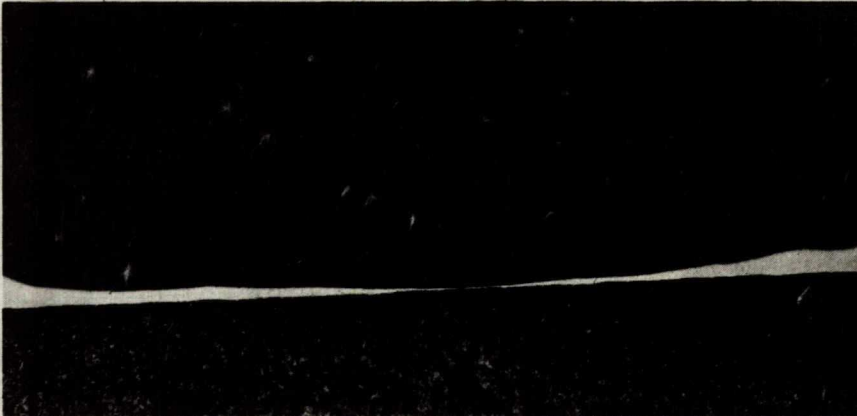
Figure 4. Area of Worn Chromium Plating.

Local areas similar to this were observed in both samples where the chromium plating had been reduced to 0.0004 in.

The thin spots (Figure 4) were observed in the chromium plating on the outside surfaces of both samples, and together with the "galled" areas on the working surface of sample A were probably the reason for rejection of the races from service.

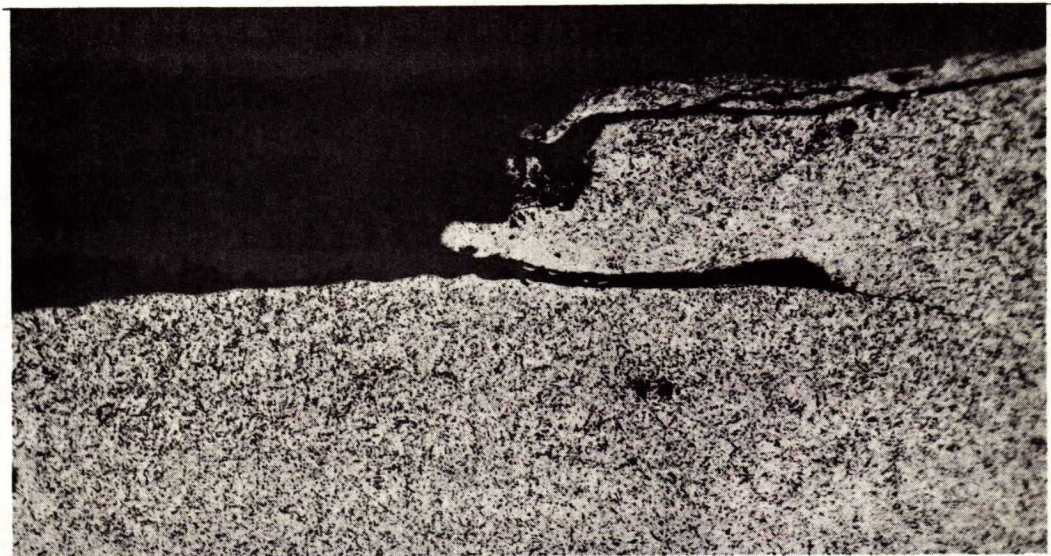
Examination of the working face of sample A showed no damage except in the "galled" areas where laps and torn surface metal were visible. A transverse section through the galled area of sample A is illustrated in Figure 5.

Figure 5. Transverse Section Through "Galled" Area Sample A.
Metal has been torn from this area by local welding
or "galling" of the rubbing surfaces.

Comparison of the working face of the "unetched" (sample A) and the "etched" (sample B) races showed that, in the galled areas of sample A, metal had been torn from the working surface and laps had formed, typical of local-welding or galling failure, but that no galling was present on the "etched" face of sample B.
