MINES BRANCH INVESTIGATION REPORT IR 60-73

# EXAMINATION OF A PITTED BOILER TUBE

D.E. PARSONS AND J.G. GARRISON

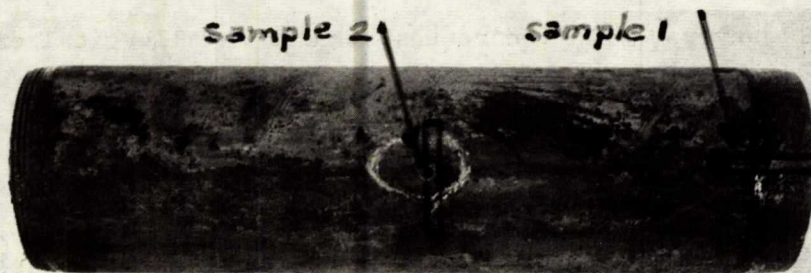
The length of boiler tube was photographed "as-received" and is illustrated in Figure 1. The deepest pit, which penetrated the tube wall, is outlined by a chalk mark in Figure 1. Numerous other pits were visible on the water surface of the tube. Each pit contained corrosion product. The inside surface of the tube was relatively smooth.

The water side of the tube was covered with black iron oxide and with a discontinuous deposit of boiler scale.

Figure 1. Boiler tube, as-received  
The outer surface of the tube (water side)  
is illustrated.  
The inner surface (fire side) was relatively  
smooth and clean.

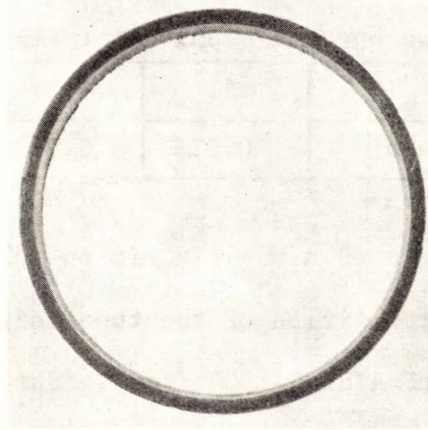
A cross-section of the tube was made and was deep-etched.  
No defects were observed in this etched ring section (Figure 2)  
taken adjacent to the pit.

Figure 2. Deep-etched cross section of the boiler tube.  
The microstructure and cleanness of this section after deep-etching 20 minutes in 1:1 HCL: water at 160°F, appeared normal.

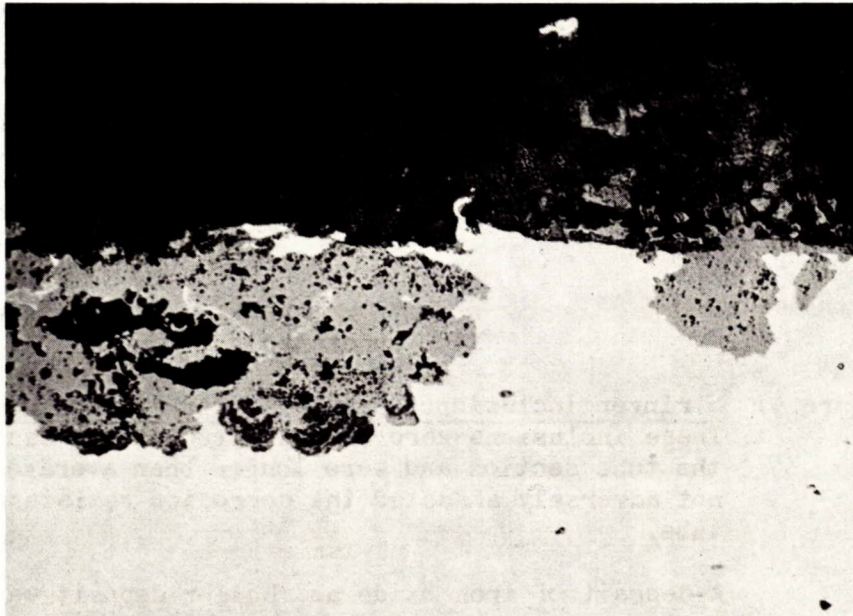
Two samples were obtained from the tube at the positions marked in Figure 1. Examination of these samples showed numerous corrosion pits on the water side of the tube which were filled with corrosion product as shown in Figure 3. The fire side of the tube was not affected by corrosion.

Figure 3. Water side of the tube, sample 1, longitudinal section  
Numerous pits were observed on this surface. One pit penetrated the tube, several penetrated about  $1/3$  the wall thickness. The pits were filled with corrosion product.

Evidence of corrosive attack and of accumulation of scale (Figures 3 and 5) was observed on the water side of the boiler tube, whereas the fire side of the tube was found to be clean and free from corrosive attack. No decarburization, grain growth or evidence of local overheating of the tube was observed.

Possibly, failure of similar boiler tubes could best be prevented by cleaning of the tubes prior to installation and by commencement of feed water treatment immediately after installation (1). Care should also be taken to avoid corrosion of the boiler during lay-up periods, for example, in the presence of acid condensate. During installation, care should be taken to avoid galvanic cells which can be formed by contact of dissimilar metals (copper and steel) in the presence of an electrolyte.

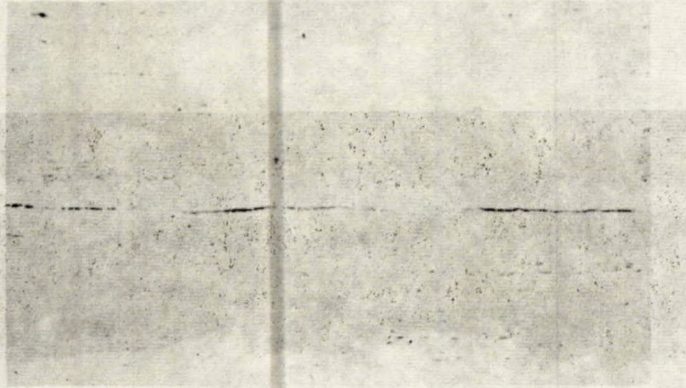
The longitudinal microspecimen shown as sample 1, Figure 1, contained stringer inclusions, as illustrated in Figure 4. These inclusions, although somewhat longer than average, had not contributed to the formation of pits.

Figure 4. Stringer inclusions, sample 1, longitudinal section  
These inclusions were concentrated at the centre of the tube section and were longer than average but had not adversely affected the corrosion resistance of the tube.

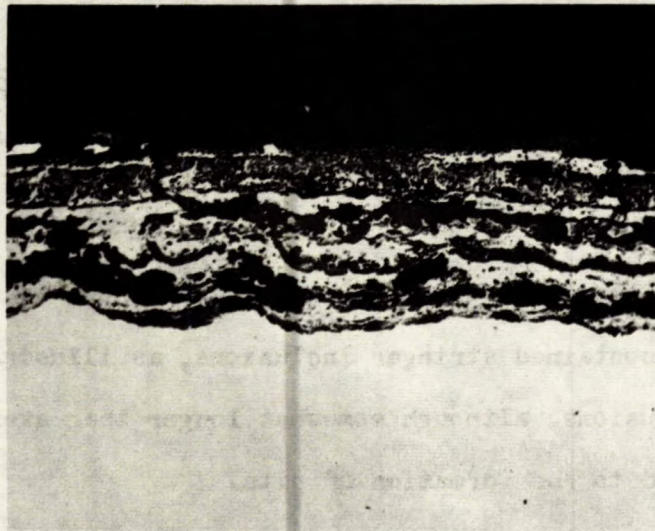
A deposit of iron oxide and boiler deposit was observed, in layers, on the water side of the tube, as shown in Figure 5.

Figure 5. Scale deposit in layers on the water surface of the tube. Sample 2, transverse section.  
The scale deposit appears thicker than normal. Its appearance suggests that scale has formed over a period of time and that it has not been effectively removed by feed water treatment.

The presence of the heavy, layered deposit of scale suggests attack of the steel surface, possibly by aggressive feed water or condensate prior to commencement of feed water control

(alkalinity and oxygen content). The presence of the heavy scale deposit also shows that feed water treatment has not been effective in cleaning and maintaining a clean tube surface.

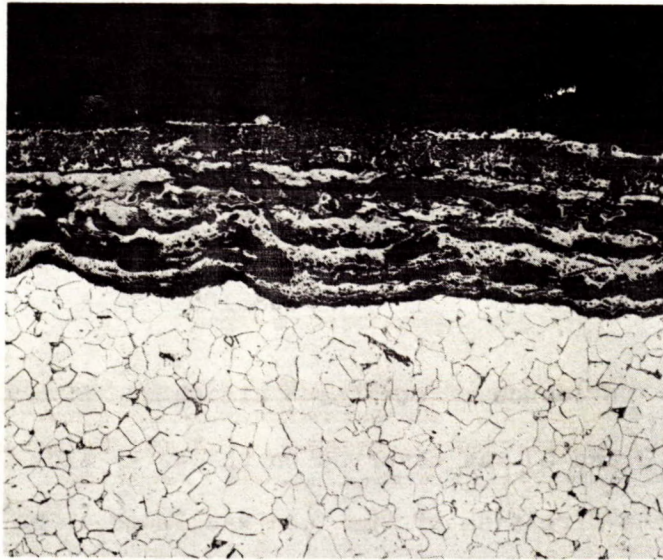
Figure 6 illustrates the etched transverse microstructure of sample 2. The ferrite grain size is small, corresponding to ASTM No. 7. No evidence of overheating was observed on the fire side of the tube. A transverse section illustrating the fire side surface is shown in Figure 7.

Figure 6. Sample 2, transverse section. Same area as Figure 5. The steel microstructure is typical of AISI-1008 steel having a fine ferrite grain size corresponding to ASTM No. 7.

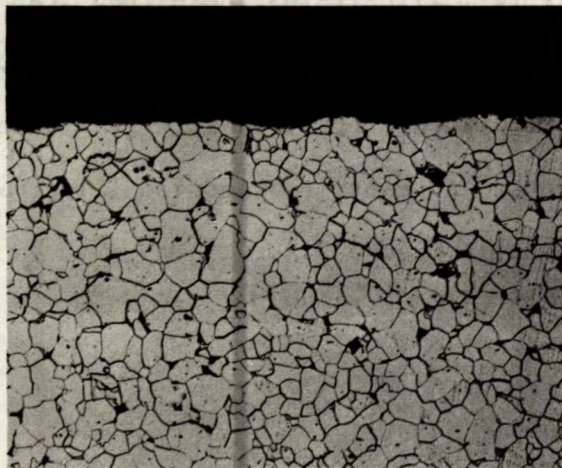
Figure 7. Sample 2, transverse section. Fire side surface of tube. The steel surface on the fire side was clean and, except for the perforation, was free from pitting. No evidence of local overheating was observed.
