MINES BRANCH INVESTIGATION REPORT IR 60-77

EXAMINATION OF CRACKED BOILER SAMPLES FROM T.S.S. 'PRINCESS HELENE.'

D. E. PARSONS

EXAMINATION OF CRACKED BOILER SAMPLES
FROM T.S.S. "PRINCESS HELENE."

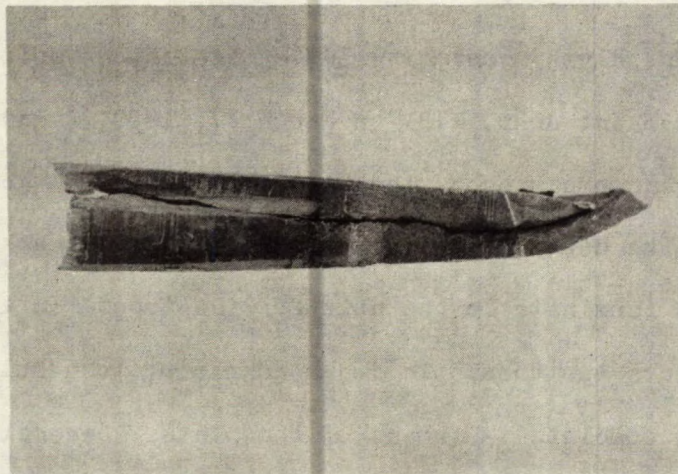
Figure 1. Tube hole surface (left), water side (right), and ligament crack. This metal, containing a crack, was cut from the water drum plate between two tube holes.

The fire side of the plate, Figure 3, appeared to be clean and was covered with an adherent black scale and was mildly pitted. The water surface of the plate, Figure 1, appeared to be clean and did not seem to be excessively coated with oxide or boiler deposit.

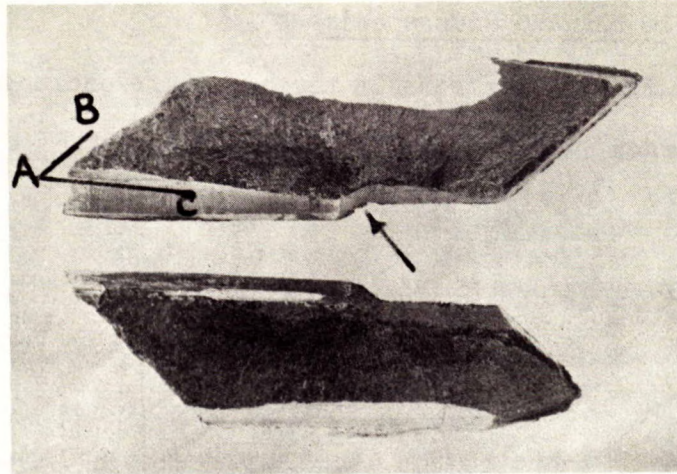
Figure 2. Crack surfaces, water side (right).
The appearance of the fracture suggests that the crack started on the water side at the change in section where the tube hole surface opened into the water drum (arrow).

The appearance of the crack surface, illustrated in Figure 2, suggests that the crack originated on the water side, where the tube hole surface met the water surface of the drum plate. The crack later changed direction and propagated, leaving a radial fracture pattern.

A shallow zone of heat-affected metal, where the pearlite was partially spheroidized, was observed on the tube hole surface in the position marked by the solid line in Figure 2. The affected zone was about 0.16 in. deep at position A, Figure 2. This metal should not have any adverse effect on mechanical properties and is not significant unless it indicates the presence of an adjacent weld or some condition of local overheating during operation of the boiler. The spheroidization observed could have been produced by heating in the temperature range 1000 to 1300°F for a short time or by heating for a longer period of time at lower temperature.

1. The appearance of the fracture, the fact that the crack had propagated slowly and the presence of corrosion product on the crack surface suggest fatigue failure possibly as a result of cyclic thermal stresses in the presence of a change of section.
2. A shallow zone of metal in the water drum plate, adjacent to the tube at the fire surface, had been heated to a temperature sufficient to cause spheroidization of the pearlite. (This zone is marked by the solid line A-B-C, Figure 2).
3. The steel composition, tensile strength, ductility and hardness appear normal for AISI 1020, cold-finished, carbon steel plate. The boiler tube material was a soft, low-carbon steel, resembling seamless boiler tubing supplied to ASIM A-83-55T having the

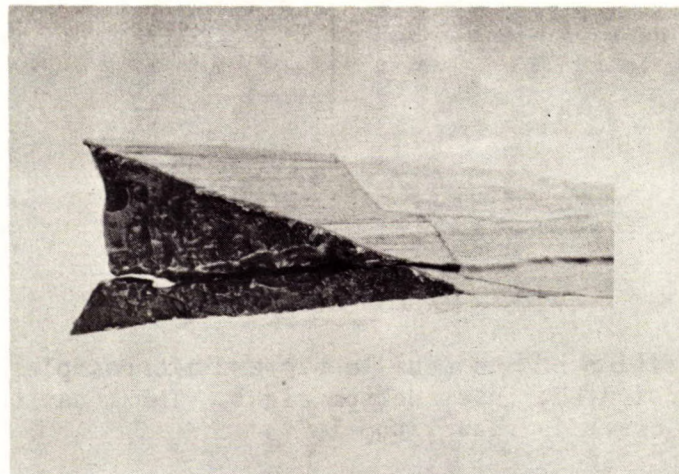
Figure 3. Fire side, water drum plate.
The fire side surface is slightly pitted, as illustrated left foreground.

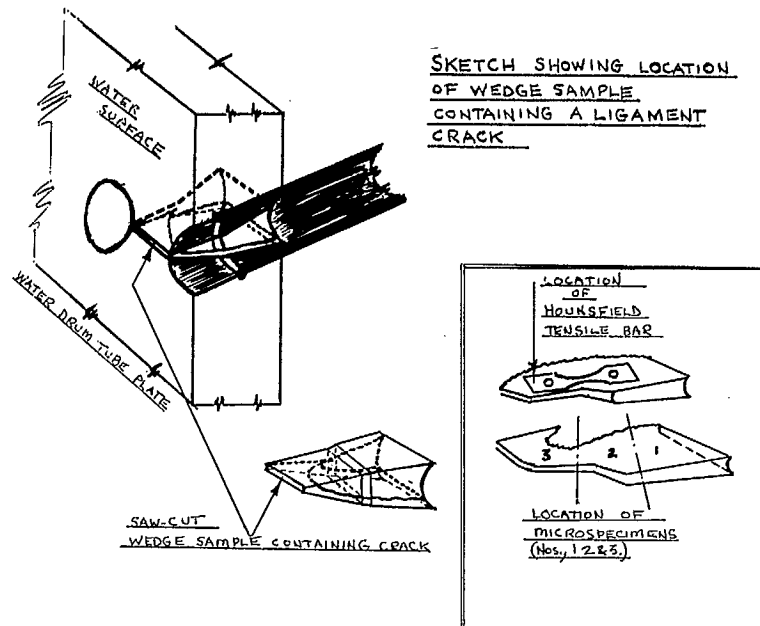
Figure 4. The position of the tensile bar and microsamples is illustrated, inset bottom right. The location of the crack is shown, top left.

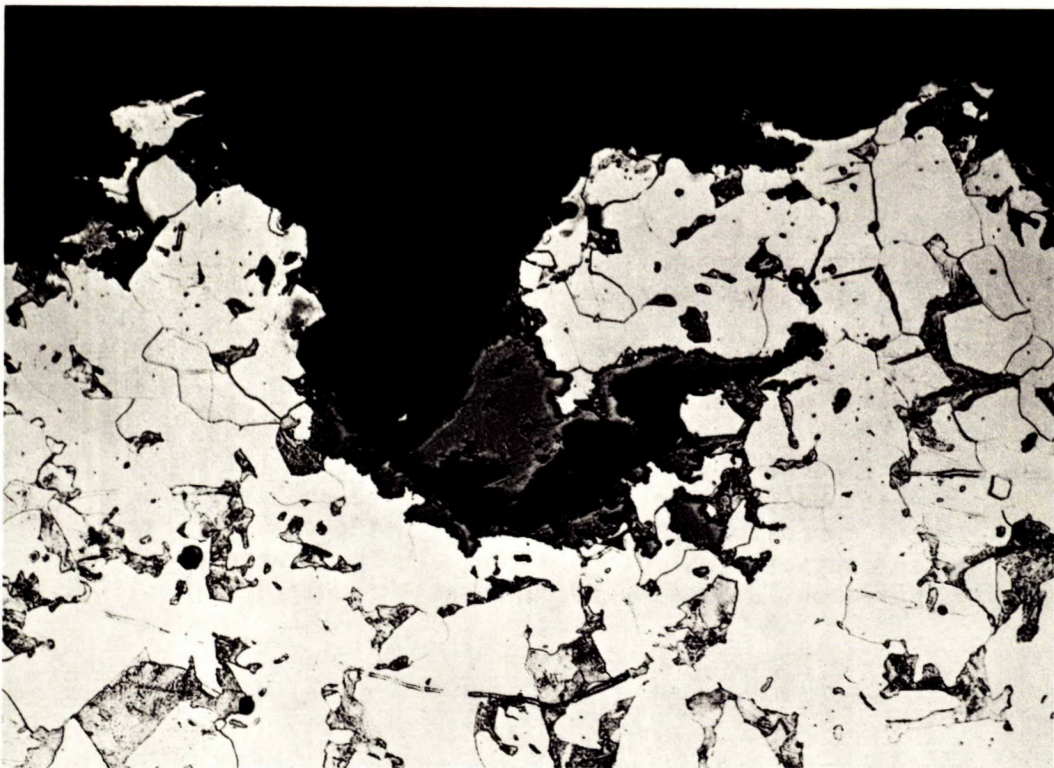
27 years of service, numerous shallow pits were present on the water side of the plate. These pits were filled with corrosion product. The path of the crack was transcrystalline and contained traces of corrosion product on the fracture surface, indicating that the crack had been exposed to the boiler water for a period of time prior to examination.

Figure 5 shows the absence of intercrystalline attack on the fracture surface and illustrates typical traces of corrosion product observed on this surface.

Figure 5. Crack surface showing corrosion product and trans-crystalline fracture path.
No evidence of intercrystalline (caustic) attack was observed.

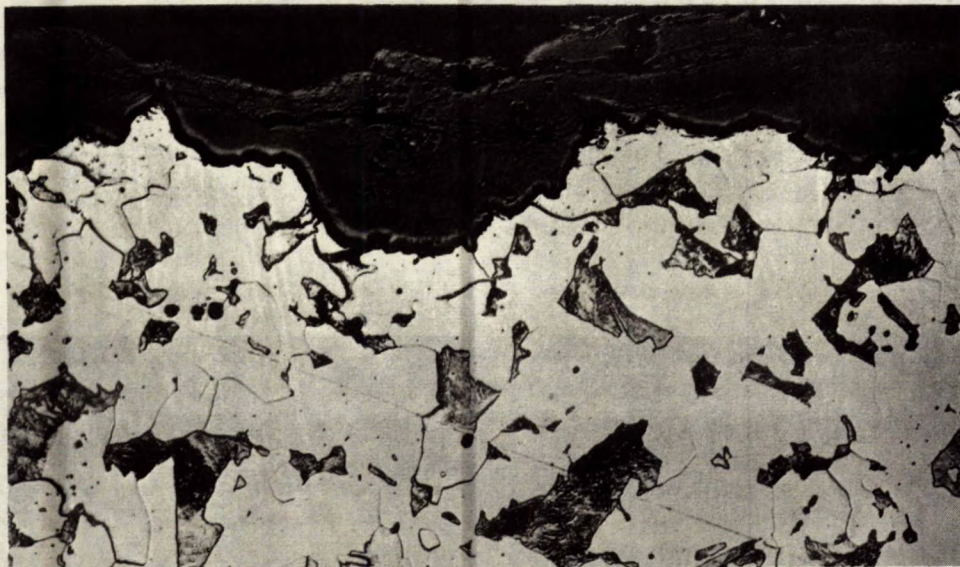
The plate microstructure, containing numerous random but shallow pits, for the surface in contact with the boiler water (water side) is illustrated in Figure 6.

Figure 6. Water drum plate - water side $\frac{1}{2}$ in. from fillet.
This photomicrograph illustrates the shallow pits and corrosion product observed on the plate surface in contact with boiler water. The pits were similar but about 3 times this depth at the change in section.

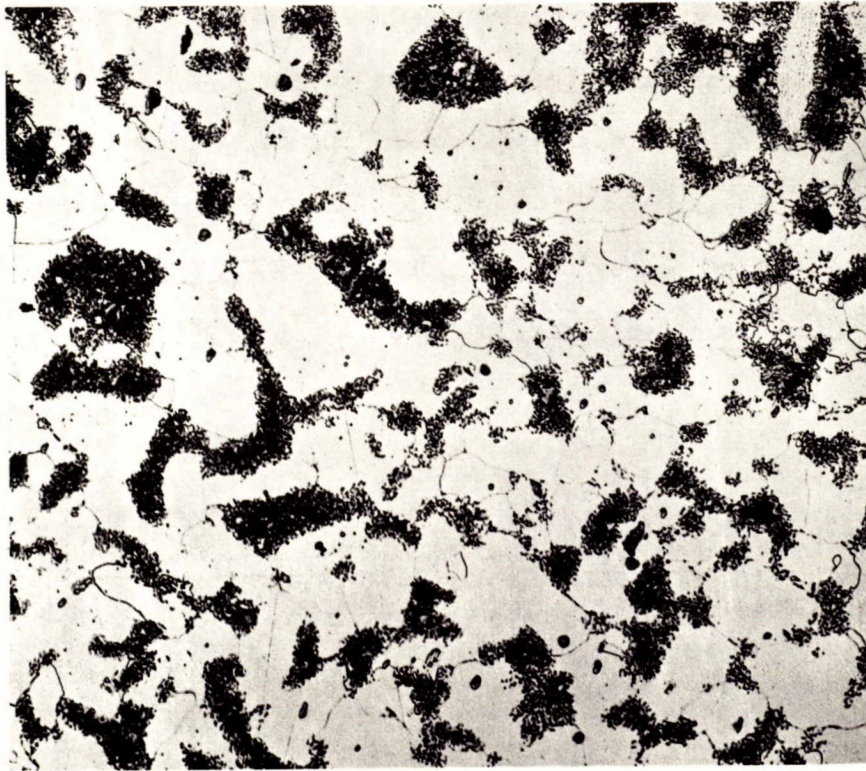
The heat-affected microstructure of the metal in the location corresponding to position A, Figure 2, is shown in Figure 7.

Figure 7. Water drum plate - spheroidized microstructure at the location corresponding to position A, Figure 2.

A shallow zone of spheroidized pearlite was present on the tube hole adjacent to the fire surface. This structural damage was limited to a shallow zone and should not affect the steel's properties, but its presence shows that the metal in this region has been heated, probably in the range 1000 to 1300°F.

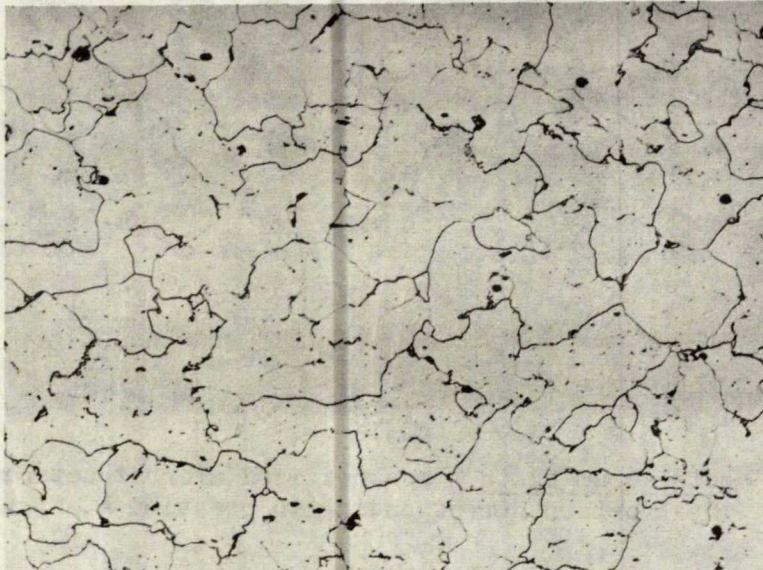
Metallographic examination of transverse sections cut through the sample of boiler tube supplied for examination showed that the carbon content of the steel was very low and appeared similar to that of seamless steel boiler tubing supplied to ASTM A-83-55T, having a maximum carbon content of 0.08%. The metal was clean and had a ferritic microstructure with traces of coarse carbide, as illustrated in Figure 8.

Figure 8. Typical microstructure of boiler tube taken from T.S.S. "Princess Helene," Johnson boiler.
