MINES BRANCH INVESTIGATION REPORT IR 60-112

# INVESTIGATION INTO THE STABILITY OF DUFFERIN TERRACE, QUEBEC CITY

A. BROWN AND F. L. CASEY

AUGUST 19, 1960

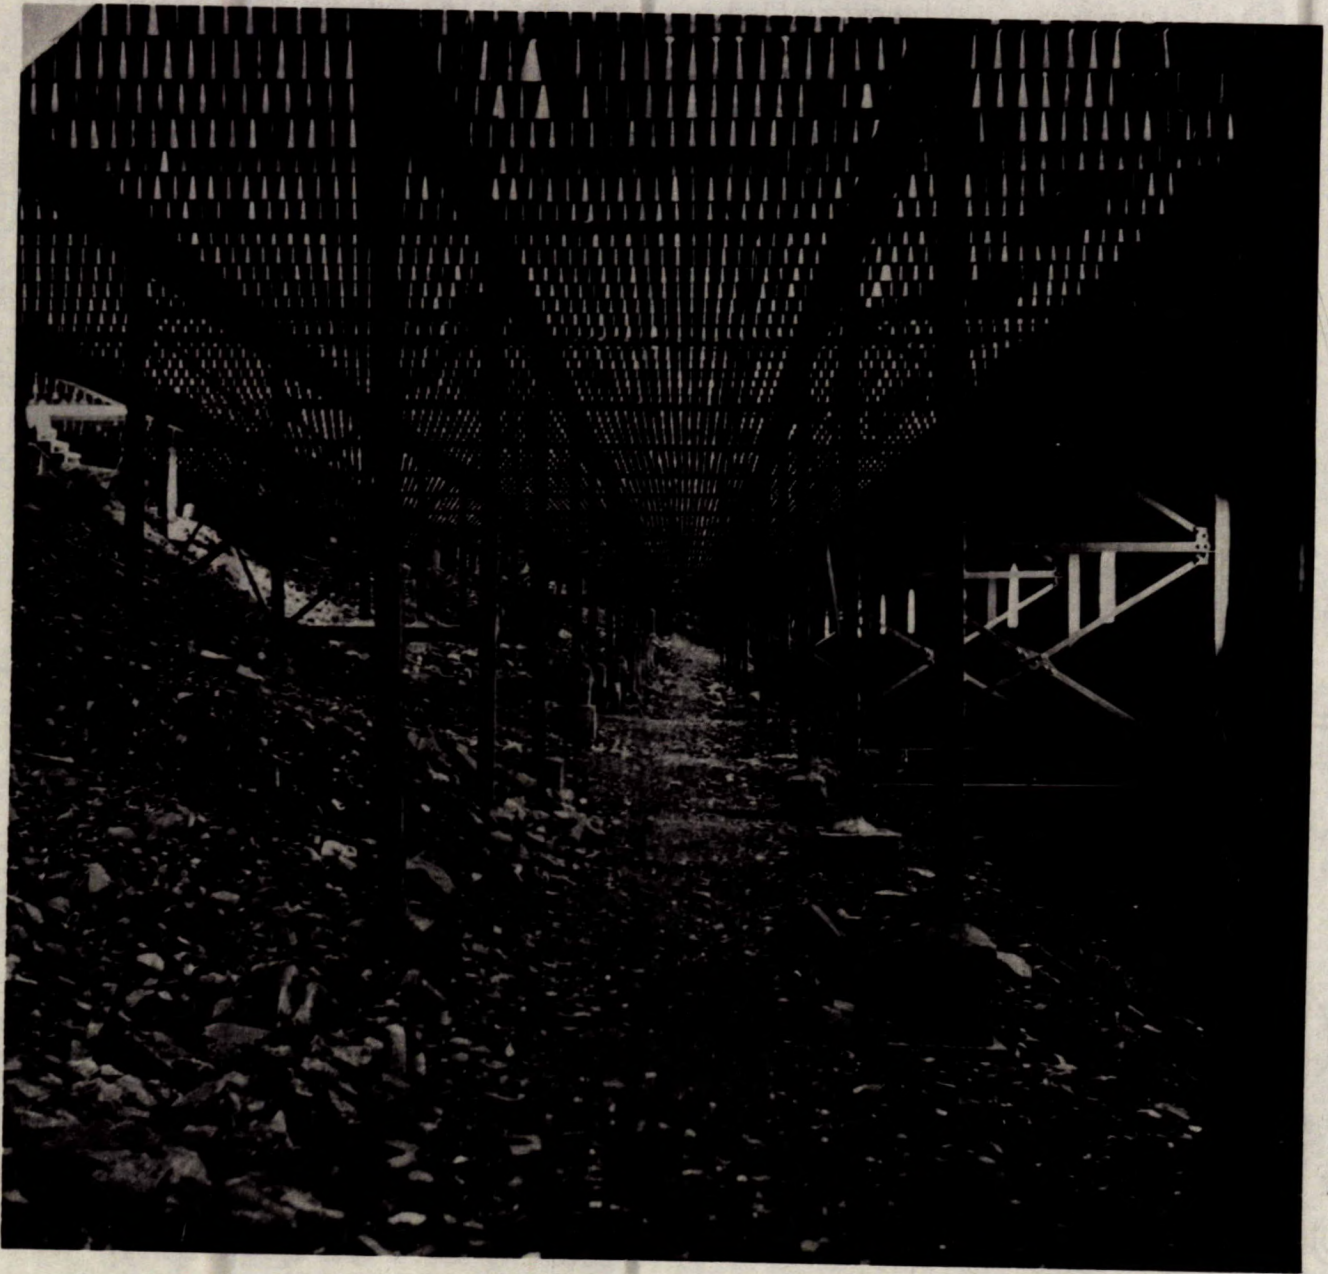
Figure 3. Understructure of Dufferin Terrace

long and from 30 to 70 feet wide. The weight of this plank deck is not carried by the front masonry wall, but is independently supported by a steel framework. The construction of this supporting framework is shown in Figure 3, which was taken below the promenade deck. In this picture, the front masonry wall can be seen on the right. Some idea can also be gained from this illustration of the amount of loose rubble that has accumulated over many years.

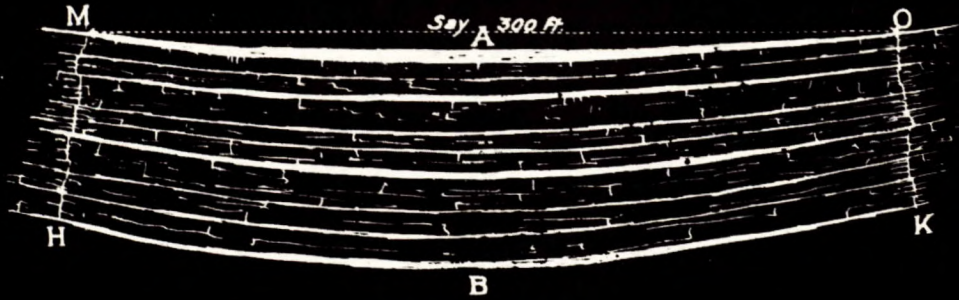
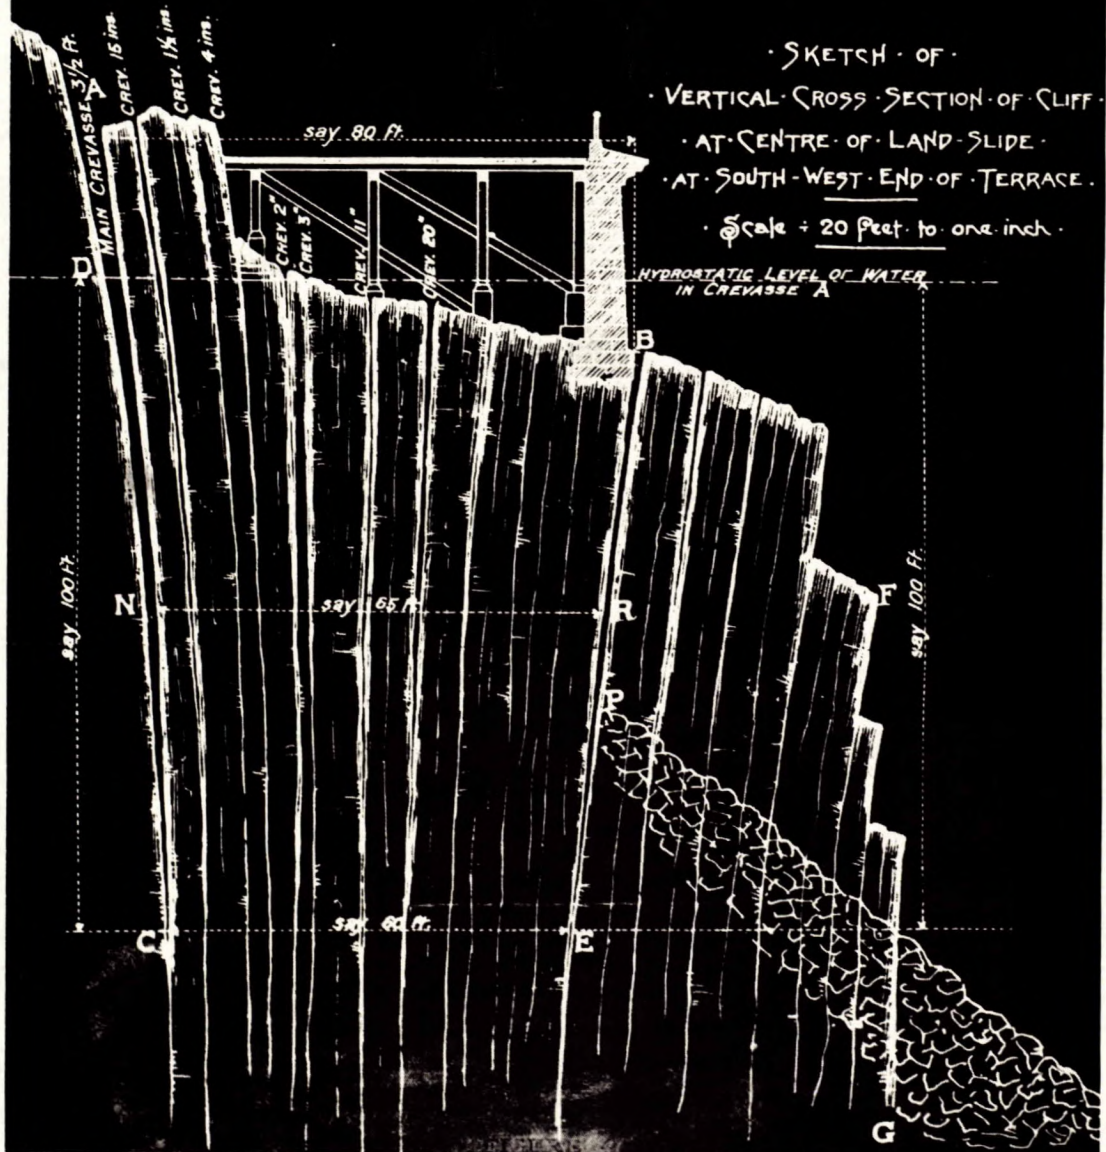
Figure 4. Fissures in cliffs according to C. Baillaigé

eight feet high and three to four feet thick to serve as a screen or fender. According to Mr. Baillairgé the houses on the opposite side of Champlain street were not purchased, and these were the ones overwhelmed by the landslide in 1889. Mr. Baillairgé's report on this disastrous occurrence of September 19, 1889, is the only comprehensive account available about a landslide at Dufferin Terrace. In summary, he reported<sup>(4)</sup> that the steeply dipping limestone beds are not in normal, intimate contact but have, over the years, separated from one another and opened up fissures of substantial widths. His ideas about the condition of the cliffs are well illustrated in Figure 4, which has been reproduced from the Baillairgé report. This illustration suggests that the fissures extend for substantial distances along the strike of the beds and to depths he postulates to be about 100 feet. Mr. Baillairgé also reported on the strongly-jointed condition of the limestone beds and expressed the opinion that these lines of weakness traversing the rock mass, in conjunction with the numerous fissures opened up along the bedding planes, create an unstable rock foundation beneath Dufferin Terrace. His report concluded that when these numerous fissures and open joint planes fill with water a hydrostatic force is developed within the rock mass that can, over a period of years, sufficiently weaken the escarpment and eventually cause a landslide. The need for adequate drainage of the escarpment was emphasized. Mr. Baillairgé also suggested the construction of a retaining wall at the foot of the cliffs, about 300 feet long, 40 feet high, and 20 feet thick at the base, tapering to 15 feet thick at the top.

collapse of an extensive portion of the southern end of Dufferin Terrace. For three or four days preceding the landslide there had been heavy rainfall in Quebec City, and in the twelve hours immediately preceding the event the rainfall had amounted to 3.4 inches.

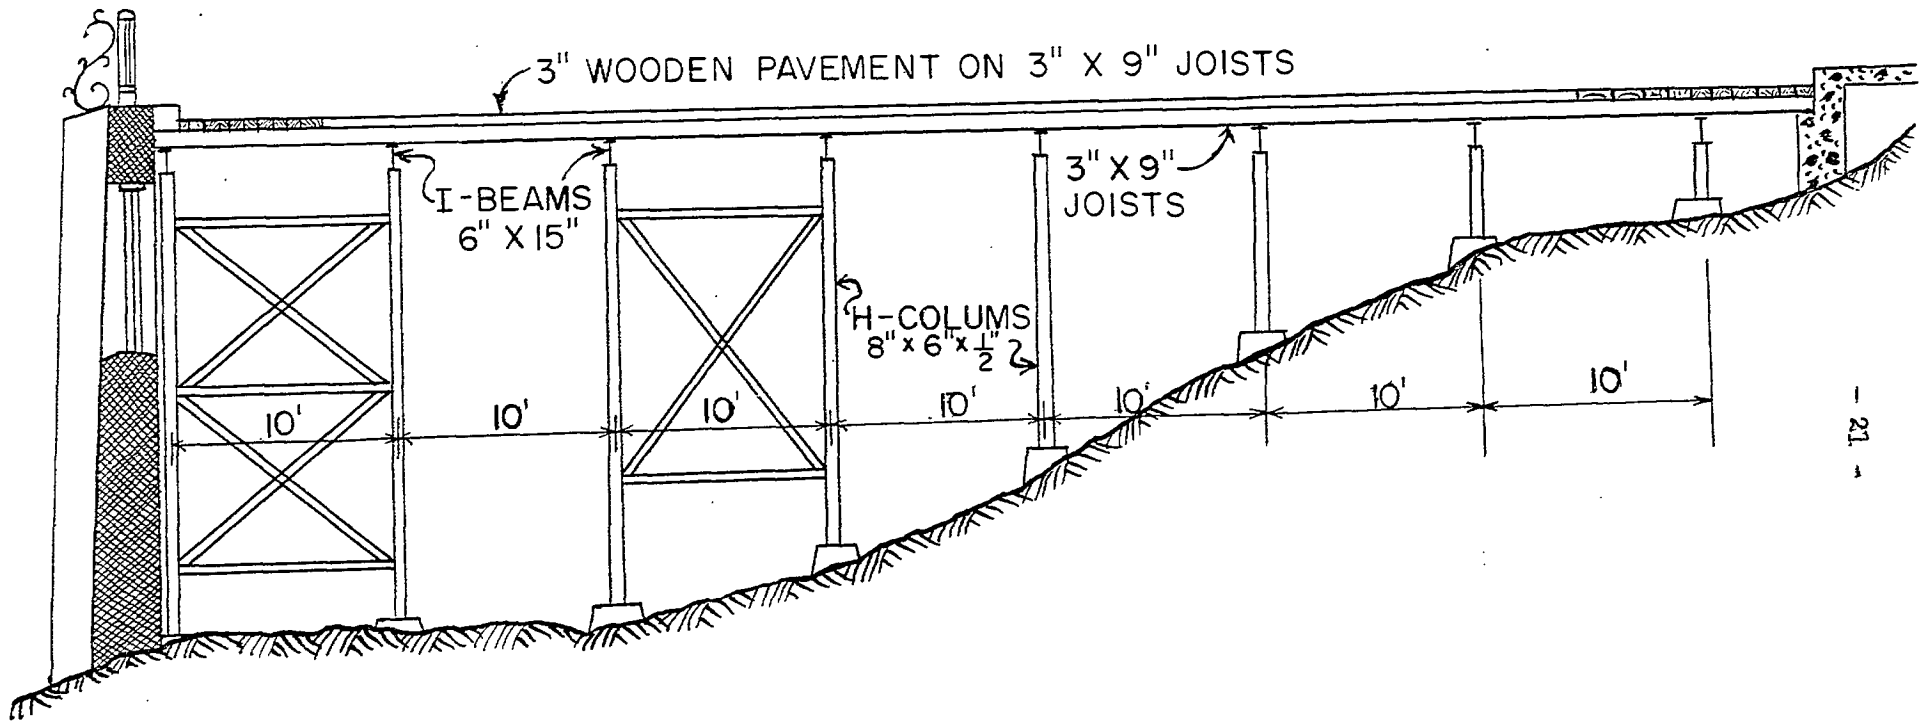
## TYPICAL CROSS SECTION

Following this inspection in Lower Town, an examination was made of Dufferin Terrace. The accompanying Figure 5 serves to illustrate a typical cross-section through this structure, and a profile of the rock surface on which it has been erected. As indicated earlier in this report, the wooden promenade deck is supported wholly by the steel framework, and the masonry front wall carries its own weight only. The steelwork, wood decking and masonry are in good condition, having been repaired or renewed in recent years by the Department of Northern Affairs and National Resources. An examination was made of the masonry front wall, particular attention being paid to signs of movement as evidenced by cracking of this brittle structure. From this preliminary examination it appeared that movement, if any, must be of a very slow order and perhaps, also, sporadic in nature. Some evidence of a regular system of horizontal cracks was observed in these walls along the northern half of the structure. These fissures were quite narrow, with small horizontal displacements, and occurred from one-third to half of the way up from the base of the walls. Some irregular cracking in the walls was also observed at the southern end of the Terrace. The rock surface on which the Terrace has been built was obscured by debris and, at the time of this visit, a layer of ice.

inspection was located beneath the southern half of the Terrace. This fissure was approximately ten inches open at its widest part and, while ice projections on its sides prevented plumbing for depth, it appeared to extend downward for a considerable distance. Of interest was the fact that a concrete block had been placed between the sides of this fissure some years ago. Examination of this block in 1957 showed no sign of any appreciable movement having taken place between the sides of this fissure. The apparent inactivity of this fissure, which is located well back from the vertical face of the escarpment, raises questions as to its originating cause of fracturing and the rate at which it has been opened to its present width. It is difficult to accept differential weathering as a probable cause, but it is interesting to conjecture that a wrenching action during the two major rock slides, that have occurred from the cliff faces adjacent to this fissure, may have dynamically produced it as well as other fissures not observed during this examination.

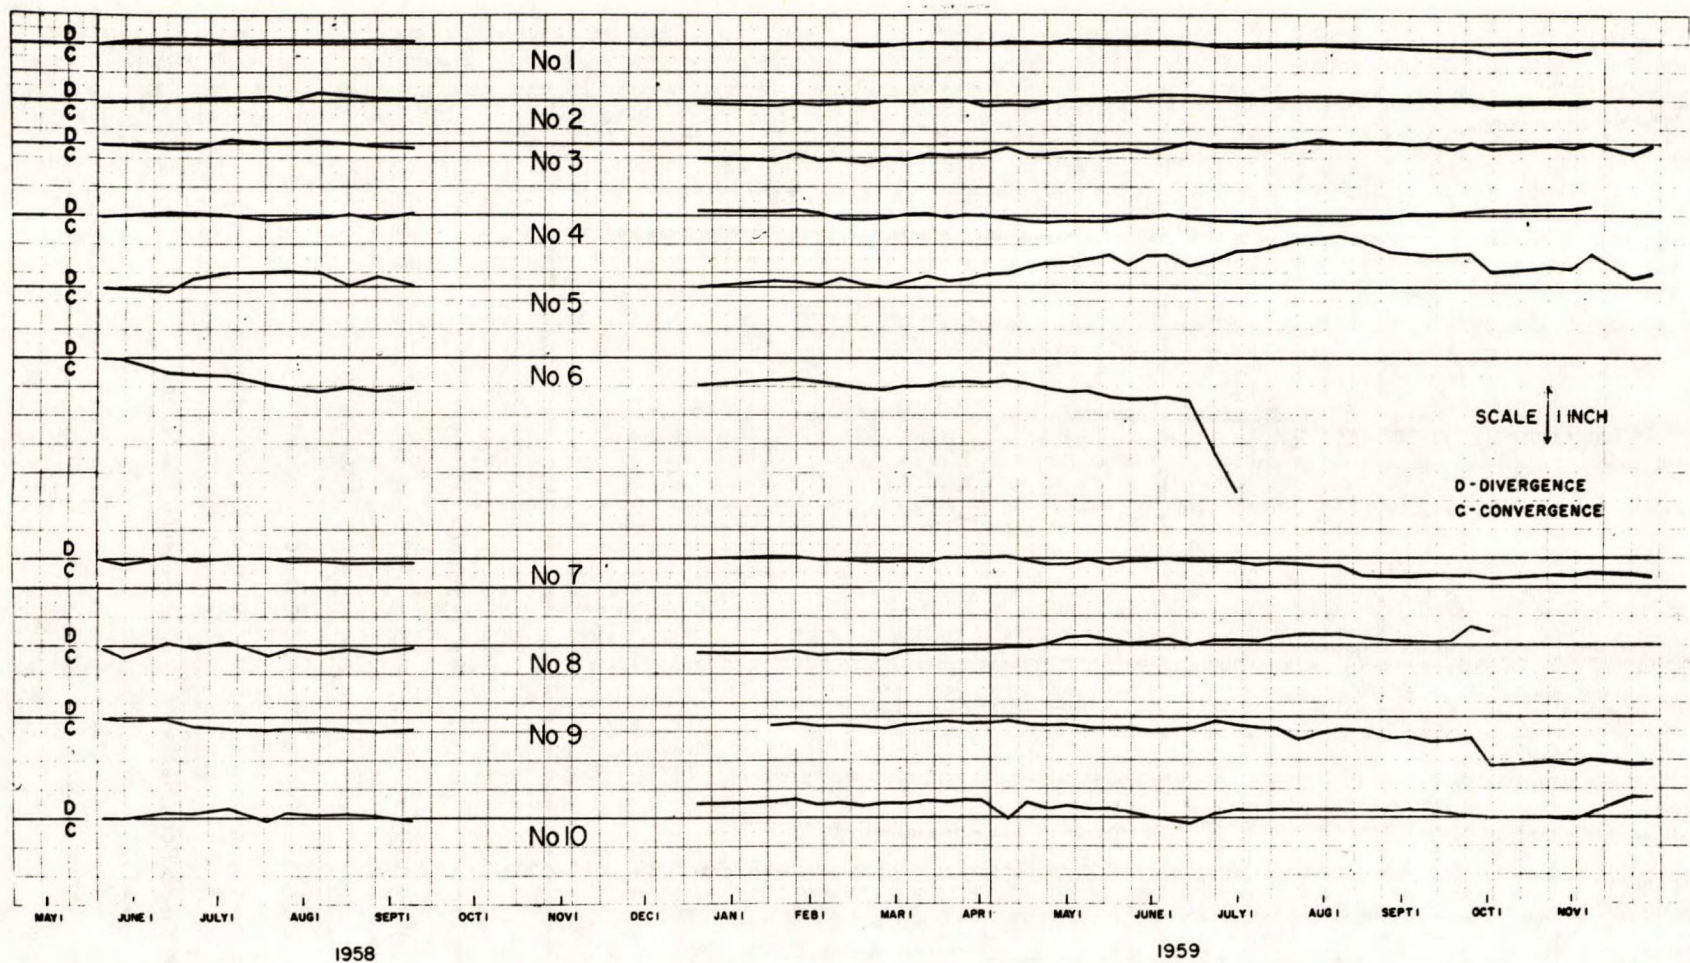
Figure 13. - Movements observed at Stations 1 to 10.  
 (Net change from Base Date in inches)

Referring to Figure 13, it will be observed that Stations 1, 2, 4 and 8 showed remarkable stability over the whole observation period, for the movements observed did not exceed the accepted observation error of  $\pm 0.12$  inch. This absence of movement is confirmed in Figure 14, where these same stations also indicate that no significant motion occurred in the main front wall at these four locations.

Stations 3, 7, 9 and 10 are a group of four stations that appeared to be stable during most of the observation period, but there are indications that sporadic movements did occur at each location. At Station 3, Figure 13, a convergence of approximately  $1/4$  inch was observed during the autumn of 1958, and this is confirmed reasonably well by the action shown at this station in Figure 14. The combined evidence indicates that around September, 1958, the front wall at Station 3 swayed toward the city (upper town) by approximately  $1/4$  inch. At Station 7, the Terrace remained quite stable until August, 1959, when, as illustrated in Figure 13, a convergence of approximately  $1/4$  inch occurred. The direction and time of this movement are confirmed in Figure 14, in which the front wall at Station 7 is shown as having moved toward the city (converged) in August, 1959. In May, 1960, as indicated in Figure 14, a more pronounced move of the front wall occurred at Station 7, and again in the direction of the city. This latter event occurred during the final month of the investigation, after the

The largest movements were observed at Stations 5 and 6. At Station 5, Figure 13, a diverging movement of approximately  $1/4$  inch occurred in June, 1958. Reference to this station, in Figure 14, also indicates front wall instability during June and July, 1958, but that the movement was a convergence, not a divergence. It is difficult to explain this inconsistency, unless the front wall moved outward at its foot and increased its inward slant at the same time. Further reference to Figure 13 indicates that a more pronounced divergence began at Station 5

The most abrupt movements observed during the investigation occurred at Station 6. A definite convergence was observed in July and August, 1958, amounting to approximately 1/2 inch. Thereafter, until May, 1959, no appreciable movement was observed at this location. In May, 1959, there was evidence of renewed activity, followed by a sudden and quite substantial convergence on June 7 and 10. Figure 15 is a reproduction of the chart taken from the automatic movement recorder that was employed at Station 6. The abrupt nature of the movements is apparent, and it may be mentioned that this type of sudden movement is typical of what has been observed at Dufferin Terrace. Reference to Figure 14 will show that, despite the convergence observed in July, 1958, at Station 6, no changes were observed in the verticality of the main front wall, indicating that it was very likely remaining stationary. This left the possibility that the convergence was caused by an inward movement of the rear wall of the Terrace. Following the more substantial convergence of June, 1959, the rear wall was examined by the Department of Northern Affairs and National Resources, and it was found that the rear wall had cracked at this location and had been thrust forward. It is considered that the break was caused by earth pressure against the wall.

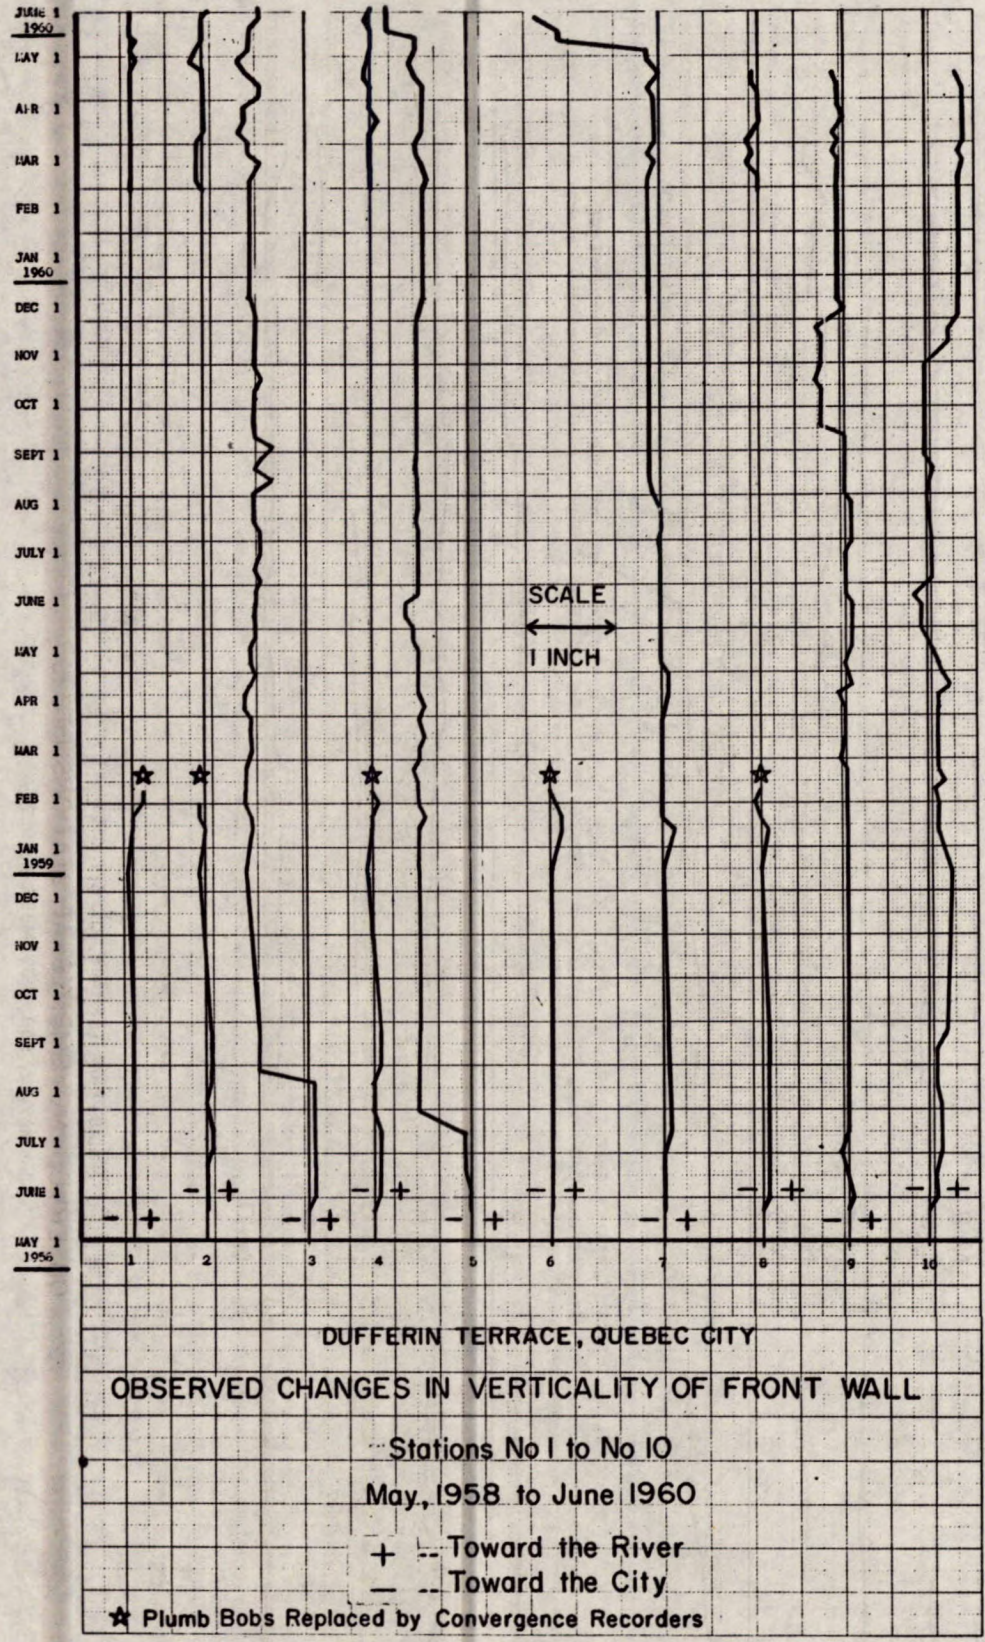
Figure 14. Changes in verticality of front wall of Dufferin Terrace

The observed changes in verticality of the front rampart of the Terrace are listed in Table 18, and graphically represented for all ten observation stations in Figure 14. For each station in Figure 14, any change to the left of its position in May, 1958, represents a shift of the front rampart toward the city, and any change to the right of this originally observed position represents a movement toward the river, or eastward. The observed movements could readily have been converted to degrees of inclination, but it is considered that a clearer idea of the magnitude of movement is imparted by presenting the actual movement, in inches, of the plumb-bob.

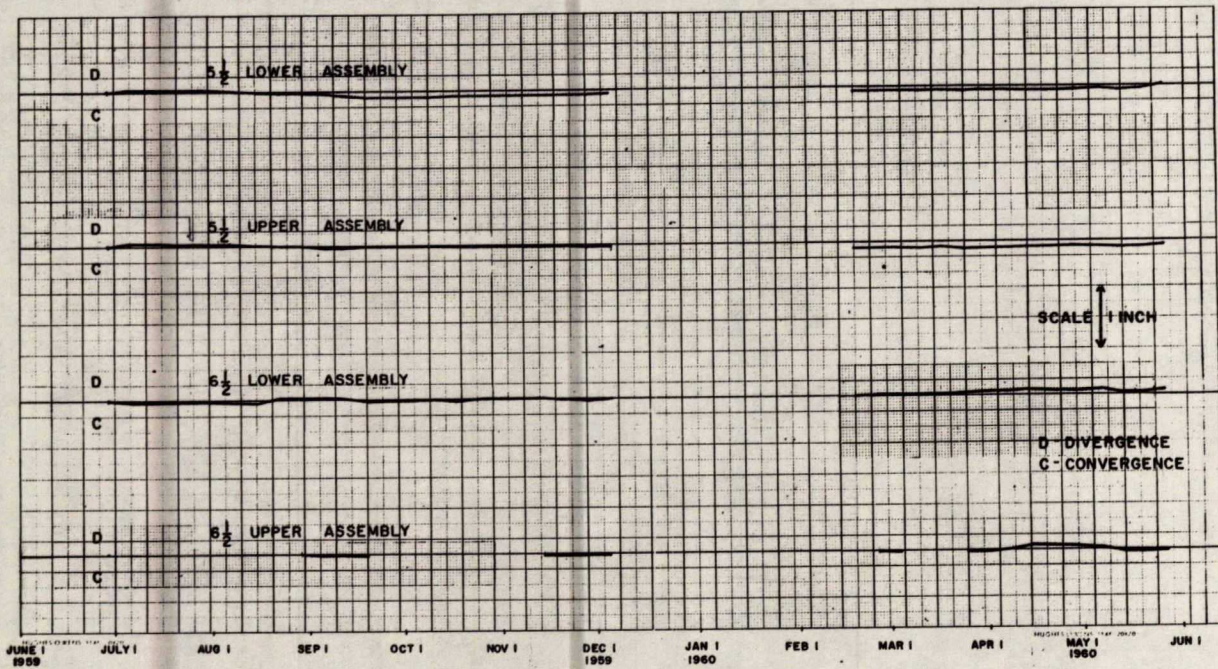
Figure 16. Movements observed at special pedestal stations

special installations that were made to check the observed instability at Stations 5 and 6. From June 1959 to May 1960, during which time these stations were under observation, no significant amount of movement was recorded. This suggests a period of stability at this portion of Dufferin Terrace.

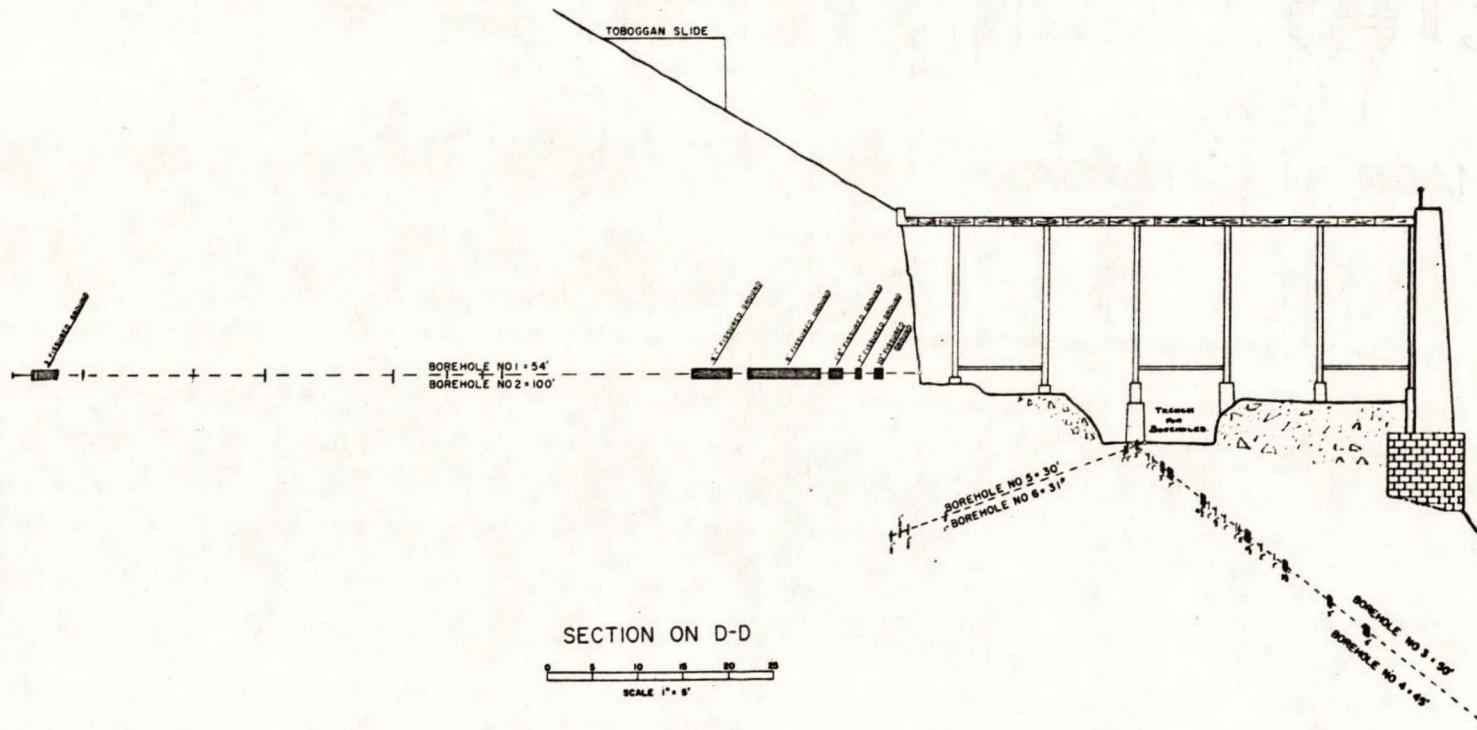
Figure 21. Fissures observed in boreholes 1 to 6

Figures 21 and 22 illustrate the fissures observed in the boreholes drilled in the escarpment. As already indicated, advantage was taken of two favorable locations in the vicinity of the boreholes to trench to bed rock and expose the tops of certain fissures. The results are illustrated in Figures 23 and 24. The widest fissures exposed by this trenching were 8 inches and 22 inches, respectively. In summary of the results of the borehole examinations and surface trenching, the main fissuring was observed to follow the planes of stratification, and was associated with less prominent breaks perpendicular to these bedding planes. No fissures were observed as wide as those reported by earlier investigators but despite this it is considered that the views expressed by G. Baillaigé with respect to water infiltration are still sound, for a multitude of smaller fissures can be quite as effective as a few larger crevasses in allowing water to enter the rock mass.

To summarize, the examination of the steeply inclined strata at Dufferin Terrace indicates that they are heavily fissured and permeable to water. The escarpment should therefore be regarded as a weak geological structure.

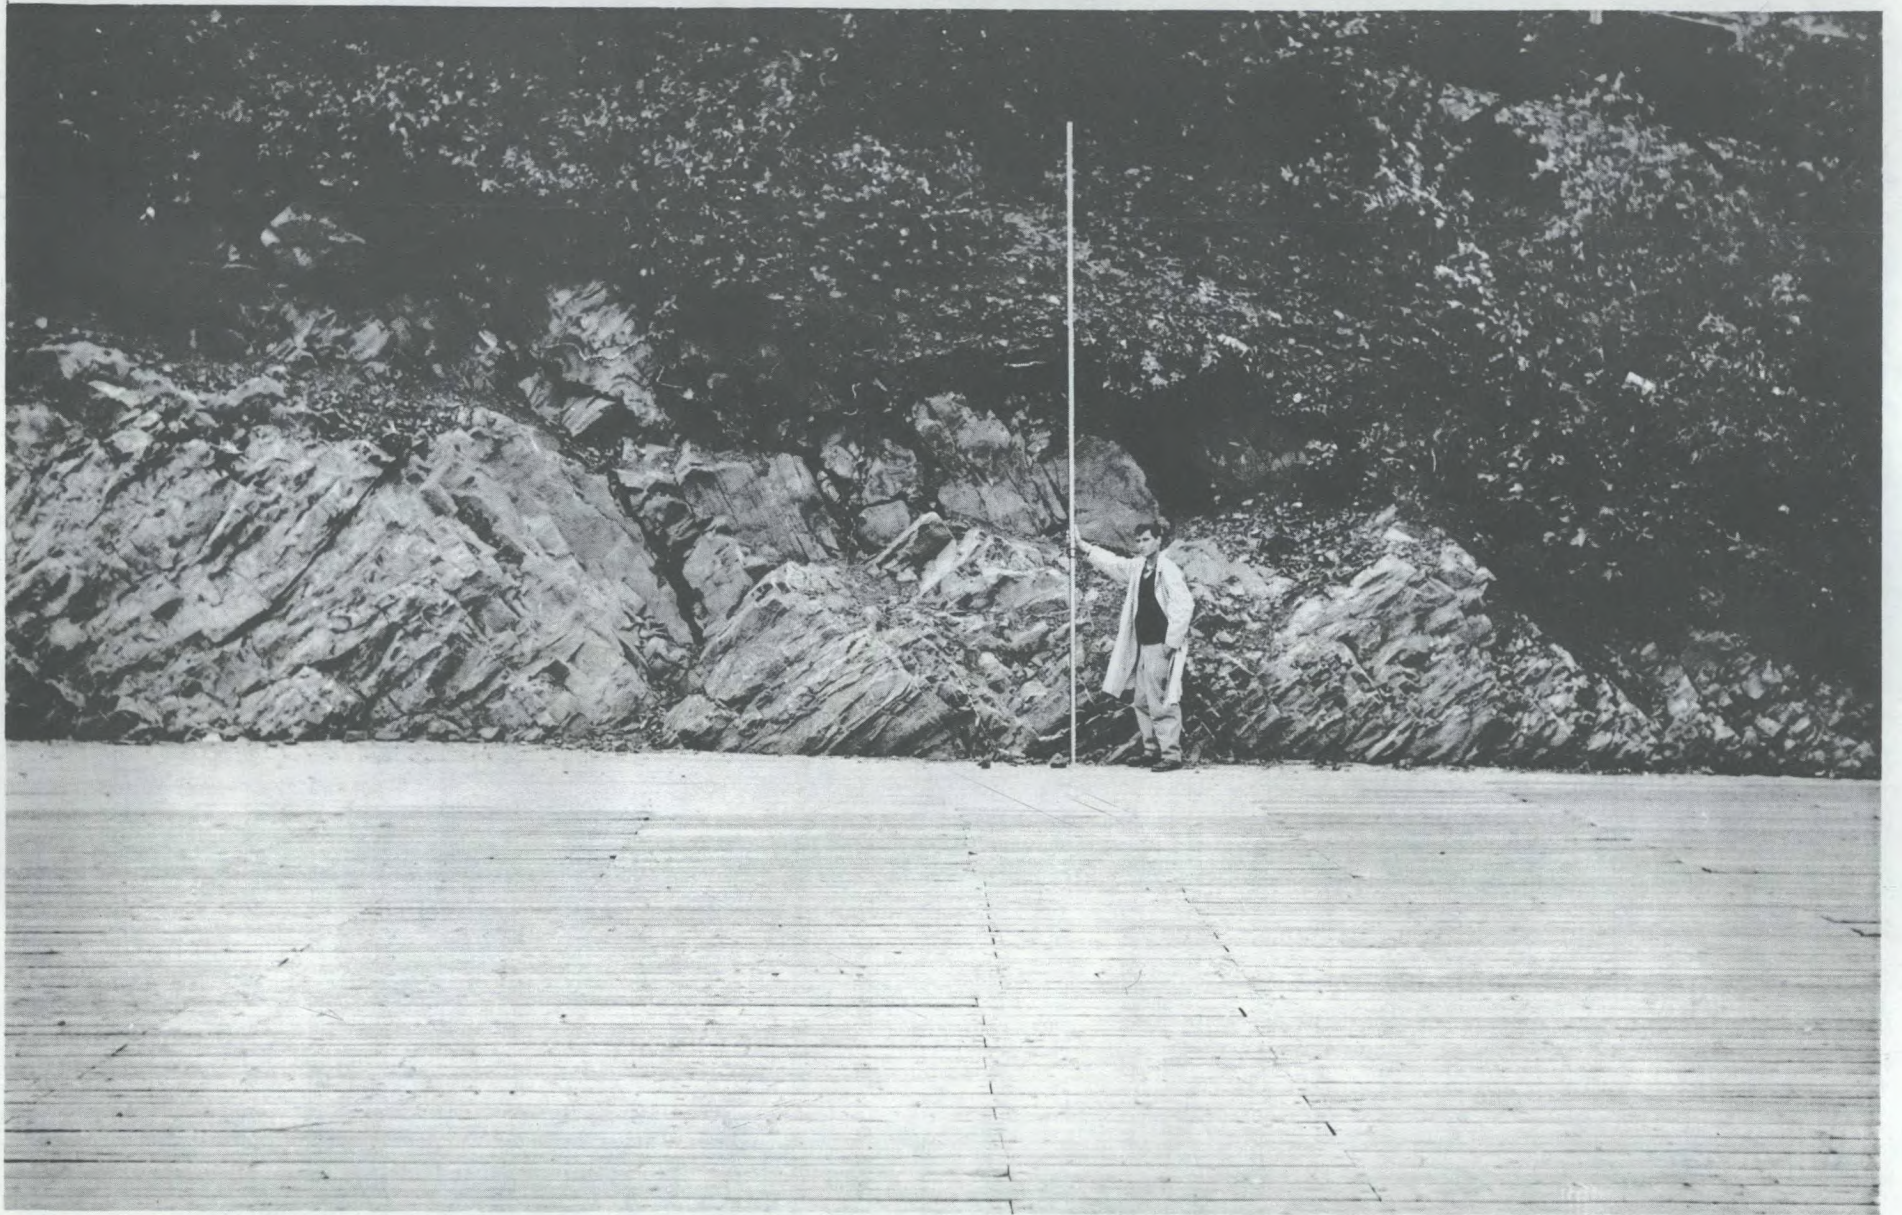
Figure 25. Site of rock bolting, above promenade deck of Terrace

On June 20, 1958, the Public Works Department of Quebec City requested the Department of Northern Affairs and National Resources to take remedial action with respect to a rock exposure near the southern end of Dufferin Terrace. Because the rock in question lay on the dividing line between property owned by the Department of Northern Affairs and National Resources and property under the control of the Department of National Defence, the latter Department was also requested by the City of Quebec to assist in any remedial action. The City recommended two possible courses of action: one, to take down the rock; and the other, to buttress it. A view of the rock exposure as seen from on top of the wooden promenade deck of the Terrace is given in Figure 25, and the continuation of the same rock below the deck is shown in Figure 26.

Upon receipt of the above request, the Department of Northern Affairs and National Resources sought the advice of the Mines Branch. Recommendations as to corrective measures were not within the scope of the Mines Branch investigation, which was limited to a study of rock movements, but when requested for an opinion by the Department of Northern Affairs and National Resources it was indicated that a form of buttressing was considered preferable to taking down the rock slabs in question, as this latter method would involve blasting. It was further indicated that buttressing or consolidating by a rock bolting

technique was considered preferable to constructing a massive concrete retaining wall on the questionable footing that exists below the Terrace. It should be emphasized that rock bolting is not considered to be a sound method for most of the cliffs at Dufferin Terrace, because of the very fissured condition of the rock. This opinion particularly applies to the exposed and steep cliff faces that lie between the front wall of the Terrace and Champlain Street below. However, the rock face in question does not form part of the main front cliffs but lies about sixty feet back on the landward side, and mainly below the wooden promenade deck of the Terrace. Because of the limited expanse of rock face involved and its relatively protected position, rock bolting was considered feasible for this particular locality.
