MINES BRANCH INVESTIGATION REPORT IR 60-114

EXAMINATION OF A FAILED BOILER TUBE

Examination of a section of boiler tube, submitted by the New Brunswick Electric Power Commission showed that failure of the tube was due to overheating of a local area of the tube (hot-spot), combined with erosion, which resulted in reduction of the section and the development of transverse thermal-fatigue cracks.

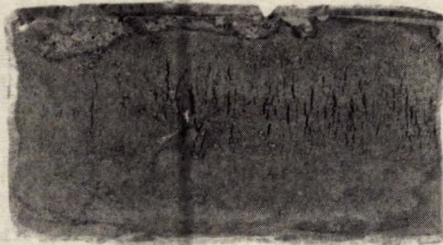
Figure 1 (a). Water-Side of Boiler Tube
Transverse cracks are visible on the water-side of the sample of boiler tube.

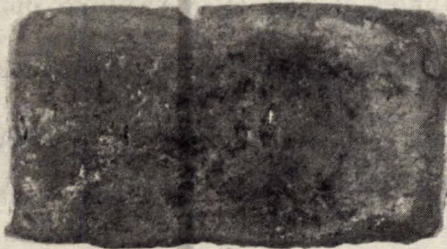
Figure 1 (b). Fire-Side of Boiler Tube
The dark area on the fire surface may be indicative of a hot-spot.

The dark area shown in Figure 1 (b) coincided with a reduction in section thickness.

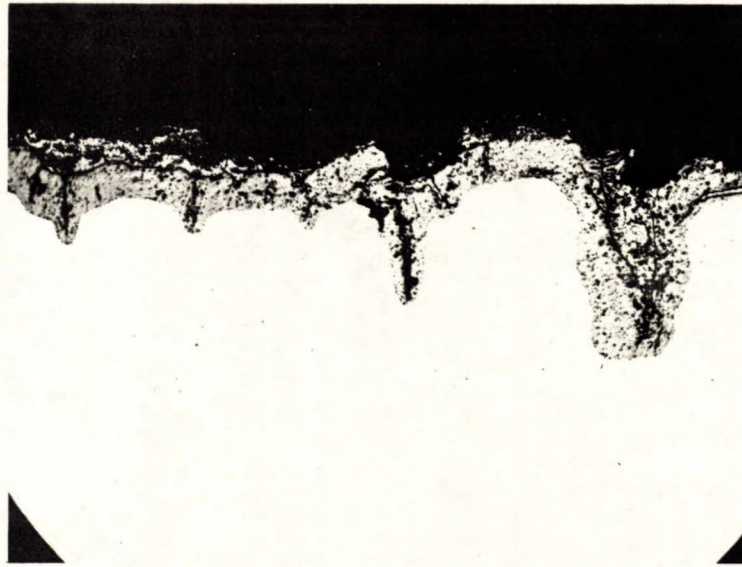
Examination of the water-side of the boiler tube (Micro Number 1, Figure 2) showed the entire surface to be covered with a uniform layer of oxide. The cracks were seen to be blunt-ended and filled with corrosion product (Figure 3).

Figure 3. Typical Section at the Water Surface of the Boiler Tube.

The uniform layer of oxide and blunt-ended cracks may be seen in this longitudinal section. (Micro Number 1, Figure 2).

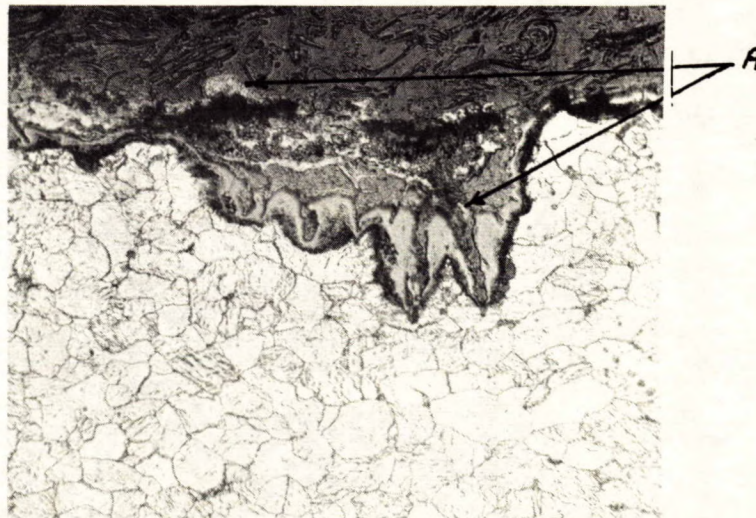
The oxide layer on the water-side of the boiler tube was seen to contain a considerable amount of copper (Figure 4, Arrows A)

Figure 4. Copper Contained in the Oxide Layer on the Water-Side of the Boiler Tube (A), (Micro Number 3, Figure 2) Longitudinal Section.

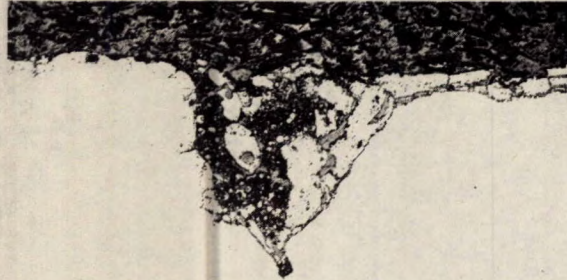
The fire surface of the tube (Figure 5) had a thinner oxide layer and contained fewer cracks than the water surface.

Figure 5. Typical Area on the Fire Surface of the Boiler Tube (Micro Number 1, Figure 2). Longitudinal Section.

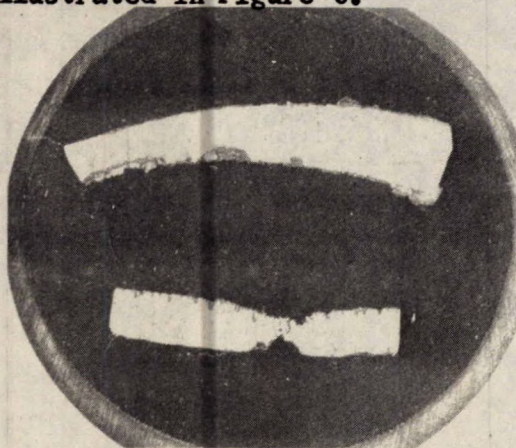
The transverse section (Micro Number 2, Figure 2) showed a reduction in wall thickness in the darkened area of the boiler tube sample as illustrated in Figure 6.

Figure 6. Micro Number 2 and Micro Number 3 (Figure 2) Transverse section number 2 (top) has a reduced section (extreme left) at a position corresponding to the dark area shown in Figure 1 (b). (The water surfaces of the two sections are closest to the centre of the specimen).

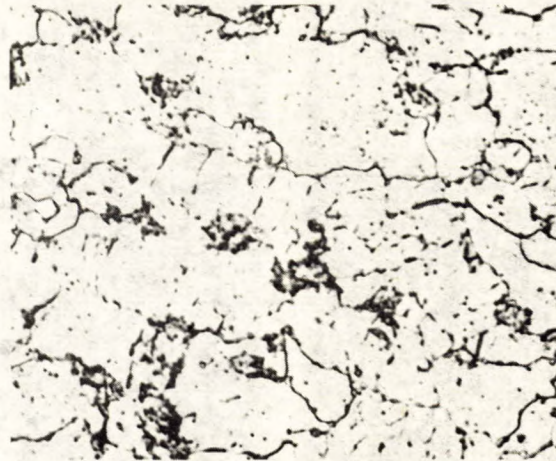
Complete spheroidization of the carbide and deposition of carbides inside ferrite grains was observed in the reduced section (Figure 7).

Figure 7. Microstructure in the Area of Reduced Section.
Complete spheroidization and deposition of carbides inside ferrite grains was observed in this transverse microspecimen (Micro Number 2, Figure 2).

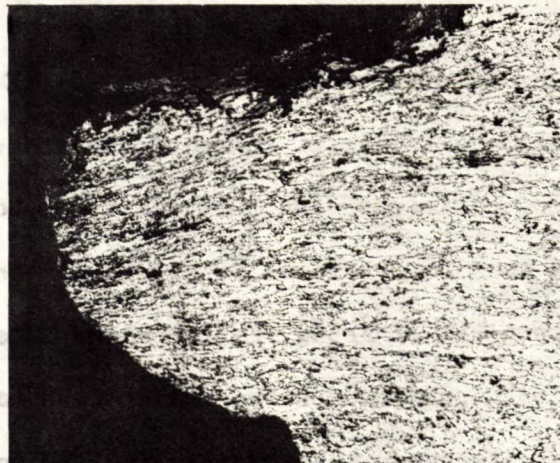
Some evidence of cold-work, as shown in Figure 8, was observed adjacent to the rupture.

Figure 8. Deformation at Point of Rupture (Micro Number 3, Figure 2)
The temperature at the time of failure was sufficient for complete spheroidization but did not exceed the A_{c3} temperature.

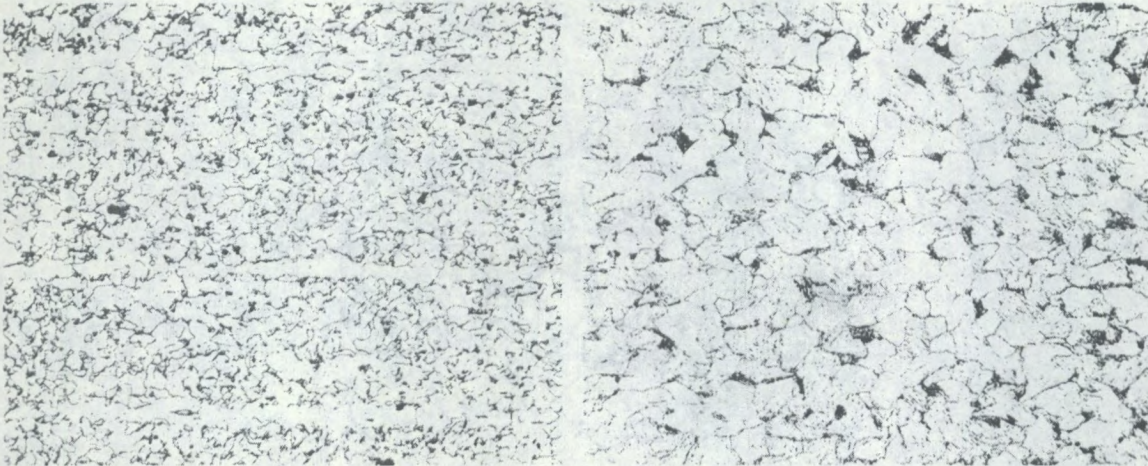
A comparison of the grain sizes in samples numbers 3 and 4 showed that recrystallization had occurred in the area adjacent to the rupture (Figure 9 (a) and (b)).

Figure 9. Recrystallization in the Area Adjacent to Rupture
(a) Microstructure adjacent to rupture (refined ferrite grain size).
(b) Microstructure $1\frac{1}{2}$ in. from the rupture (original ferrite grain size).
