**MINES BRANCH INVESTIGATION REPORT IR 61-10**

**PITTING CORROSION IN COPPER WATER  
SUPPLY LINE IN PRINCE GEORGE, B.C.**

**G. J. BIEFER**

**FEBRUARY 10, 1961**

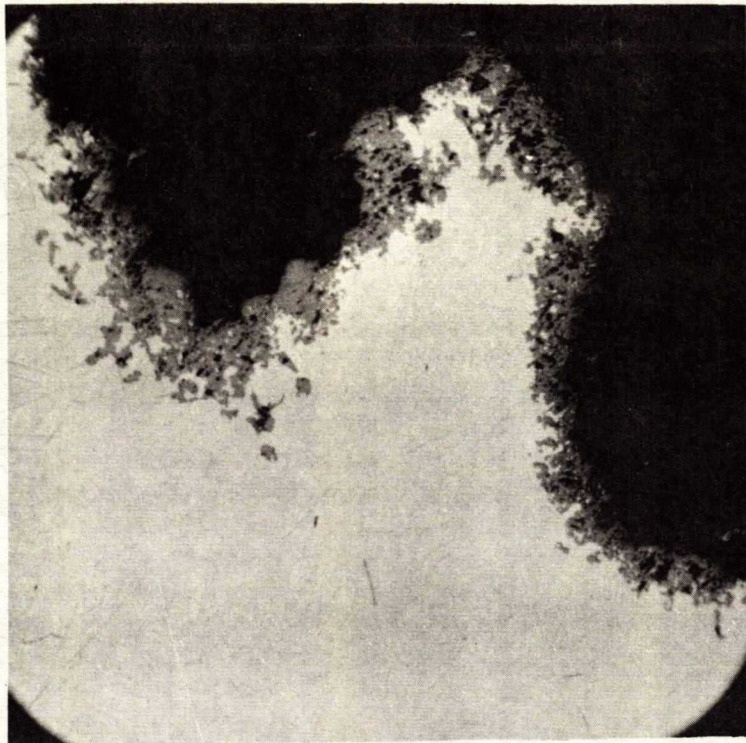
(a) Plate 3287

Metallographic cross sections showed no abnormalities in the structure, which appeared to be fully recrystallized. The pitting attack on the inner surface of the tubing was seen to be not intergranular, and was similar in appearance to attack reported by the British Columbia Research Council.<sup>(2)</sup>

Figure 1 - Polished cross-sections of the severely pitted copper tubing, showing (a) the severely pitted inner surface and (b) outer surfaces. X150.

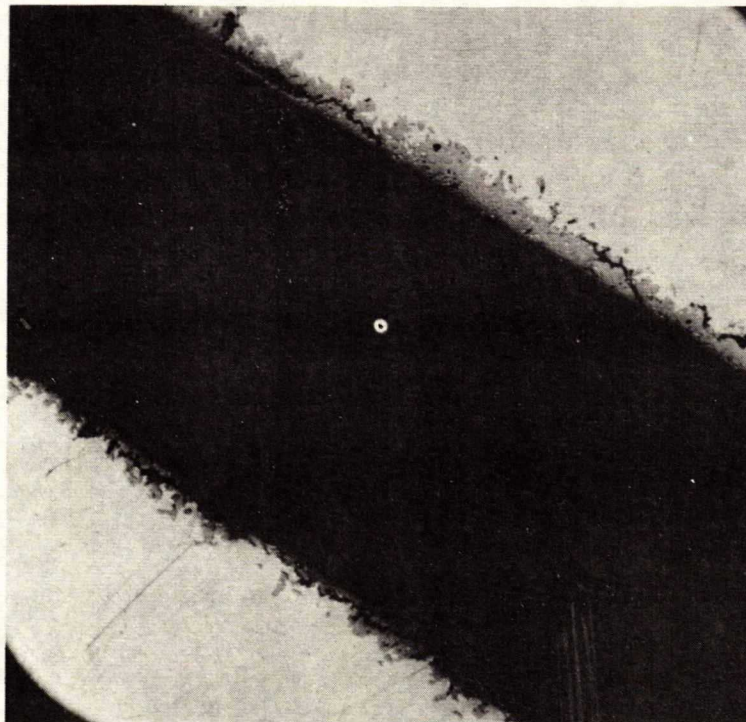
(b) Plate 32819

The outside surface of the tubing was also noticeably corroded. In contrast to the inner surface, the corrosion penetration was quite uniform. As with the inner surface, the attack was not intergranular.
