MINES BRANCH INVESTIGATION REPORT IR 61-30

**FRACTURE OF 65S ALUMINUM BAIL ANGLE
ON CAGE OVER SKIP COMBINATION
AT LEITCH GOLD MINES LTD.,
BEARDMORE, ONTARIO**

G. J. BIEFER

APRIL 11, 1961

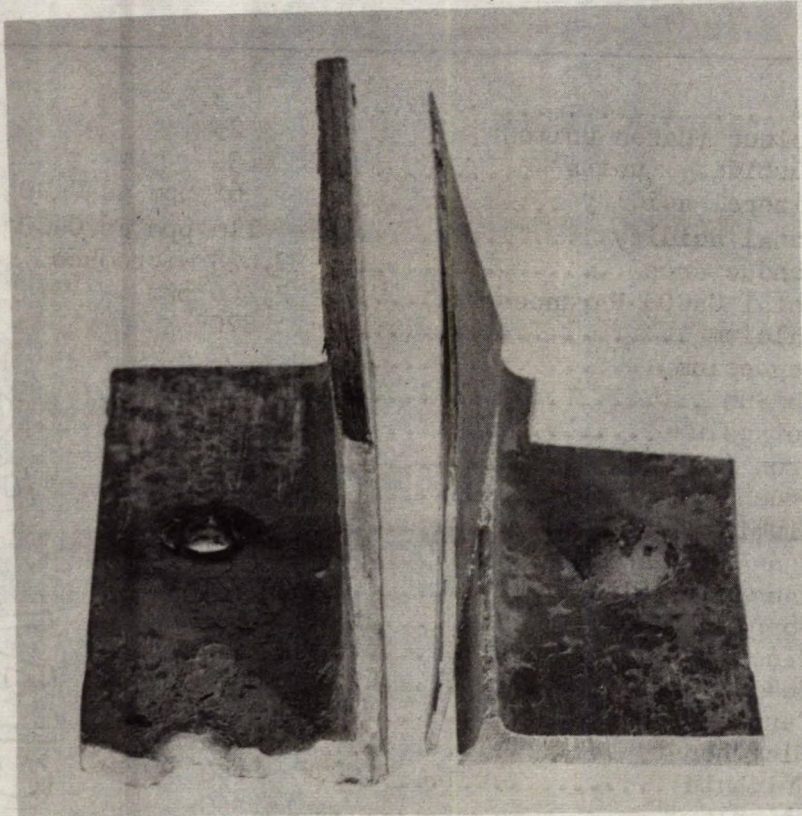
The short lengths of fractured aluminum angle sent by Leitch Gold Mines are shown in Figure 1. In service, the distance between them was sufficient for the vertical arms to enclose a wooden guide, but otherwise they are positioned correctly relative to each other. The thinning of the right hand vertical arm, due to wear against the wooden guide, is particularly evident.

For the left-hand angle of Figure 1, the fractured **face** is shown. The fracture occurred in the plane of a rivet hole, that is where the load-carrying capacity of the angle was least. From available information, the rivet hole was empty at the time of fracture. It should be noted that the right-hand angle of Figure 1 fractured in the same way as the other; however, the area of the fracture near the rivet hole had been sawn off for metallography before the photograph was taken.

Both fracture faces could be divided into two distinct regions. Extending from the rivet holes was a dark area, which appeared to be corroded. The rest of the fracture was brighter in appearance. The darker areas showed no necking down, indicating that the fracture had been brittle. The brighter areas showed necking down; that is, the fracture had been ductile. In Figure 1, at the right of the rivet hole, the line of demarcation between the two different regions, and the necking-down to the right of it, can be clearly seen.

Figure 1 - Short lengths of fractured aluminum angles. The left-hand angle exhibits the fractured face; this face was cut from the right-hand angle before the photograph was taken. About X1/2.

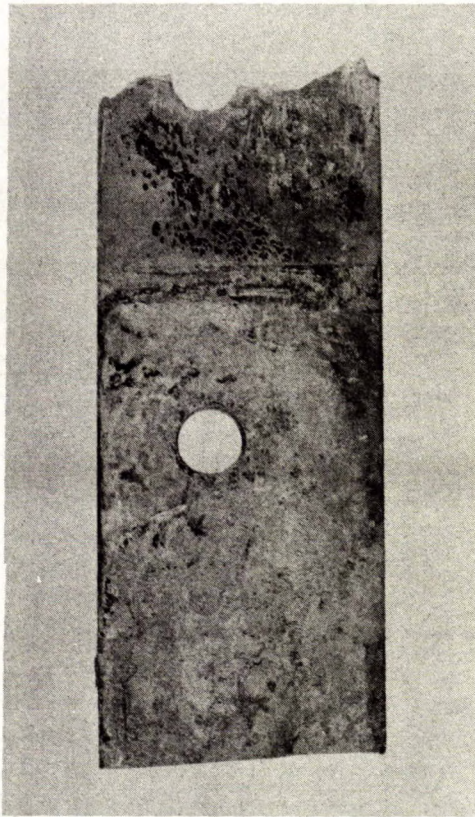
It is reported that the angles were provided with steel reinforcing plates over part of their lengths, but not at the point of fracture. Figure 2, which shows the underside of the left hand angle of Figure 1, exhibits a distinct line of demarcation which evidently marks the edge of the steel reinforcing plate. The lighter area below the line of demarcation was observed to be severely etched, due to galvanic attack of the aluminum in contact with the more cathodic steel.

Figure 2 - Underside of left-hand fractured aluminum angle of Figure 1. The fracture is at the top of the photograph. About X1/2.

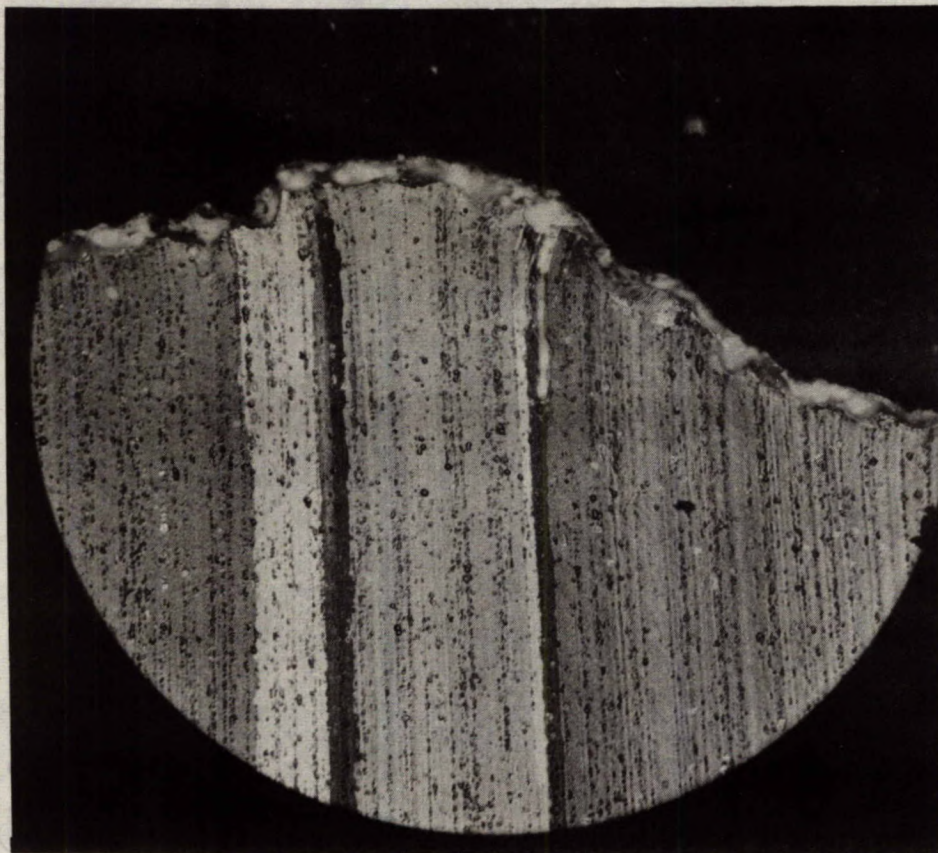
For the region near the fractures, examination with a low power stereo-microscope and metallographic cross-sections did not reveal any major cracks in addition to that represented by the fracture. However, the cross-sections showed that intergranular corrosion was taking place. (Figures 3 and 4)

Figure 3 - Anodized metallographic cross-section in a plane at right angles to that of the fracture. The fracture edge is seen at the top, with a single intergranular corrosion penetration near the centre of the plate. X100.

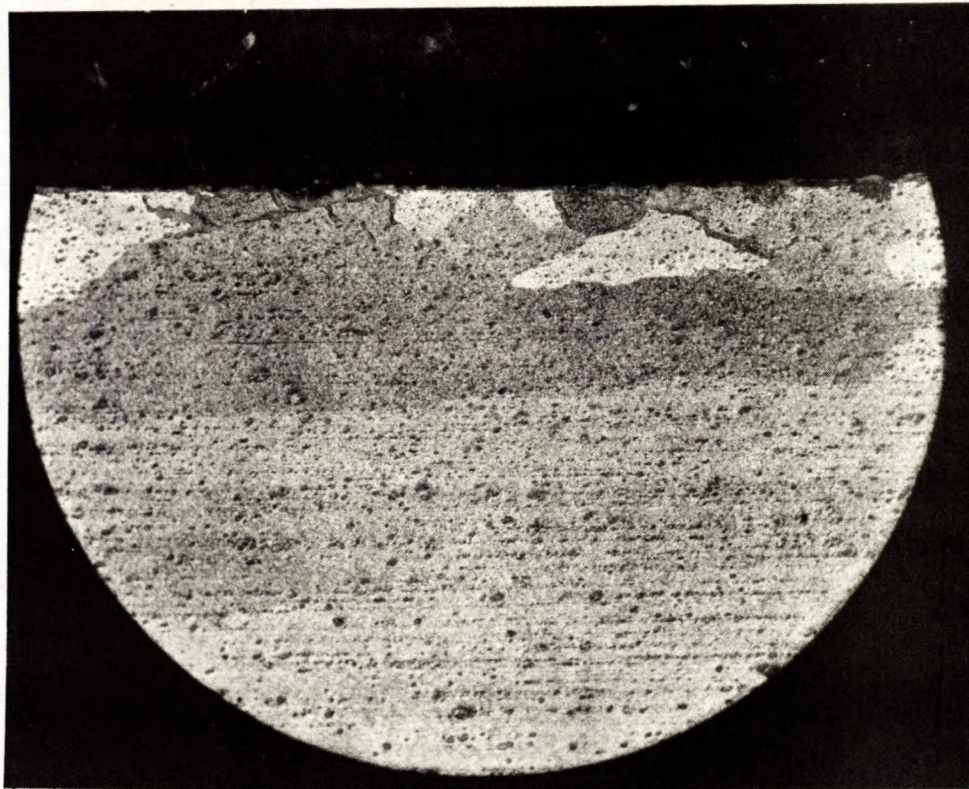
Figure 4 - Anodized metallographic cross-section in the plane of the fracture, at a point just below the fracture. The top edge of the plate is an outer surface of the angle (such as that shown in Figure 2) and exhibits intergranular corrosion attack. X100.

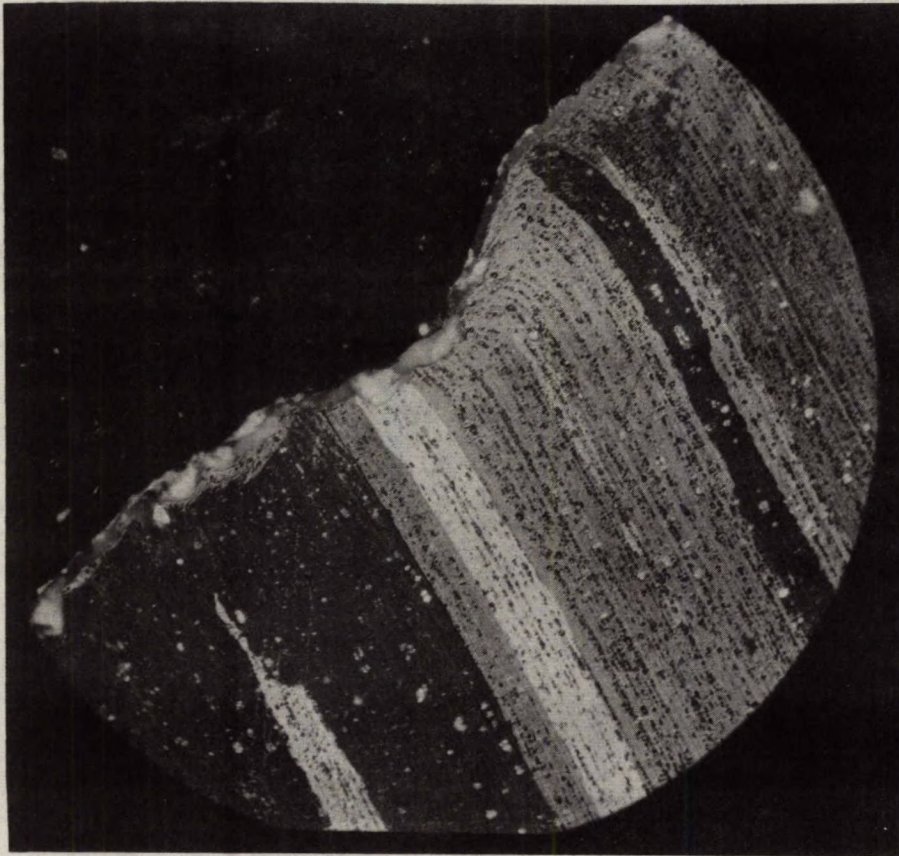
Some of the grains at the fracture were distorted indicating that the fracture was partly transgranular. (Figure 5) Other grains at the fracture were undistorted; the fracture on these was probably intergranular.

Figure 5 - Anodized metallographic cross-section in a plane at right angles to the fracture. The fracture edge is shown at the top of the plate; grains are seen to be distorted. X100.
