**MINES BRANCH INVESTIGATION REPORT IR 61-67**

**EXAMINATION OF A FAILED HIGH-TEMPERATURE  
WATER DISTRIBUTION LINE**

**D. E. PARSONS & J. G. GARRISON**

**JUNE 30, 1961**

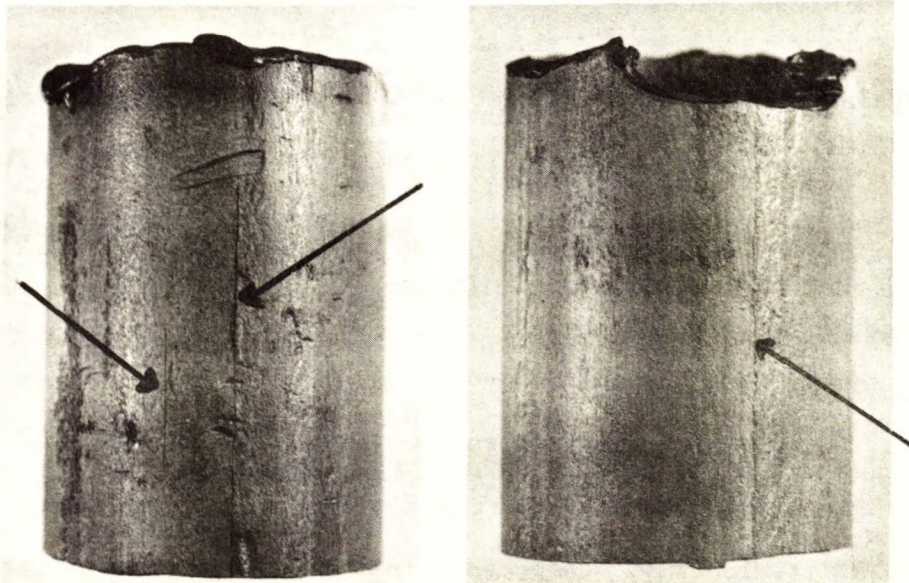
Figure 2. Deep-Etched Length of Failed Pipe

A short piece of the 12 in. length of pipe was cleaned and etched in hot aqueous 50% hydrochloric acid and was photographed on two sides. The appearance of this "deep-etched" section is illustrated in Figure 2.

Two cracks are visible (arrows) in Figure 2a. Roll marks and a lap (arrow) are visible in Figure 2b.

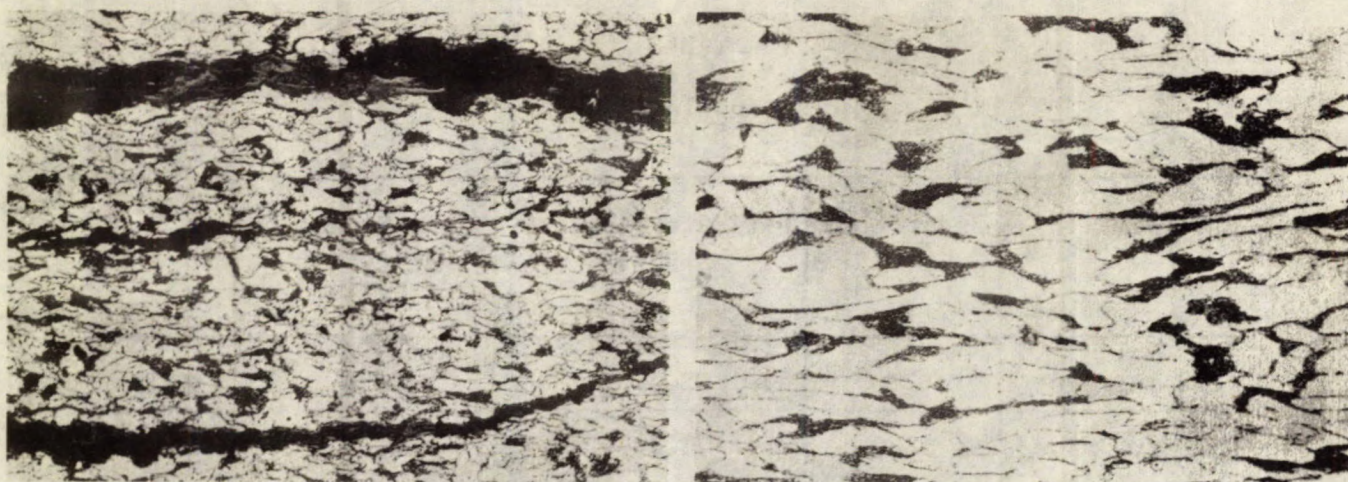
Figure 3. Microstructure of 12 in. Length of Pipe

The 7 in. and 12 in. pipes contained heavily cold-worked metal. Figure 3 illustrates the appearance of the microstructure for the failed 12 in. pipe.

(a) Transverse section showing cold-worked metal and intercrystalline cracks.

(b) Longitudinal section showing cold-worked metal.

1. Cold-drawn pipe should receive a full-anneal or normalizing heat treatment (in a controlled atmosphere furnace) prior to service in an environment where minimum susceptibility to stress-corrosion is required. (Allowance is necessary for the accompanying reduction in tensile strength).
2. During installation and service the drainage and chemical environment of the pipe should be carefully controlled. (Good drainage would minimize corrosive attack from ground water and prevent leaching of insulating cement).
3. The method of application of the insulating cement surrounding the pipe should ensure that the cement does not adhere and impose restraint to thermal expansion and contraction.
4. An adequate guarantee as to quality of workmanship and materials should be included in the construction contract.

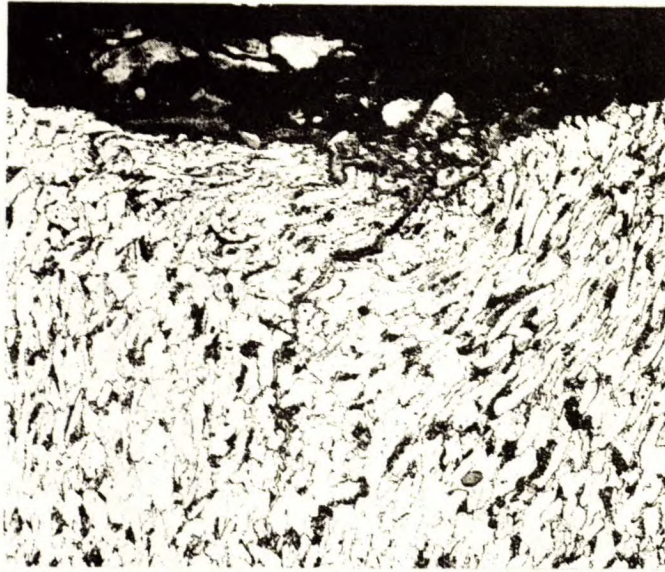
The cracks in the 7 in. and 12 in. lengths of pipe were intercrystalline and were filled with corrosion product. All the cracks in these lengths of pipe originated on the outside surface of the pipe (Figure 4).

Figure 4. Intercrystalline Crack Originating at the Outside Surface of the 12 in. Length of Pipe

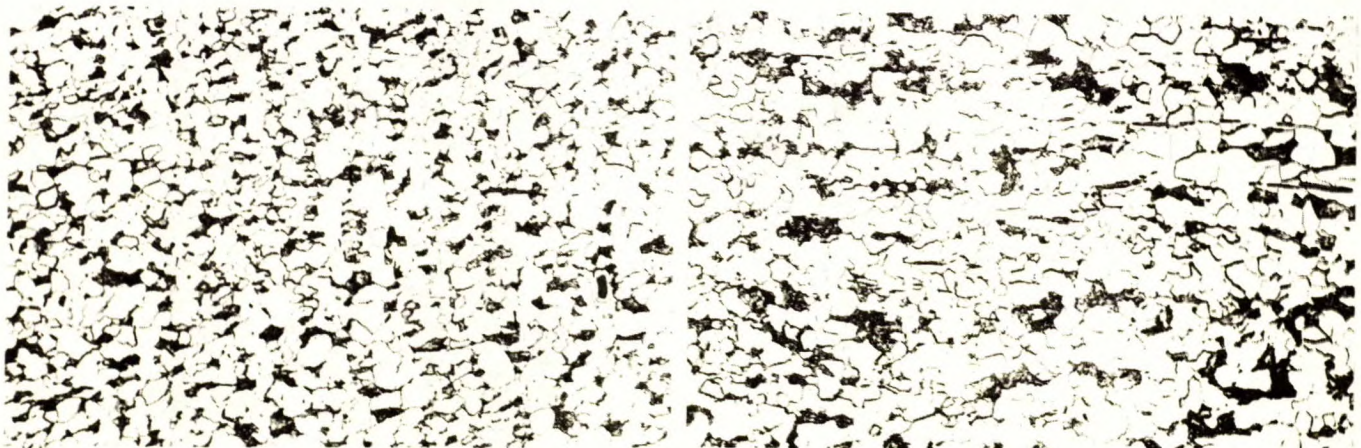
Figure 5. Microstructure of the 16 in. Length of Pipe

The 16 in. length of pipe was found to be free of cracks, but an examination of the transverse and longitudinal micro-specimens obtained from this length of pipe showed that the steel in this sample was cold-worked and had a fine ferrite grain size.

(a) Transverse Section.

(b) Longitudinal Section.

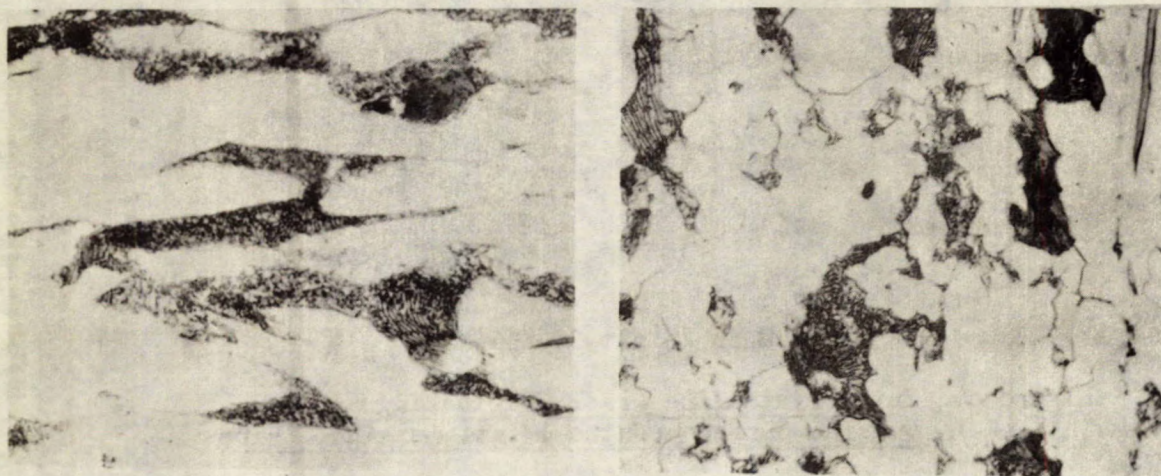
Figure 6. Pearlite Structure of the Pipes

The pearlite in the 12 in. and 16 in. lengths of pipe was fine and partly spheroidized. Spheroidization was more advanced in the 12 in. sample than in the 16 in. specimen (Figure 6), suggesting some variation in the sub-critical annealing temperature.

- (a) Longitudinal section of the 12 in. length of pipe.
- (b) Longitudinal section of the 16 in. length of pipe.
