MINES BRANCH INVESTIGATION REPORT IR 61-82

**INVESTIGATION OF THE FAILURE OF A SHEAVE
WHEEL AXLE FROM SHAFT #4, V.C. McMANN LTD.,
MINTO, N.B.**

JULY 28, 1961

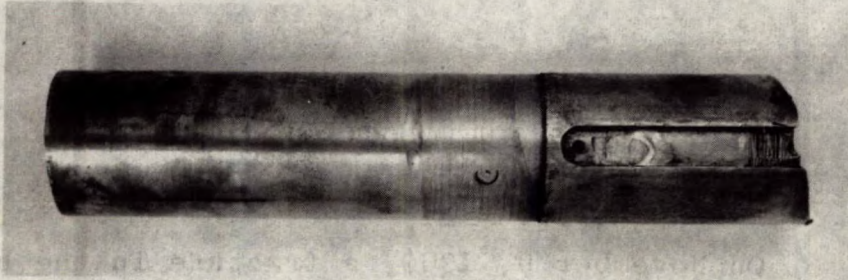
The axle, which was made of an unspecified steel, was received in two pieces, the fracture having occurred close to the end of the keyway used for location of the sheave wheel on the axle (Figure 1). The length of the axle was 21 in. and, from markings on the axle, it was deduced that the bearing length at either end was 6 in. The diameter of the axle in the bearings was approximately $2 \frac{3}{8}$ in., and that of the centre section locating the sheave was $2 \frac{1}{2}$ in.

Figure 1. Part of Failed Axle Showing Keyway.

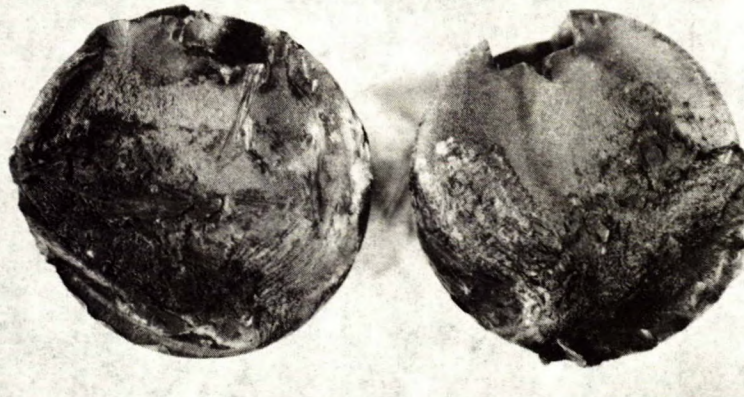
The fracture (see Figure 2) can be considered as typical of failure by fatigue under conditions of rotating bending. The characteristic markings of a fatigue failure are particularly noticeable on the right-hand piece in Figure 2, originating from the vicinity of the left-hand bottom corner of the keyway. The keyway itself had some very pronounced scoring marks at the bottom (Figure 3), but it is considered by the mine foreman that these were caused during disassembly of the unit after failure. However, in the absence of positive evidence to support this, the possibility of operation with a loose key cannot be eliminated.

The fracture itself passed through a drilling tip at the end of the keyway, but close examination of the fracture did not suggest that the failure had, in fact, been nucleated at this point.

Figure 2. Fracture Surfaces

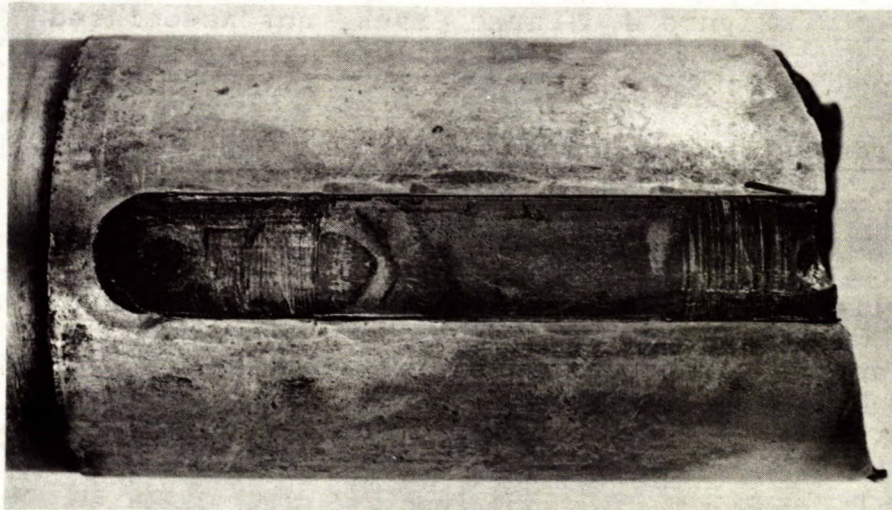
Figure 3. Keyway of Axle

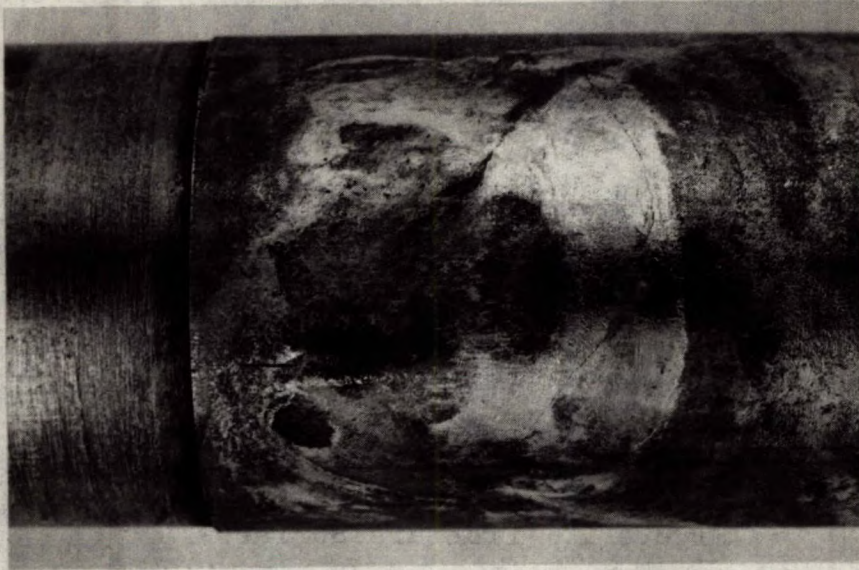
Examination of the axle surface in the section containing the keyway showed a large crack running around approximately one-quarter of the circumference (Figure 4). As this crack was not directly associated with the fracture, it could only have had a minor effect on the failure of the axle caused by modifications to the stress distribution pattern within the wheel fit.

Figure 4. Large Crack, not associated with Failure

Before conclusion of this discussion, mention must be made of the presence of the unrelated, but large, crack present at the other side of the axle to the keyway (Figure 4). For such a crack to have nucleated, there must have been a stress-raising factor present of the same order as that in the keyway. A section containing the crack was cut from the axle, and machined to expose the

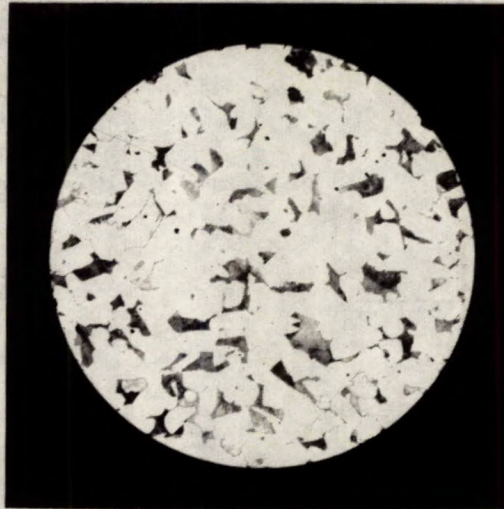
An examination was made of polished and etched sections taken from several positions in the cross-section of the axle, close to and away from the failure. In all cases the structure was found to be pearlite in a ferrite matrix, which corresponds with the hardness and tensile values previously noted (see Figure 5). Except as noted subsequently, the number, size and distribution of inclusions were within the limits normally accepted for this steel.

Figure 5. Typical Photomicrograph
of Cross-Section

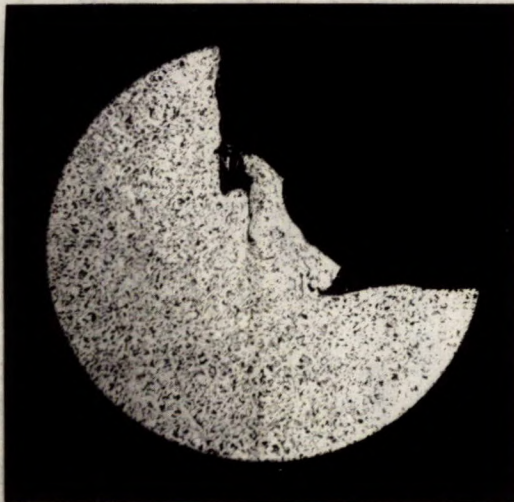
A micro-section of the keyway, taken very close to the fracture, was examined, and, in one corner corresponding to the position of the indicated origin of the failure, evidence of inadequate machining was found (Figure 6).

Figure 6. Section of Keyway
near Fracture

It appears that a cutting from the keyway root has not been completely removed, and has been folded over and forced into the corner. It is certain, from visual examination of the unit, that this did not occur on disassembly, but it is not clear whether the cutting was forced into the position noted during the final machining operation, or whether this occurred during initial assembly of the unit.

There is no information available as to the effect of poor machining of the root (Figure 6) on the overall stress concentration factor of the keyway. However, as the failure appeared to originate in this region, it may be concluded that the poor machining resulted in even higher local stresses than would otherwise have existed.

The use of an axle of only $\frac{1}{2}$ in. larger diameter (viz 3 in.) will lower the nominal working stress, under the same conditions of shaft length, to a value of 7,000 psi. The use of larger radius fillets is a necessary corollary when using a 3 in. diameter shaft, and a fillet root radius of not less than $\frac{1}{8}$ in. is recommended.

If geometrical considerations preclude the use of an axle of larger diameter it is possible to improve the fatigue characteristics of the design by specifying a higher strength steel. A steel of SAE 1340 composition, or a near equivalent, would be satisfactory for this application, providing an ultimate tensile strength of the order of 100,000 psi, while still retaining good machining properties. It is interesting to note that such steels, or even steels of higher strength, are normally specified for axle service of the nature encountered in this instance.

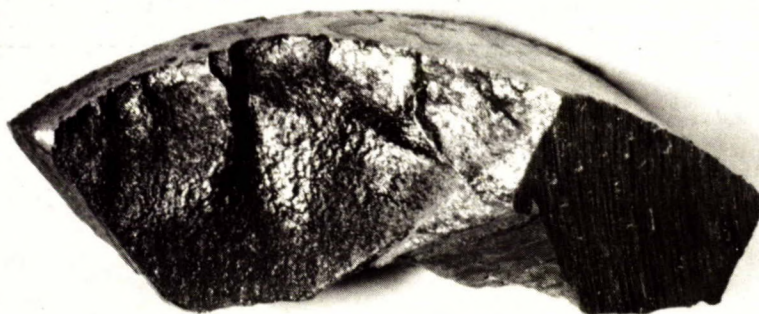
surface of the crack. The crack, at its deepest penetration into the axle, was typical of a fatigue failure; closer to the axle surface the crack was smoother and had a brighter surface (Figure 7). A detailed examination revealed the presence of some dark coloured powder in a crevice of this crack near the surface of the axle. On X-Ray analysis, the powder proved to be Fe_2O_3 . This oxide is frequently encountered in the outer layers of scale on steel, and it seems probable that the inclusion originally present was caused by some defect present during the rolling process. In service, fatigue had originated from this inclusion.

Figure 7. Surface of Crack shown
in Figure 4.
