MINES BRANCH INVESTIGATION REPORT IR 61-87

**MATERIAL EXAMINATION OF THE FRACTURED
PROPELLER BLADES FROM THE ICEBREAKER
C.M.S. CAMSELL**

T. S. PLASKETT

JULY 24, 1961

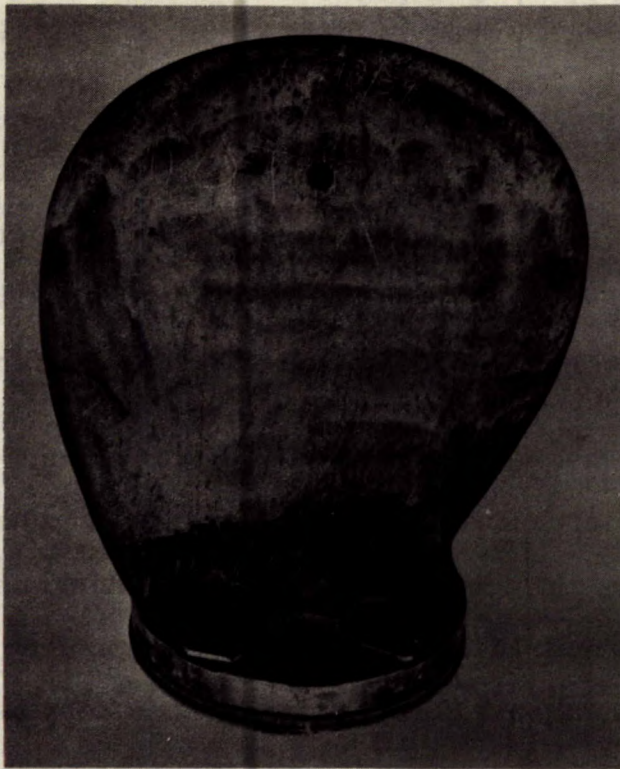
Figure 1. General appearance of the propeller blades. Grooves on the root of the blade shown are where cracks were chipped out in preparation for repair welding.

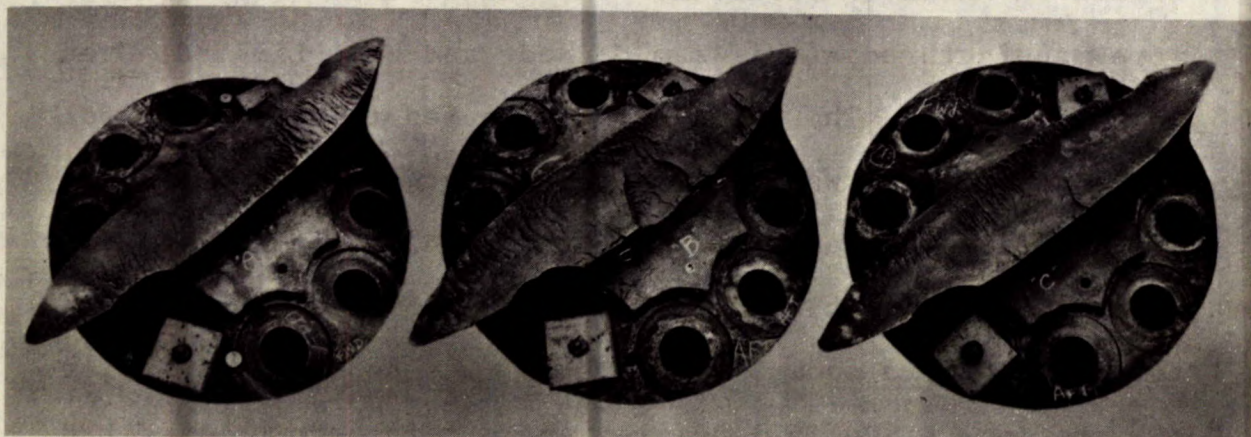
Figure 2. Fractured stubs submitted for examination. White markings on stubs are cracks which were detected visually and by magnafluxing.

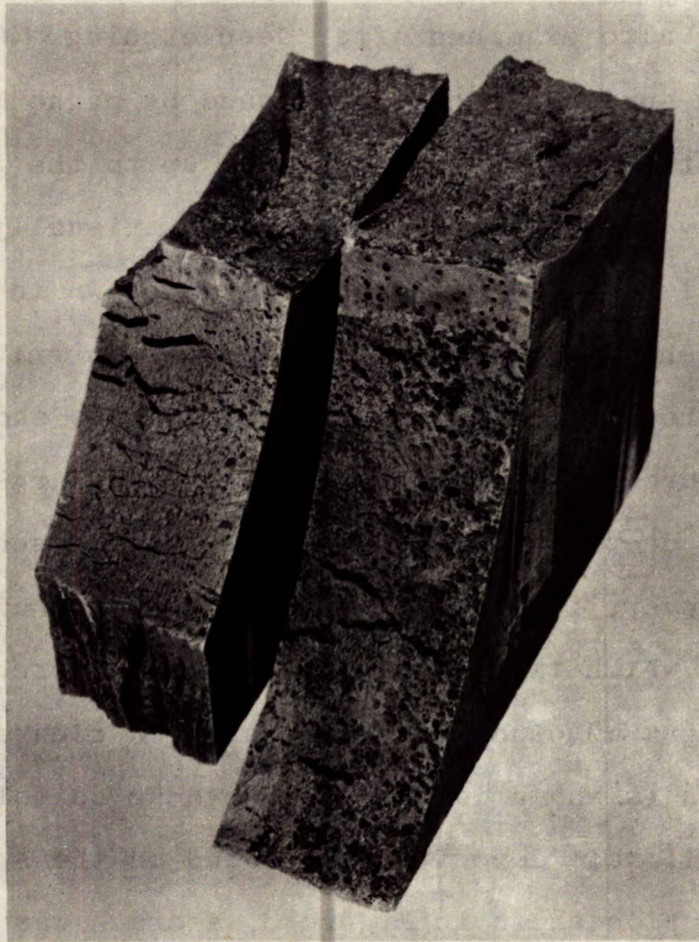
The surfaces of the two blades investigated were examined visually by magnetic particle technique. The surfaces were also examined after deep etching. On stub "B", numerous surface cracks were found by magnetic particle examination in the root area and up to the fracture surface. Many of the cracks were evident visually. A typical example of the surface cracks is shown in Figure 3. The surfaces shown are both sides of a cross-section taken at the fracture. The top edge of the sections shown are the fracture. The cracks are slightly enlarged as a result of the deep etch treatment given to the sections. The etch, however, indicated the presence of a hairline crack network which is probably the result of etching out of a primary grain boundary precipitate. A clearer indication of this is shown later. Some cracks do follow the network. Small weld deposits were found on the surface, and in the section shown in Figure 3, a crack was found in a weld deposit.

Figure 3. Section taken from stub "B" showing opposite surface of the casting. Top surface shown in the photograph is the fracture.

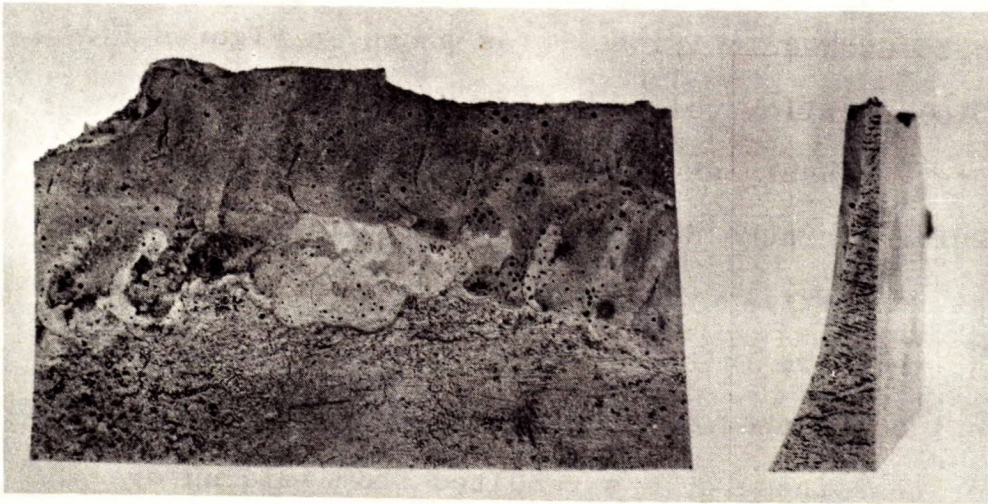
In stub "A", no cracks and only a slight indication of grain boundary network were found on the surface. A section of the surface, after etching, is shown in Figure 4. Again, a weld deposit was found at the fracture but, in this case, only one large deposit was found on each side.

Figure 4. Section taken from stub "A" showing the surface (photograph on left) of the casting at the fracture. Top edge is the fracture. Photograph on right is a view of the edge of the same section.

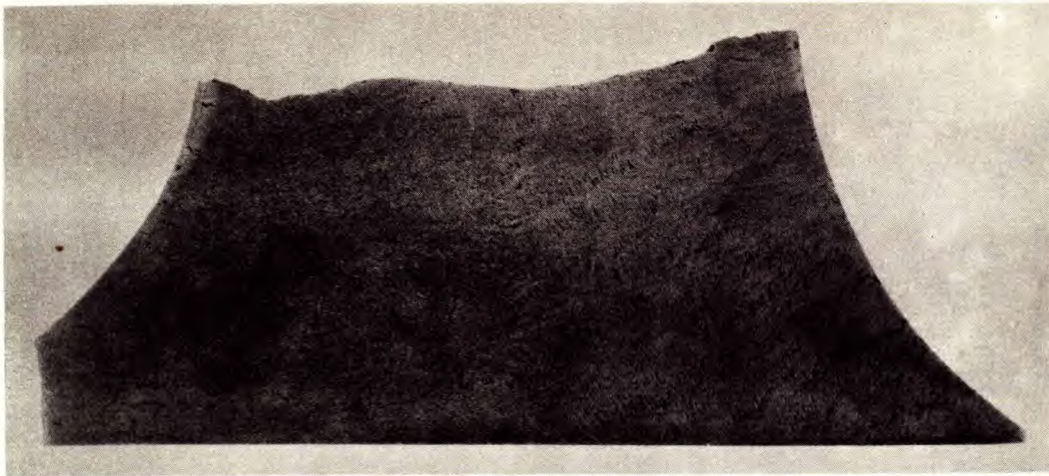
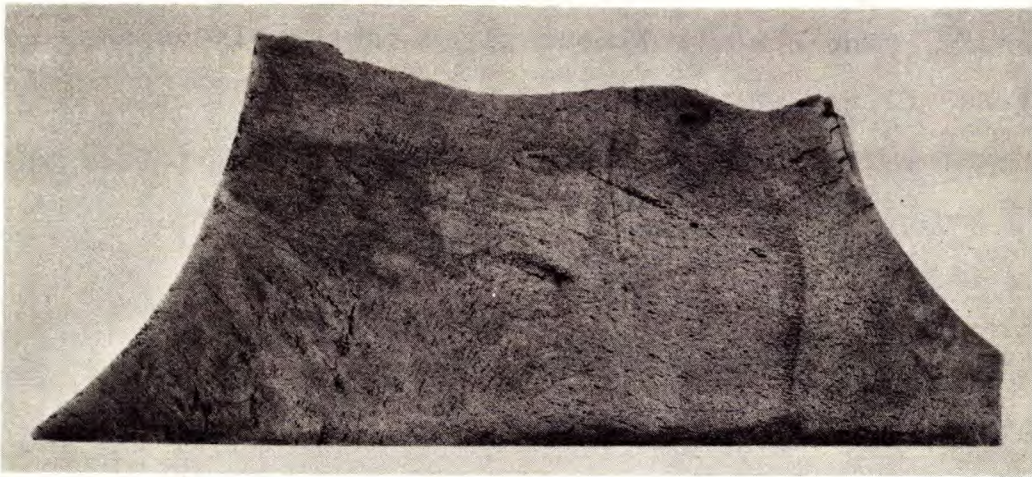
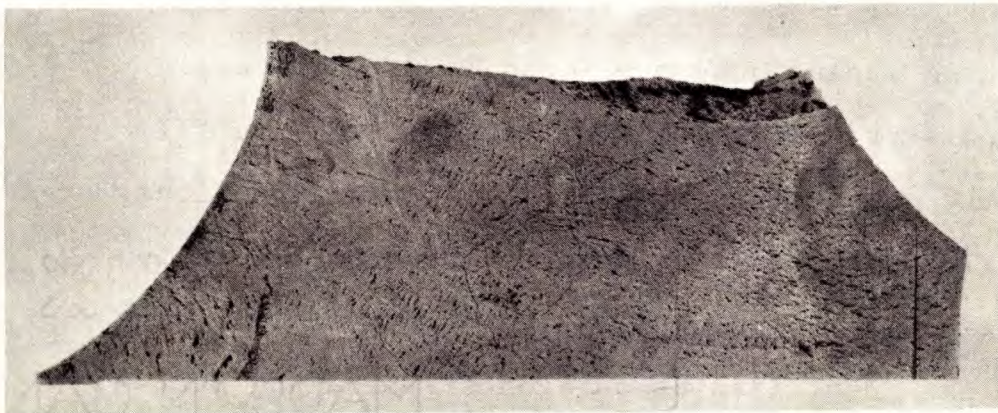
The macrostructures from three different cross-sections of stub "B" are shown in Figure 5. The fracture surface intersects the prepared surface at the top of each photograph. Each cross-section was deep-etched in 1:1 HCl. As shown in Figures 5(a) and 5(b), shallow weld deposits were found on the surface, probably as a result of repairing some of the surface cracks during the manufacturing. Many cracks were still evident on this stub. It was also found, as shown in Figure 5, that some cracks were present below the weld deposit which would indicate either that these cracks resulted from welding or that the cracks were not chipped out deep enough prior to repair welding. The latter is more probable, as the welding tests of the material from stub "B" resulted in no cracks being formed. A hairline crack network was found on the macrostructure which, as reported by Lorig and Elsea⁽³⁾ is indicative of a primary grain boundary precipitate. This network can cause brittleness in the material and result in an intergranular (rock candy) fracture. The fracture studies described later verify the presence of some grain boundary precipitate.

Figure 5. Macrostructure of cross-sections taken from stub "B". Top surface of each cross-section is the fracture surface.

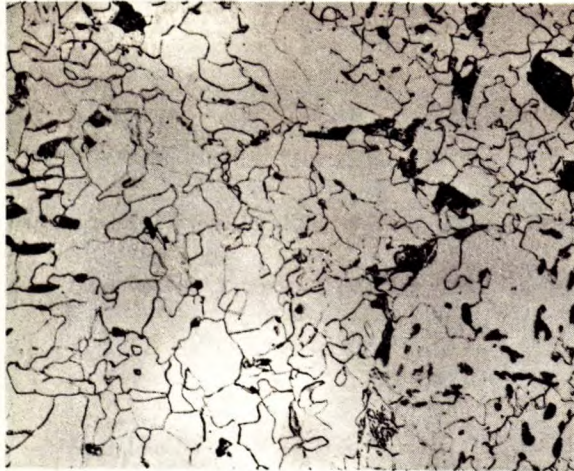
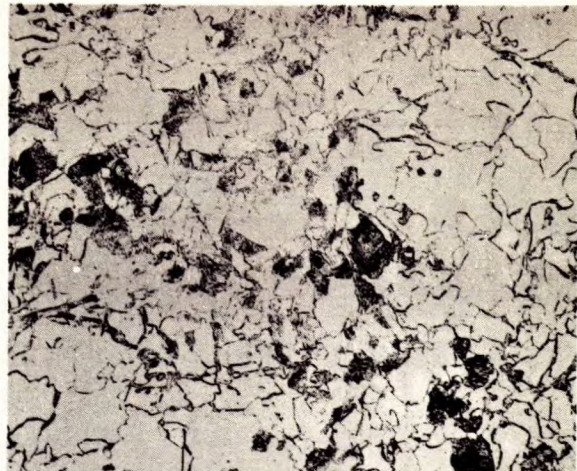
The general microstructure of the material taken from the centre of the casting is shown in Figure 6. The structure is typical of an annealed structure. The heat treatment given to the blades as supplied by the manufacture is:

Figure 6. General microstructure of material.

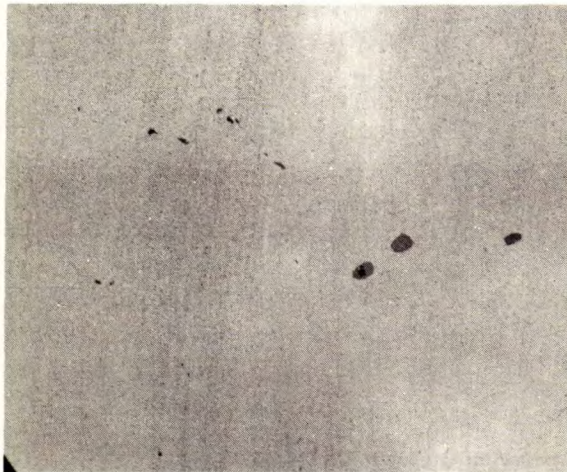
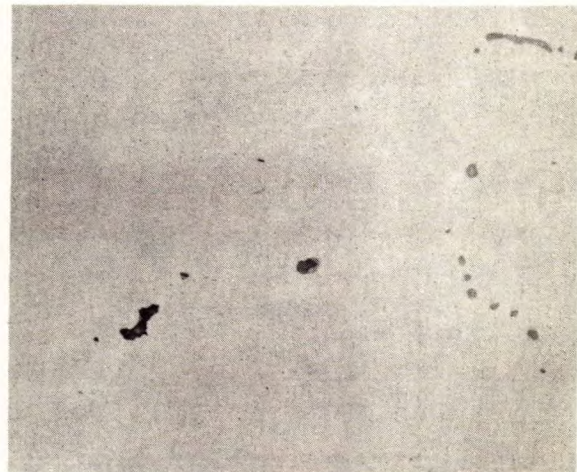
The unetched microstructure showing the inclusion type is shown in Figure 7. Sulphide and zirconium inclusions were found. The sulphide inclusions were mainly high melting point, Type III. Near the surface, some low melting point, injurious, Type II inclusions were found. The other inclusion was orange in colour and by the etch tests(2), part of it was identified as an iron sulphide and part as either zirconium sulphide or zirconium nitride.

Figure 7. General Inclusion Type.

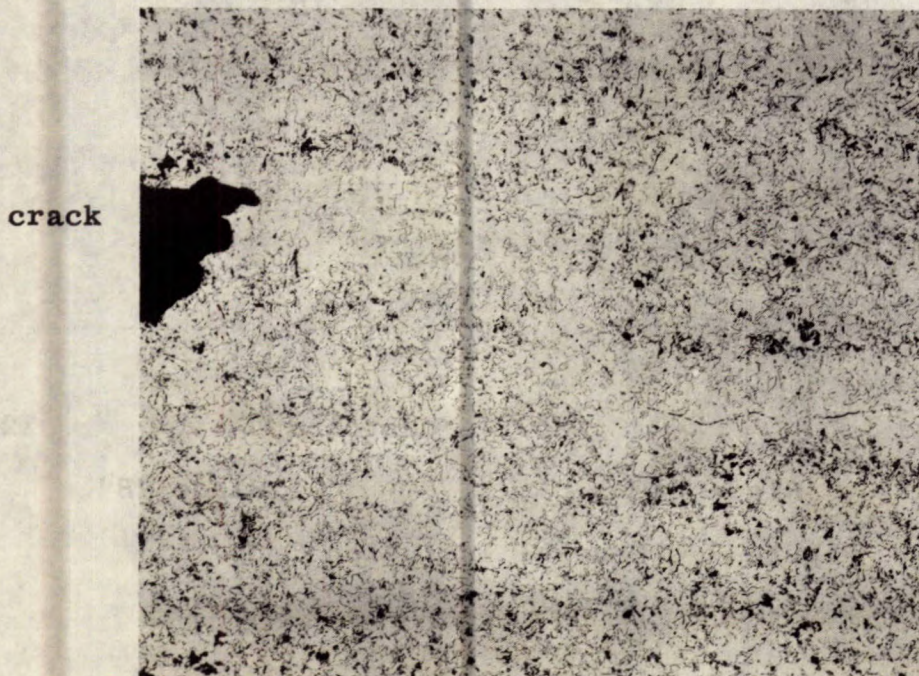
The microstructure of the material below one of the surface cracks of stub "B" is shown in Figures 8 and 9. The crack appeared to extend into a decarburized zone. In the decarburized zone, as shown in Figure 8, there were Type II sulphides.

Nital etch X40
Figure 8. Microstructure at the base of one of the surface cracks.

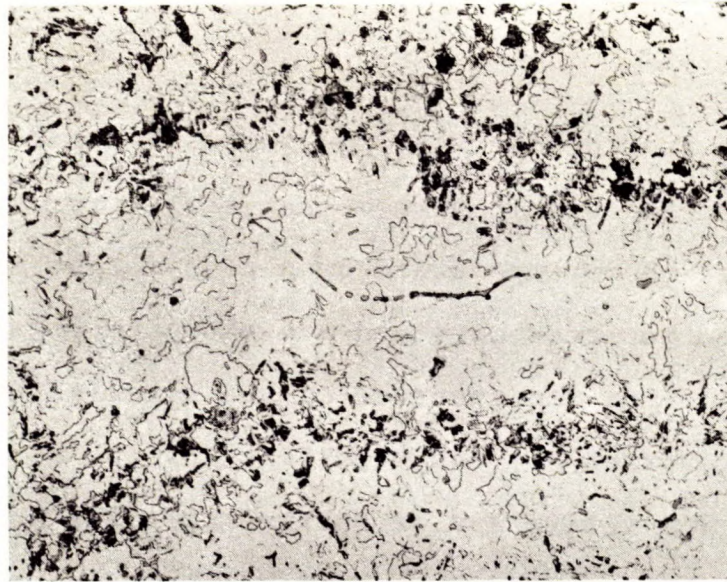
Figure 9. Magnified section of decarburized zone extending below the crack shown in Figure 8.

The cracks in some cases were found to follow the hairline crack network. This, however, does not necessarily mean that the cracks resulted from the primary grain boundary precipitate which is believed to cause the network. The fact that decarburization was associated with several cracks suggests hot tearing which also would occur at the primary grain boundary but above the temperature at which the precipitation of aluminium nitride would occur. If the aluminium nitride precipitate caused the cracking, cracking would have to occur below 1150°C (2100°F) and less decarburization would be expected.

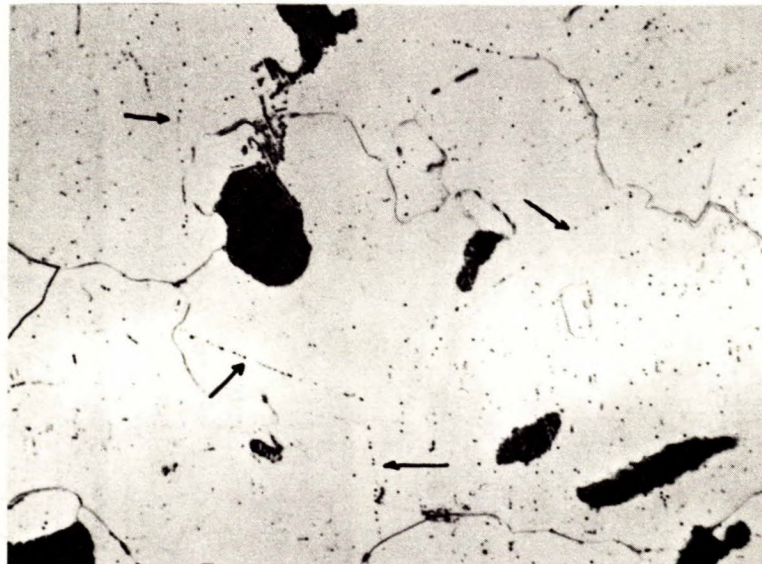
A careful microscopic investigation was undertaken to find a grain boundary precipitate which caused the network formed on the macroetches. In Figure 10, a fine chain-like precipitate was found, possibly located at the primary grain boundary. The precipitate was too fine to identify. Lorig and Elsea⁽³⁾ and Woodfine and Quarrell⁽⁴⁾ have associated precipitates of this type with intergranular fracture.

Figure 10. A fine precipitate (marked by arrows) possibly at primary grain boundaries.

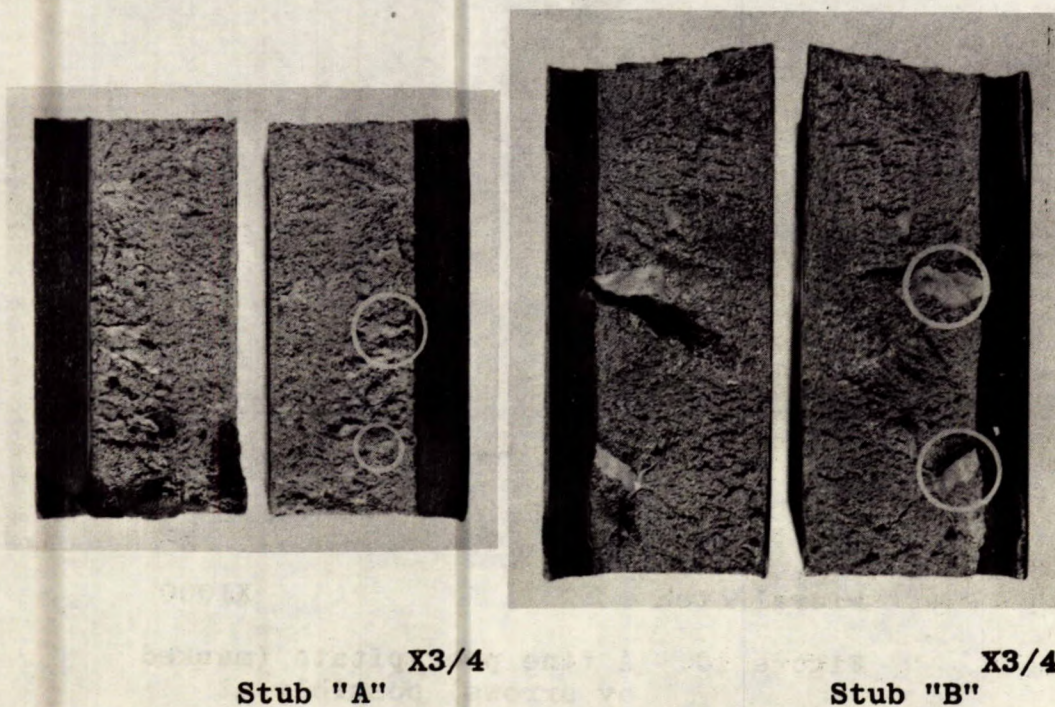
Rectangular test specimens of about $1\frac{1}{2}$ " x 3" in cross-section were cut from each stub, notched and fractured at room temperature by a drop-weight apparatus. The fracture surfaces obtained are shown in Figure 11. About 5 to 10% of the fracture of the material from stub "B" was intergranular, and much less for the material from stub "A". The intergranular surfaces are the shiny parts of the fracture shown in the photographs. In stub "B" each intergranular surface was much larger in area than stub "A", which indicates a larger grain size. An intergranular fracture is often referred to as a "rock candy" fracture.

Figure 11. Fractured surfaces of the test specimens taken from stub "A" and stub "B". Specimen fractured at room temperature. The top edge in both photographs is the fracture surface which occurred in service. Examples of intergranular fracture are shown within circles.
